Riparian Health Assessment of the Gaspereau River

F209-125

January 2020

EOS Eco-Energy Inc.

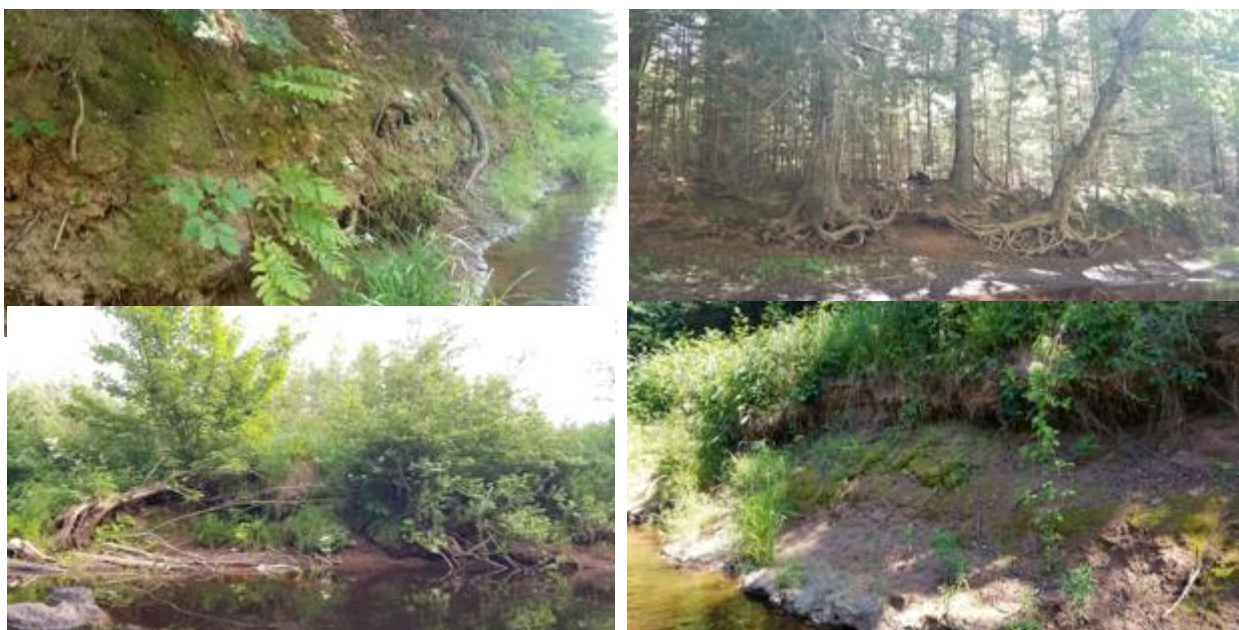
Indicators of an unhealthy riparian area include signs of bank erosion; undercut banks; bare ground (sometimes with rutting or hummocking) from livestock or human activity; standing dead woody vegetation; lack of preferred tree and shrub establishment and regeneration; and an abundance of invasive weeds or disturbance caused plants (Figure 4).

Figure 3: Examples of unhealthy reaches of the Gaspereau River

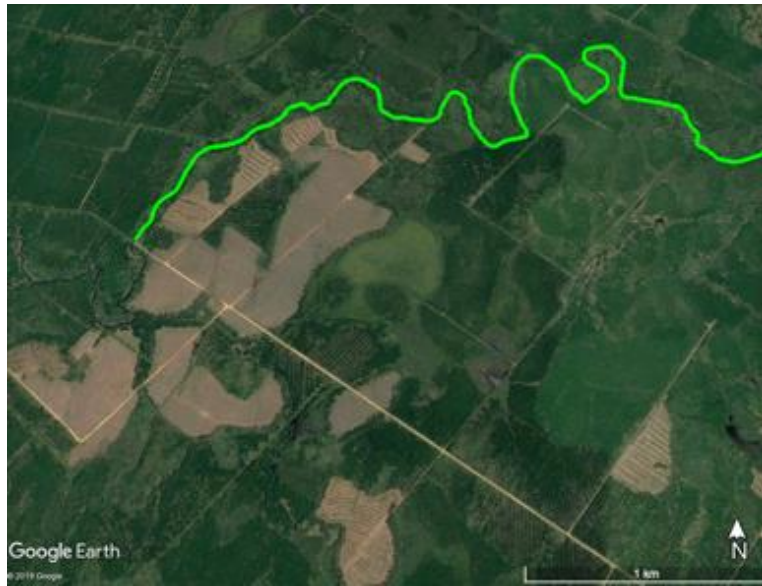
The stretch of river downstream from Coburg Road was accessed at the end of a logging road with some sections of clear-cutting in the vicinity of the river (Figure 4). This first section of the river had 14 assessments taken, 9 assessments were healthy and 5 assessments were healthy with problems (table 2 & 3). In terms of vegetation ratings, 7 assessments were healthy, 6 assessments were healthy with problems, and 1 assessment was unhealthy. For soil/hydrology ratings, 9 assessments were healthy and 5 assessments were healthy with problems.

Figure 4: Aerial view of forest loss in the vicinity of the assessment downstream from Coburg Road

The first 4 assessments (~ 2 km) of the river were healthy with problems. This is mostly due to the human impact and clearcutting in this area. There were invasive and disturbance caused plants present. However, the biggest issue was the lack of streambank root mass protection (4/6) and the reach being structurally altered by human activity (clearcutting, 0/3). Clearcutting was noticeable while walking the river for the first kilometer with thinned out trees or younger (1-3 inch trunk) conifer plantations (Figure 5). The Coburg Road access point also appeared to be a popular gathering spot for campfires as beer cans and other food packing was scattered around the end of the road down to the banks of the river. This continued throughout this reach of river, with debris and garbage being found a ways downstream. There was also a good amount of industrial debris within the first few kilometers (e.g. tires, oil canisters, beams of wood, material scraps from erosion fencing, etc.).

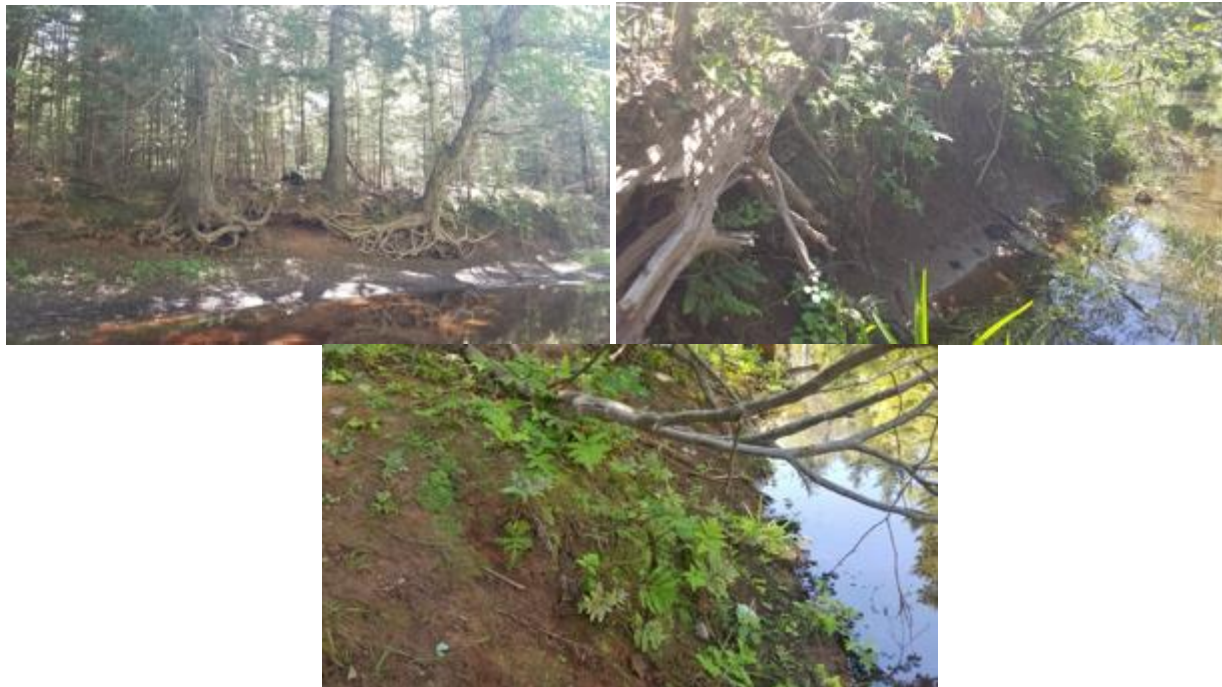
After the first 4 assessments (2 km), the river was rated healthy, aside from assessment 12 which was healthy with problems (table 2 & 3). This was due to lack of human impact as well as the good vertical stability of the stream channel (the riparian zone was very wide, with minimal to no slope, allowing the stream access to its floodplain during high water events). For the most part, this stretch of river was wide, shallow and rocky in most areas, and could be easily walked through. Tree cover was consistent through this section and a good mix of younger trees and plants could be seen amongst the mature trees along the river. There were a lot of frogs, mussels, and minnows present. We also saw moose tracks. The one assessment that came as healthy with problems (assessment 12) was due to a lack of streambank root mass protection. As we progressed further down the river, we saw a change from lots of trees and shrub species in the riparian area providing deep roots and bank stability, to a riparian area with exposed banks scattered with mosses, ferns, and grasses. Bank erosion was also present in this stretch with roots exposed, undercutting and disturbance caused plants present. There was also a lot of deadwood present (Figure 6).

Figure 6: Cases of bank erosion along the Gaspereau River

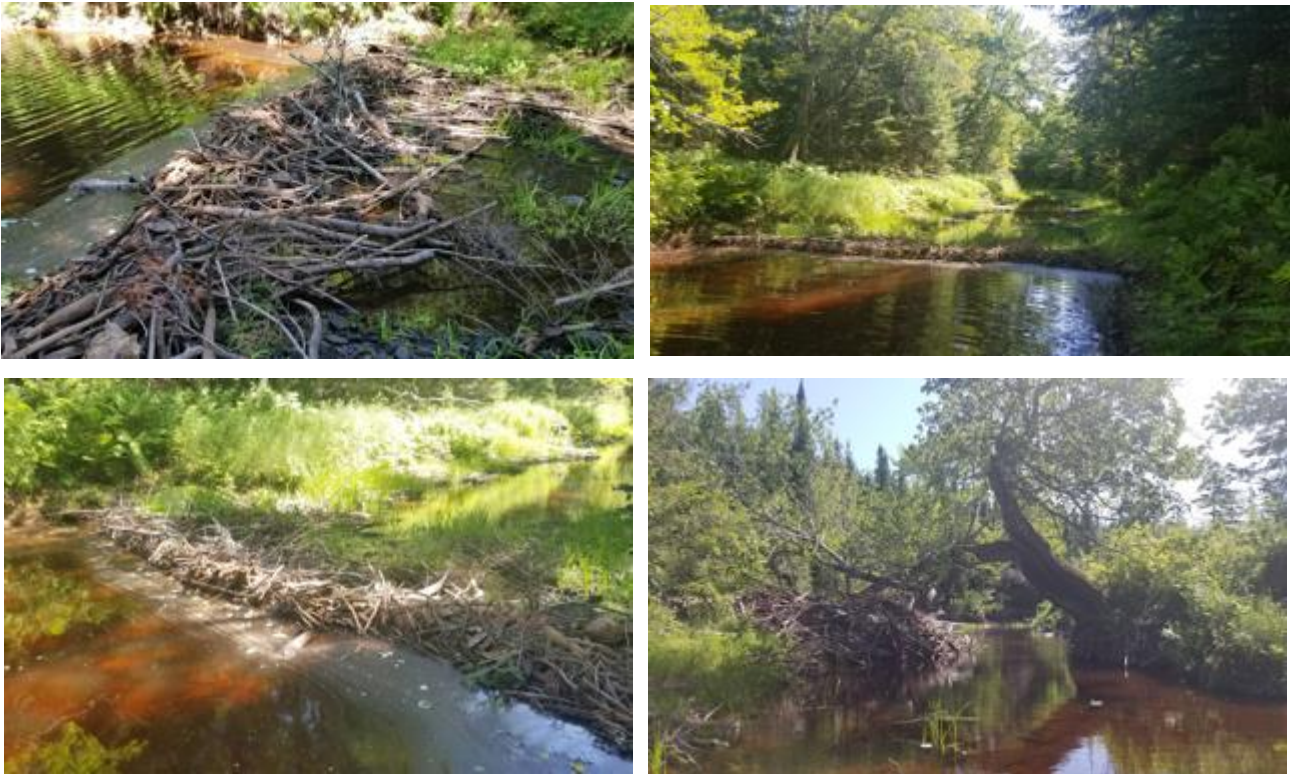
Some other notable characteristics of this stretch included a couple beaver dam/wood build ups presenting a barrier across the river (Figure 7). The wide, shallow river also had such low water levels it appeared to disappear sometimes among emergent aquatic vegetation (Figure 8). The low water levels and warm water temperatures also resulted in massive stretches of the river covered in algae (Figure 9).

Figure 7: Cases of beaver activity along the Gaspereau River

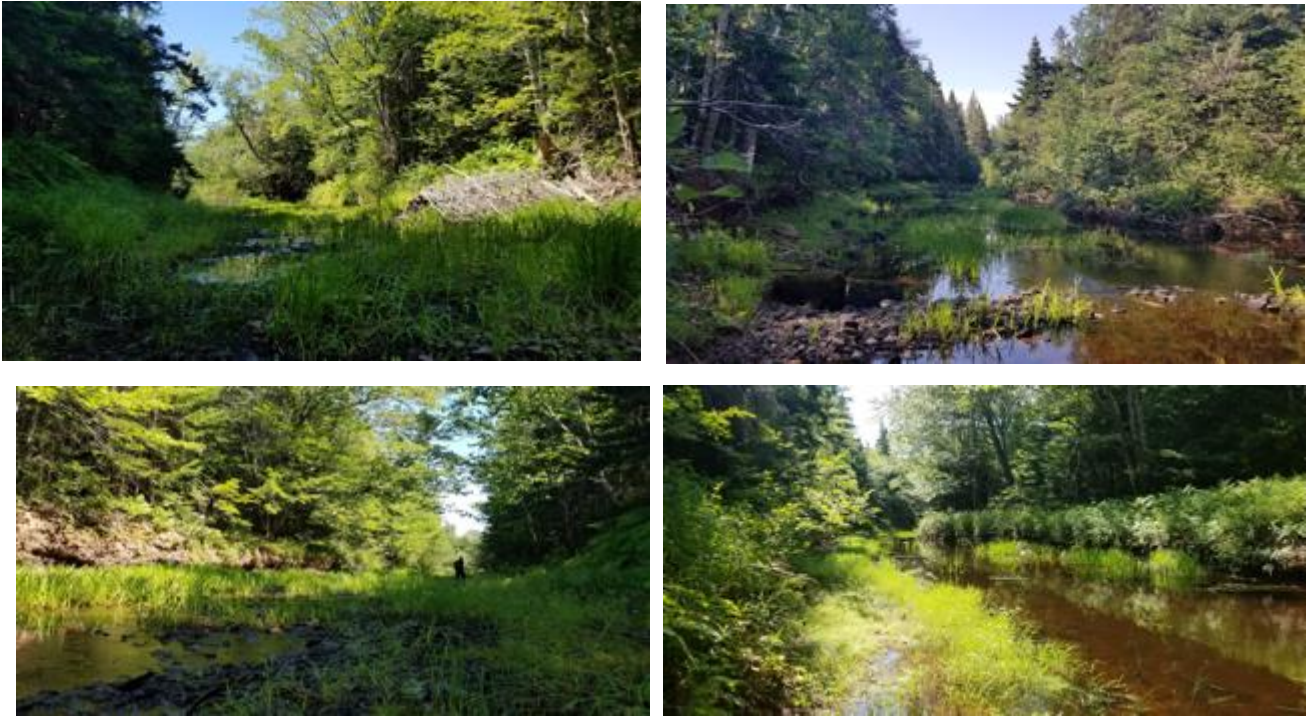
Figure 8: Emergent vegetation in the Gaspereau River

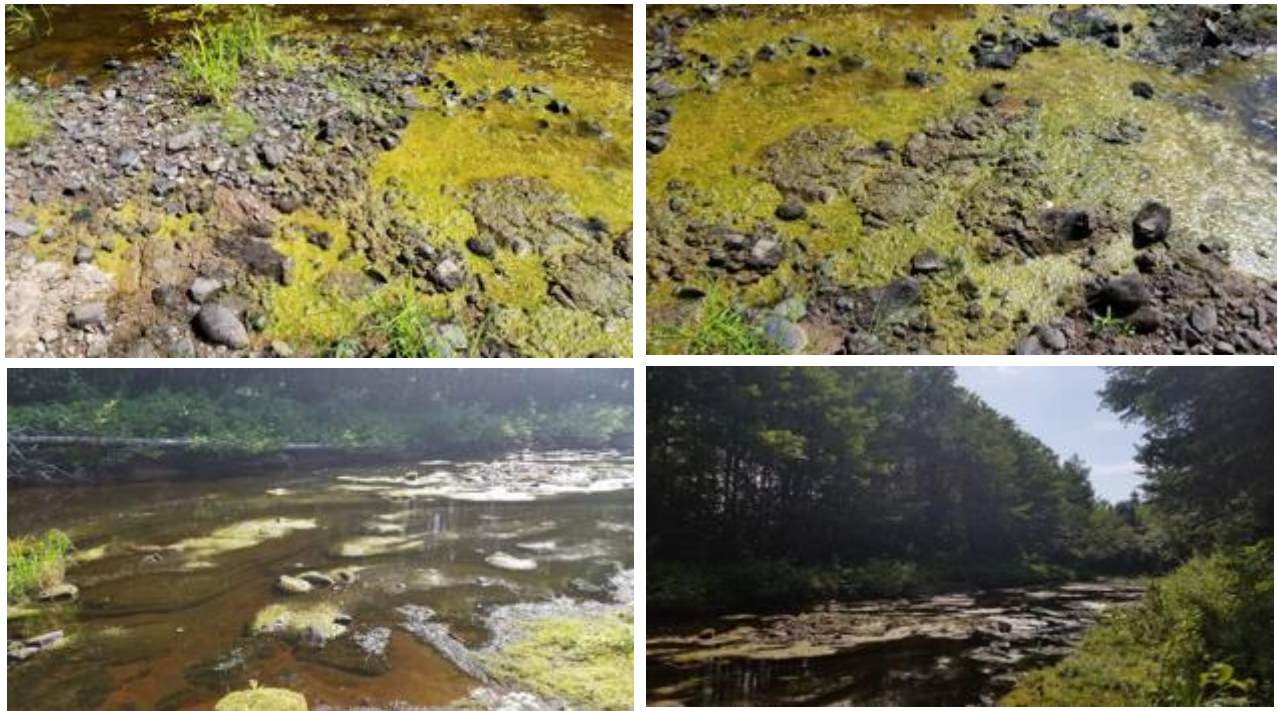
Figure 9: Algae growing in the Gaspereau River

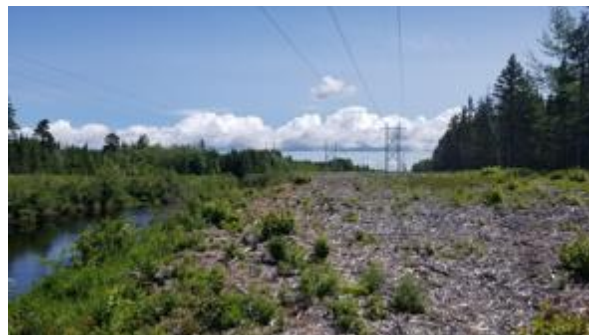
Our next assessment was accessed by portaging through the powerline clearing on Route 15 to assess upstream (Table 4). Four assessments were completed for the assessment upstream of the powerlines on Route 15. Overall, 3 assessments were healthy and 1 was healthy with problems. In terms of vegetation ratings, 2 were healthy and 2 were healthy with problems. For soil/hydrology ratings, 3 were healthy and 1 was healthy with problems. This stretch of river was very similar to the first section in that the first 3 assessments were healthy and the 4th assessment was healthy with problems. Assessment 4 was the section of river next to the powerline clear-cut (Figure 11).

Figure 11: Powerline clearing off Route 15

It scored a 77% in vegetation and a 63% for soil/hydrology. While it had some preferred, deep rooted vegetation (e.g. alder, sweetgrass), it also had disturbance caused plants present and was lacking any

preferred tree and shrubs for regeneration due to the clear-cutting. The bank was lacking in streambank root mass protection and was quite channelized with some slight undercutting present and exposed roots emerging from the banks. Overall this river reach was mostly channelized, with good overhead tree cover (primarily coniferous with some maple, as well as alder and meadowsweet present) with a mix of old and young trees along the right-hand bank facing downstream. The left-hand bank facing downstream had scattered trees and more grassy fields. There were also a few cottages on that side of the stream. The riverbed changed from rocky upstream to very silty downstream. The rocky river bottom had lots of macrophyte growth. This stretch of river marked the end of signs of tidal influence on the river. We stopped our assessment based on having to stop and carry the canoe for several kilometers again when the river widened out and water became very stagnant and slow moving upstream.

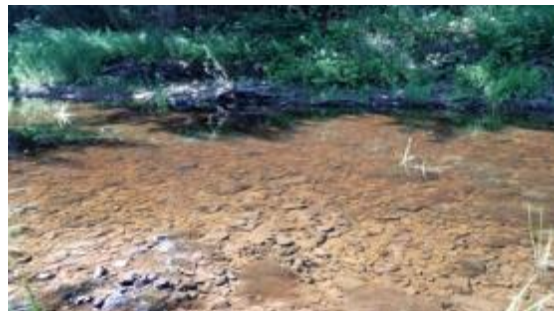
Assessment 1 started up by the powerlines on Route 15, so it was similarly rated healthy with problems due to the lack of bank stabilizing vegetation, channelized banks, and the reach being structurally altered by humans. There was lots of disturbance caused plants and aquatic vegetation present in this stretch with the bottom of the river made up of rocks covered in silt (Figure 12)

Figure 12: River bottom of rocks covered in silt

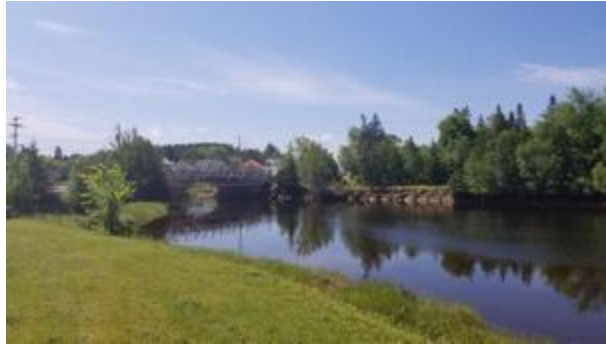
Assessment 5 & 6 scored lower in soil/hydrology (healthy with problems) as we approached the Village of Port Elgin. The streambank & reach were structurally altered for the Route 16 bridge which was accompanied by rock rip-rap. There were also some wooden shore stabilization structures down near the riverside park in Port Elgin (Figure 14).

Figure 14: Wooden shore stabilization near the Main St. bridge in Port Elgin

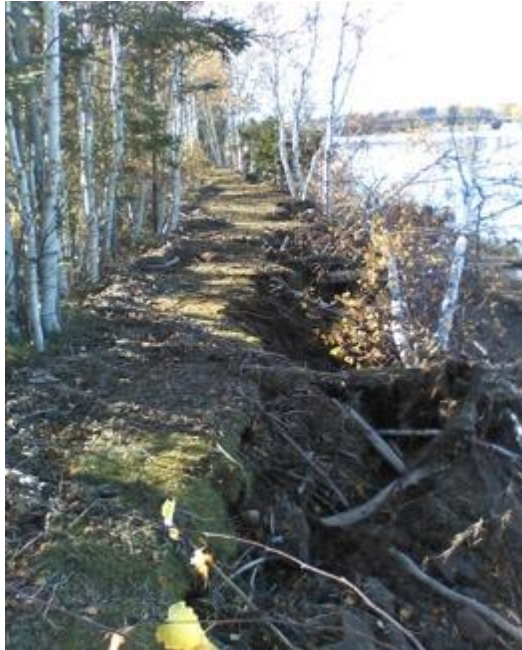
The last two assessments were from the Main St. bridge down to the Trans Canada Trail bridge (Table 6) and from the Trans Canada Trail bridge to the river outflow (Table 7). Both these assessments were healthy with problems overall. Their vegetation ratings were both healthy with problems and their soil/hydrology ratings were unhealthy. This stretch of river goes through the heart of Port Elgin, passing under 2 bridges and passing the community dock. Human streambank alteration lowers the soil/hydrology scores in these assessments. This stretch of the river is also tidally influenced and transforms into mudflats at low-tide (Figure 15). The bottom stretch of this river has experienced drastic streambank erosion (Figure 16). In October 2019, after our assessment was complete, EOS partnered with NatureNB, the Village of Port Elgin, and Shediac Bay Watershed Association to plant 130 trees along an eroded section of the Gaspereau River to help stabilize the streambank and help protect the village sewage lagoon.

Figure 16: Streambank erosion and downed trees along the Gaspereau River

Looking at the summary of our assessment results (Table 8), 58% (15 reaches) of the river were found to be healthy, and 42% (11 reaches) of the river was deemed healthy with problems; while no reaches of the river were found to be unhealthy. Some of the issues could be addressed by increasing and maintaining native vegetation along shorelines. Planting this deep-rooted, native vegetation along the banks/riparian area will help stabilize the soil/hydrology of the streambanks, as well as encourage further growth of vegetation. There could also be a planned river clean-up. From talking to community members, it was discovered that there used to be annual river clean-ups back in the 90s to remove garbage, debris, and beaver dams. Based on the garbage and debris seen during the assessments, the river could benefit from a clean-up.
