Habitat Assessments of the Johnson Creek Watershed

F200-214
February, 2021
Kelli-Nicole Croucher, Watershed Coordinator 2020
Julia Campbell, Watershed Coordinator 2021
Truman Wood, Student Intern

EOS Eco-Energy Inc.
P.O. Box 6001, 43D Main Street
Sackville, NB E4L 1G6
www.eosecoenergy.com

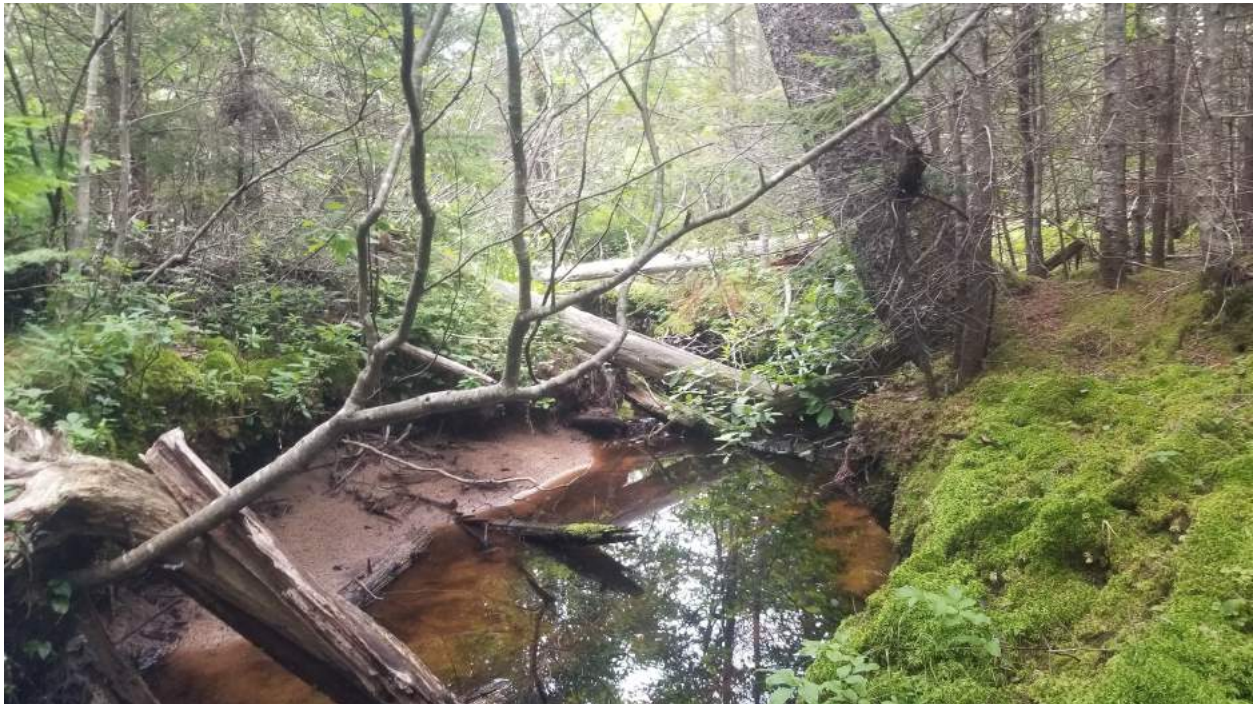
Channel conditions were on average relatively healthy, with the exception of high amounts of fine sediment in North Brook (Figure 2). Combined averages of bedrock and boulder remained above 50% for Johnson Creek and East Brook, while North brook had a lower average with 30% (Table 2). Combined averages of gravel and fines remained below 50% for Johnson Creek and East Brook, while North brook had an average of approximately 70% (Table 2). High amounts of fine sediment can disrupt important habitat for aquatic plants, insects, and fish. Fine sediment can smother aquatic insects which are an important food source for fish, restrict plant and algae growth, and can easily be resuspended which increases stress on fish.

Figure 2: Image of North Brook with High Percentage of Fine Sediment

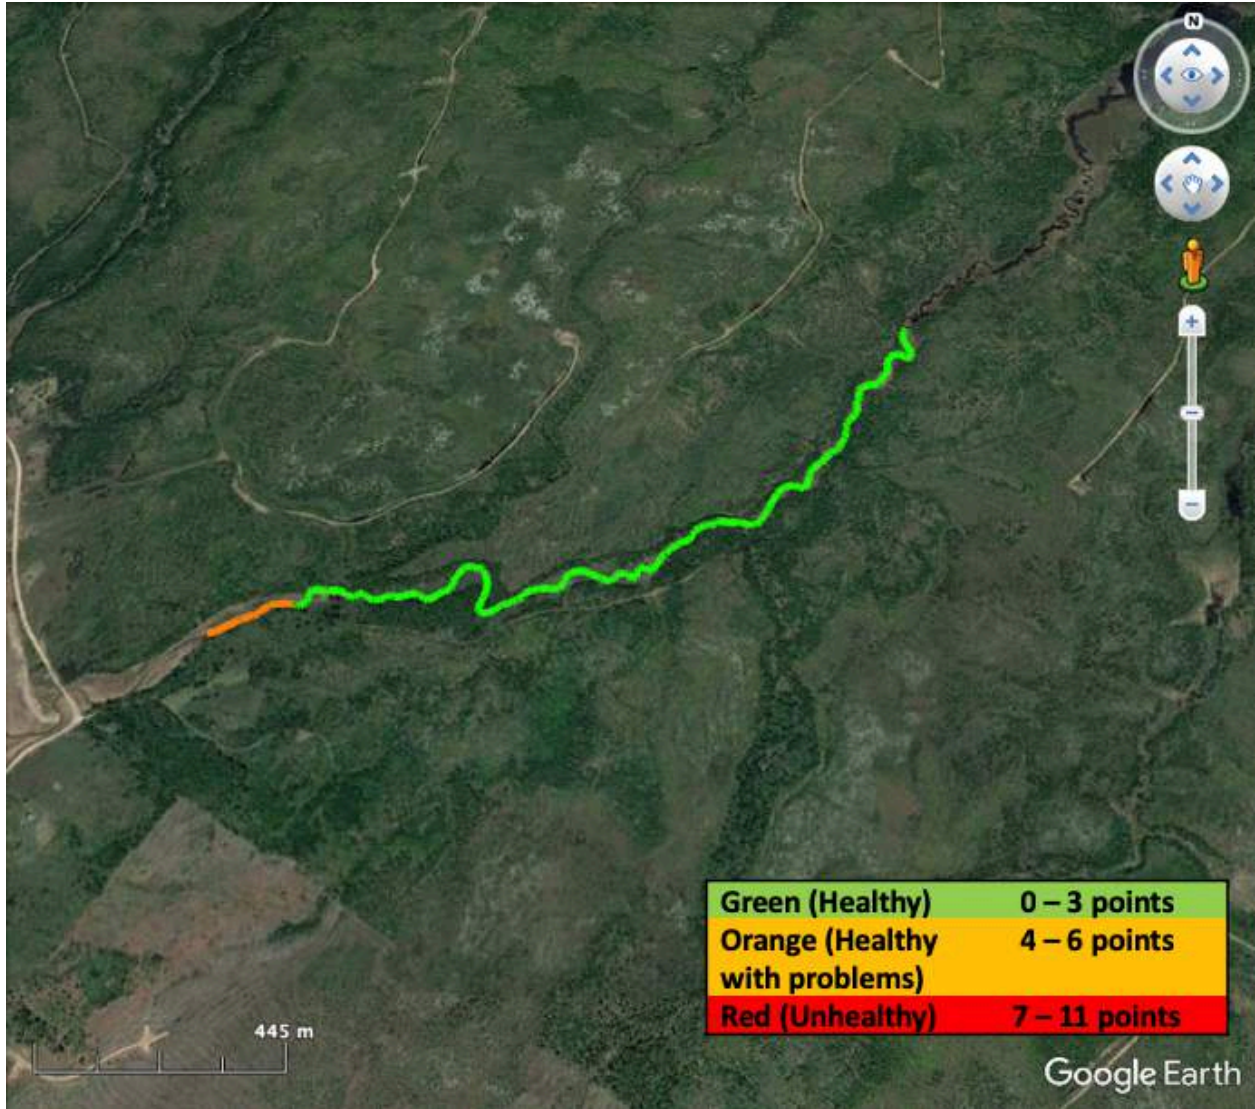
Figure 3: Johnson Creek Point System Map

Habitat assessments on Johnson Creek began ~300m down British Settlement Rd. off Route 935 and commenced for 2km, resulting in 20 assessments. Of these 20 assessments, six out of 20 sites had a total score of zero, meaning 30% of these sites were in good condition, while, 70% of sites could benefit from potential restoration projects. The remaining 14 sites ranged in the number of total points. Most sites were designated as healthy (i.e., 0 – 3 points), with the exception of two sites designated as healthy with problems (i.e., 4 – 6 points) (Figure 3) (Appendix 2, Table 6).

Of these 14 sites, one site recorded DO < 5 mg/L, four sites recorded stream substrate containing 60% or more fine sediment, five sites recorded < 25% shade cover, one site recorded stream banks that were 25% or more bare of vegetation, and 12 sites recorded vegetation consisting of 60% or more grasses (Appendix 2, Table 6).

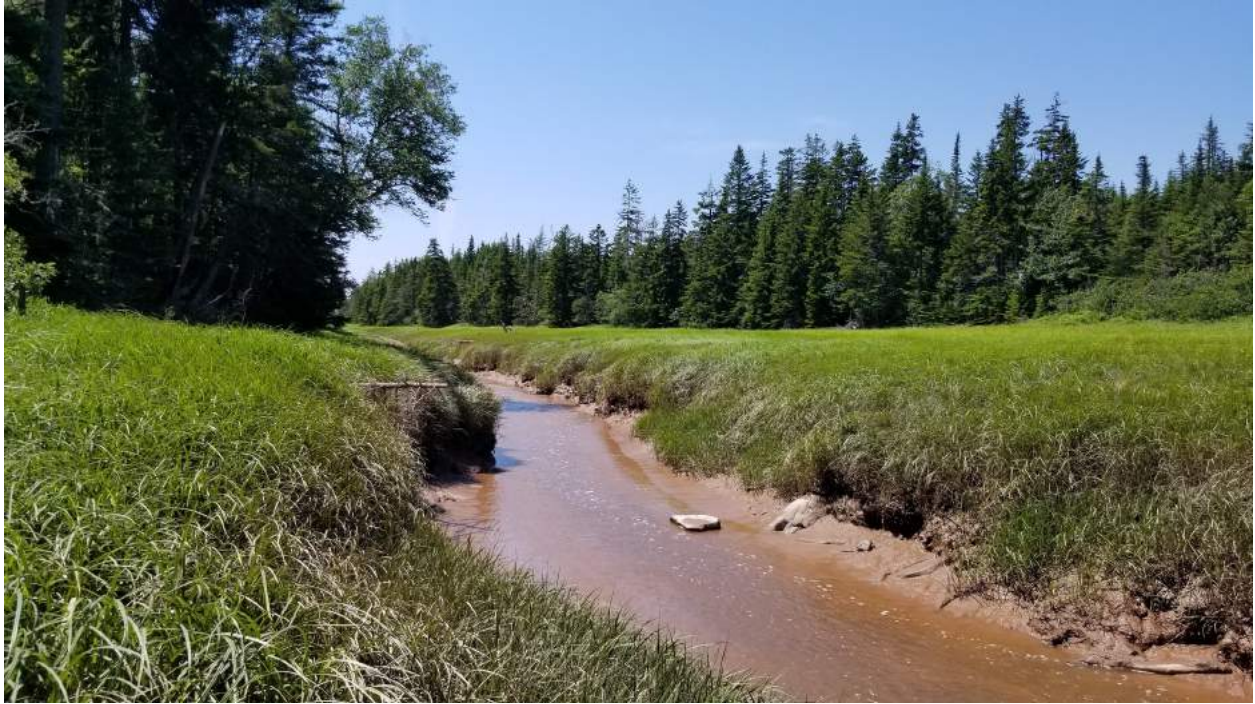
Figure 4: Photo from JC-001 showing grassy vegetation and fine sediment

- 1) Tree planting in riparian zones for sites with stream banks that are 25% or more bare of vegetation and/or has vegetation consisting of 60% or more grasses.
- 2) Remove large debris at sites with substrate containing 60% or more fine sediment to allow for better flow to free-up loose sediment.
- 3) Install brush mats at sites with substrate containing 60% or more fine sediment to capture sediment and build-up healthy stream banks with gradual slope.

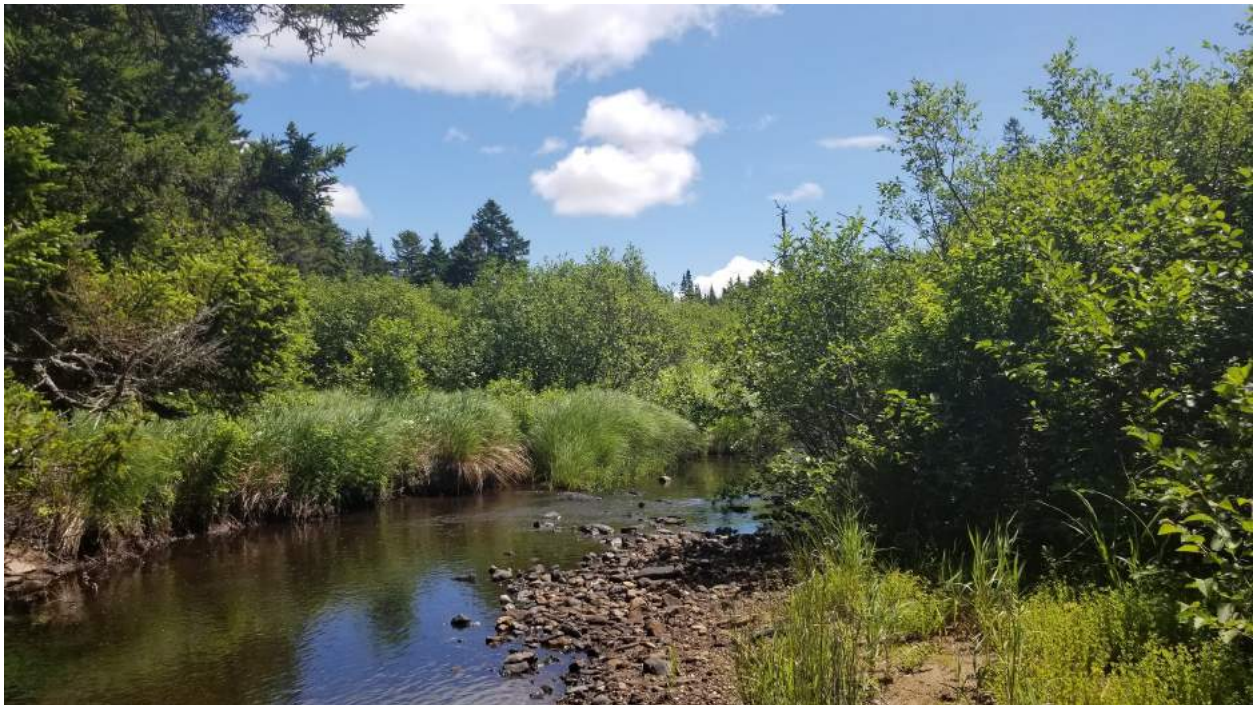
Figure 5: Photo from JC-009 showing low shade cover

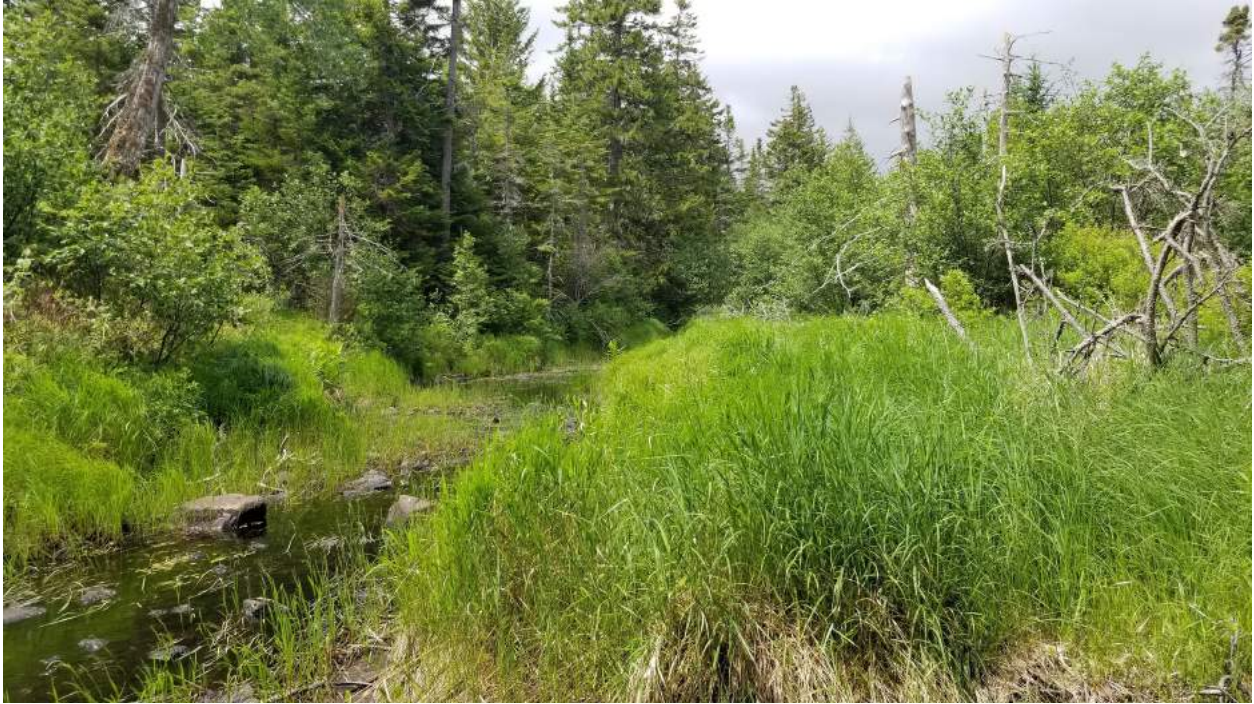
Figure 6: Photo from JC-016 showing grassy vegetation

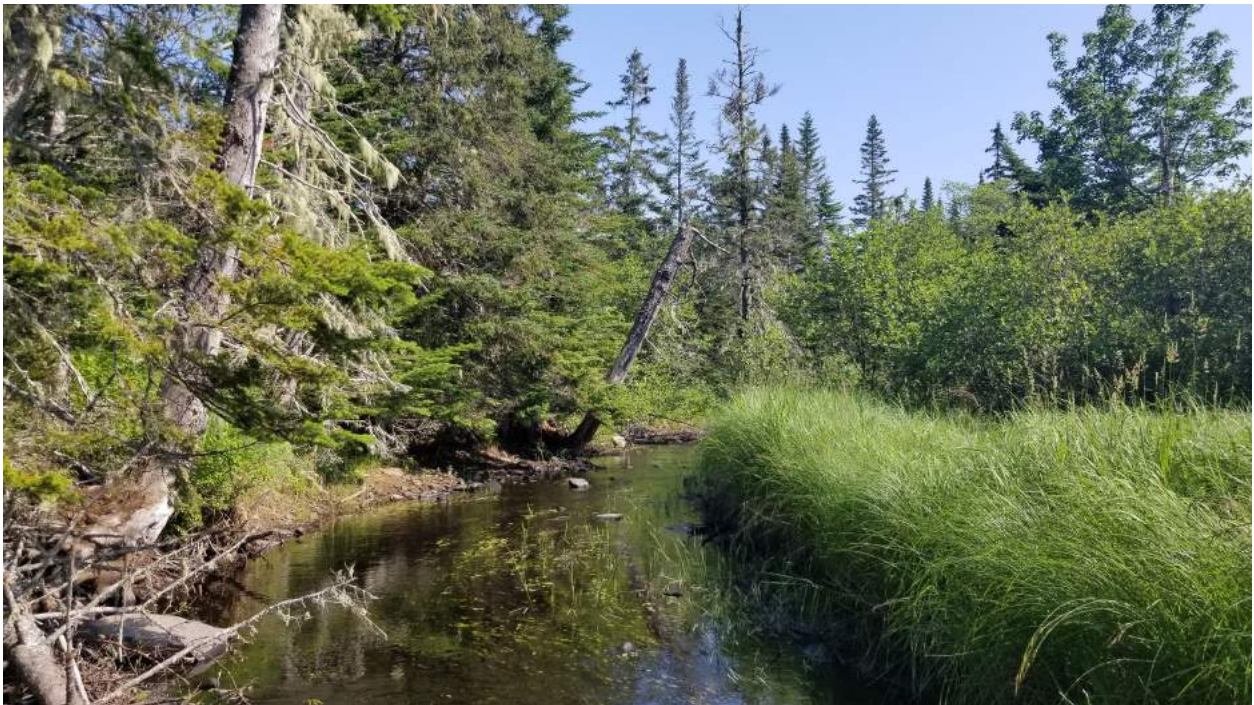
Figure 7: Photo from JC-019 showing grassy vegetation

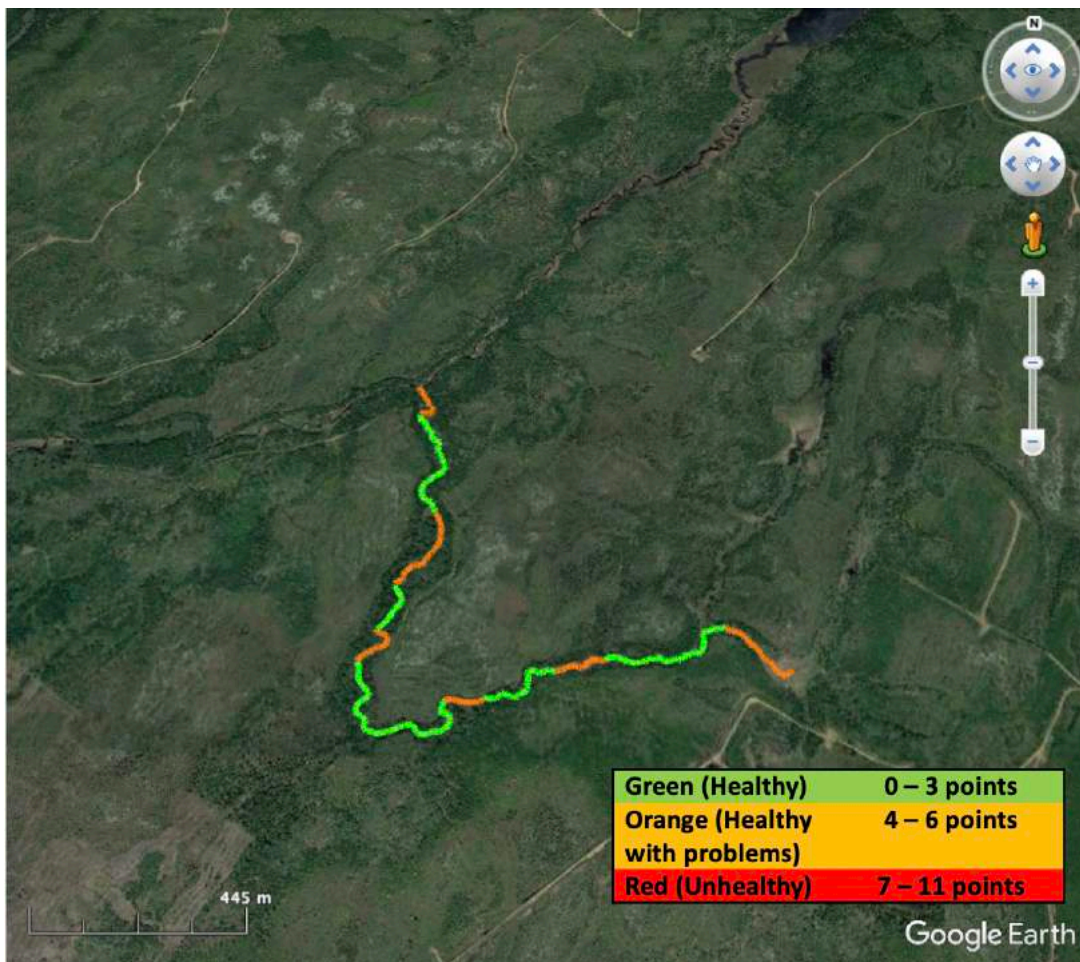
Figure 8: East Brook Point System Map

Habitat assessments on East Brook began ~1.5 km down British Settlement Rd. off Route 935 and commenced for 2.2km, resulting in 22 assessments. Of these 22 assessments, only one out of 22 sites had a total score of zero, meaning 5% of these sites were in good condition, while, 95% of sites could benefit from potential restoration projects. The remaining 21 sites ranged in the number of total points. There were 13 sites designated as healthy (i.e., 0 – 3 points) and eight sites designated as healthy with problems (i.e., 4 – 6 points) (Figure 8) (Appendix 2, Table 7).

Of these 21 sites, two sites recorded DO < 5 mg/L, one site recorded over 40% of stream banks that were slightly eroded, five sites recorded stream substrate containing 60% or more fine sediment, one site recorded < 25% shade cover, 10 sites recorded stream banks that were 25% or more bare of vegetation, and 15 sites recorded vegetation consisting of 60% or more grasses (Appendix 2, Table 7).

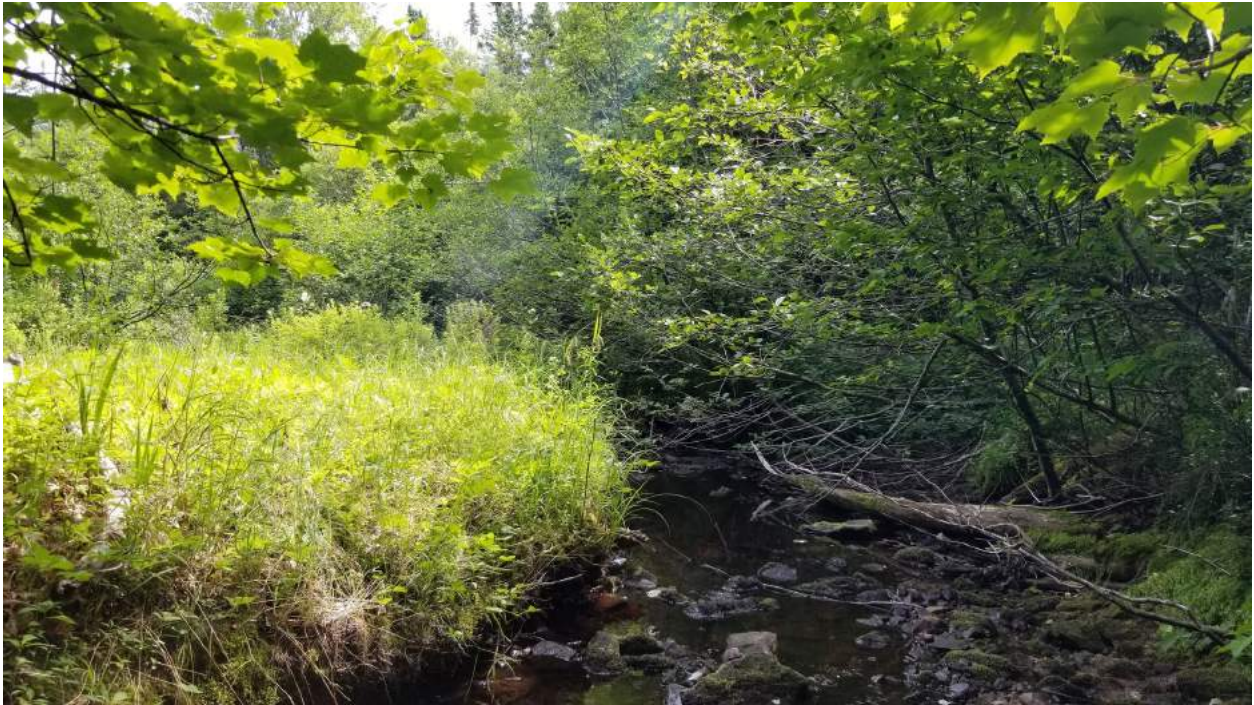
Figure 9: Photo from JC-EBrk-002 showing grassy vegetation

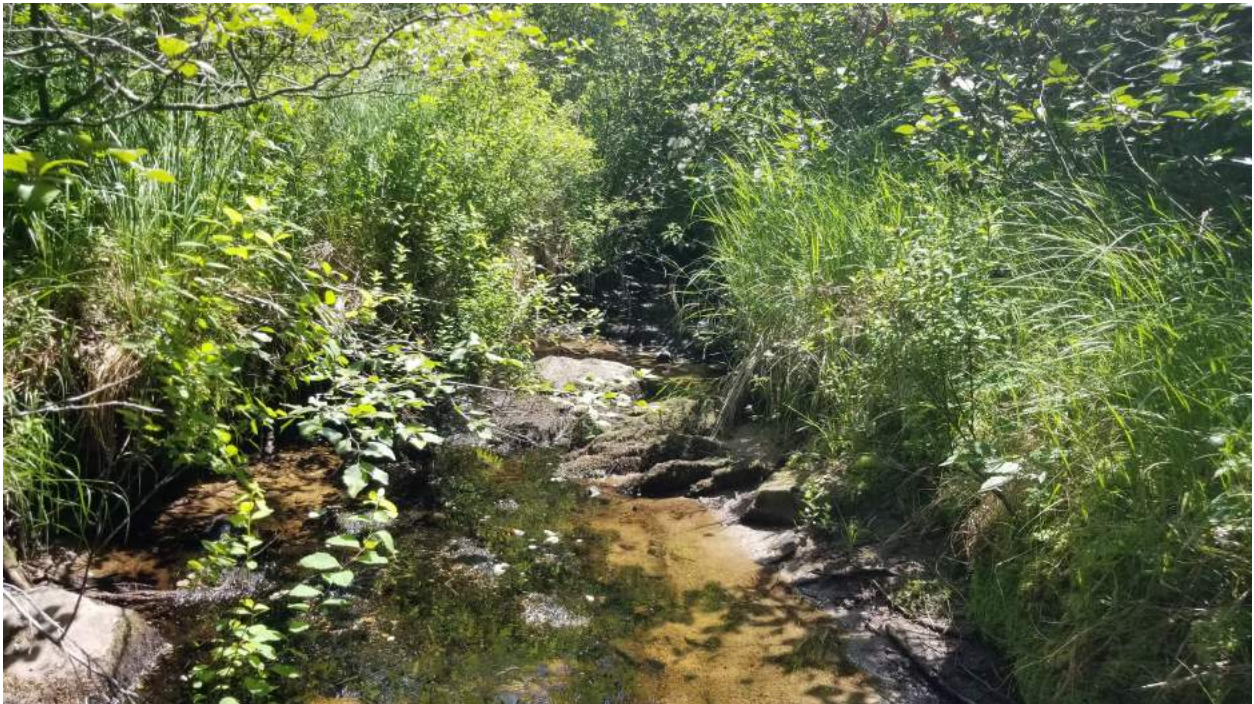
Figure 10: Photo from JC-EBrk-011 showing grassy vegetation and fine sediment

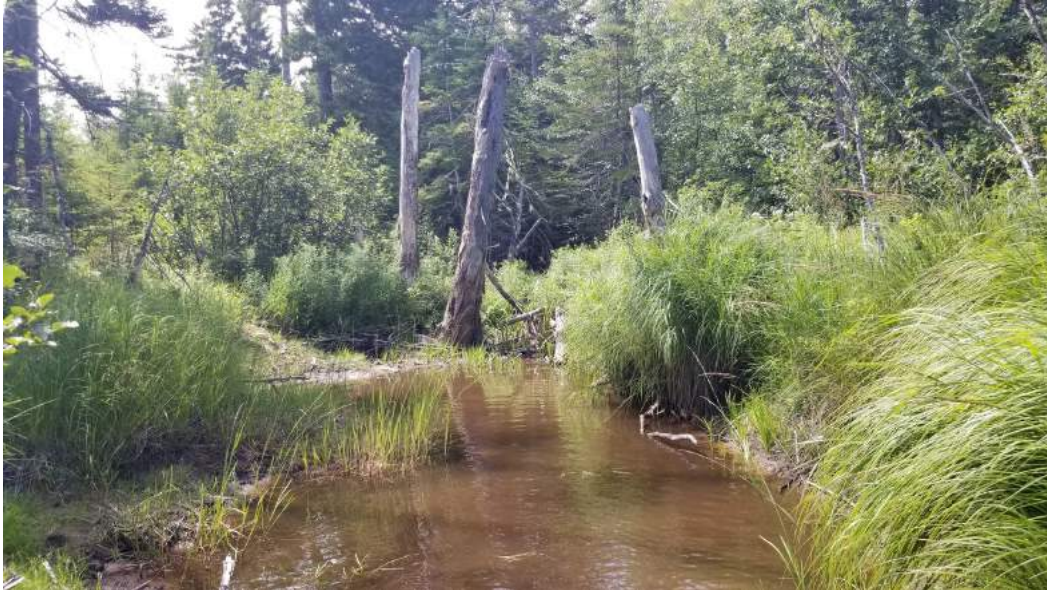
Figure 11: Photo from JC-EBrk-015 showing grassy vegetation and fine sediment

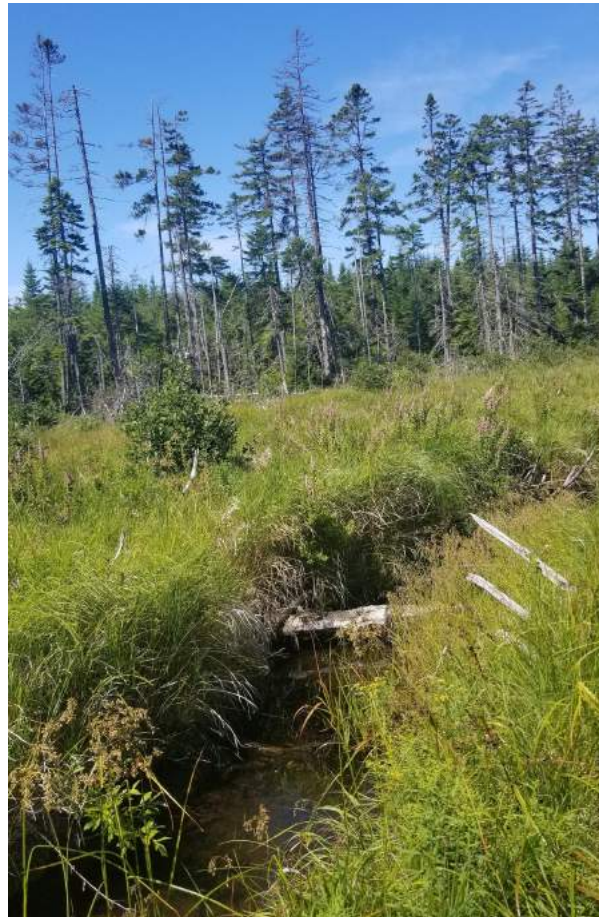
Figure 12: Photo from JC-EBrk-021 showing grassy vegetation

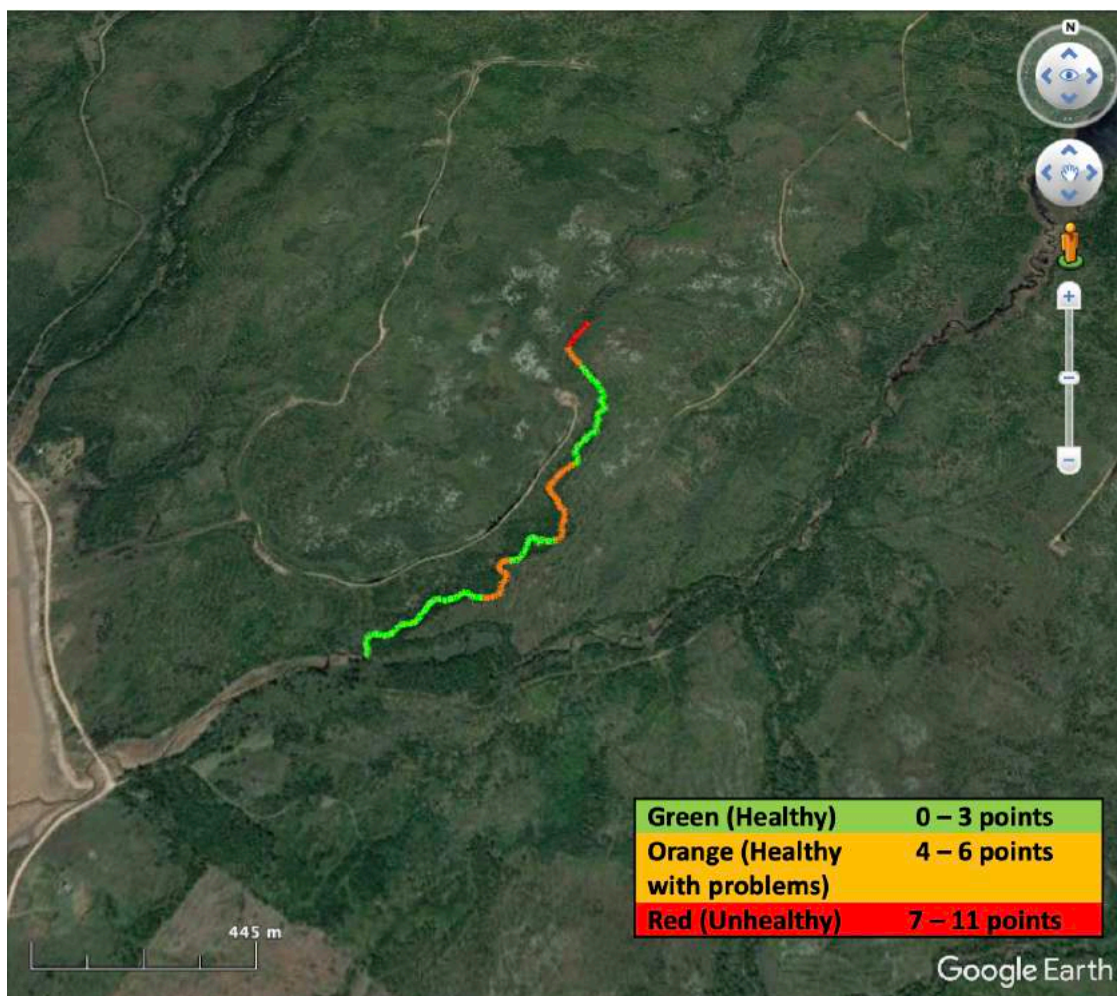
Figure 13: North Brook Point System Map

Habitat assessments on North Brook began ~550m down British Settlement Rd. off Route 935 and commenced for 1.3km, resulting in 13 assessments. Of these 13 assessments, no sites had a total score of zero, meaning 100% of sites could benefit from potential restoration projects. Sites ranged in the number of total points. There were eight sites designated as healthy (i.e., 0 – 3 points), four sites designated as healthy with problems (i.e., 4 – 6 points), and one site designated as unhealthy (Figure 13) (Appendix 2, Table 8).

Of these 13 sites, one site recorded DO < 5 mg/L, three sites recorded over 25% of stream banks with heavy erosion, 10 sites recorded stream substrate containing 60% or more fine sediment, 11 sites recorded stream banks that were 25% or more bare of vegetation, and one sites recorded vegetation consisting of 60% or more grasses (Appendix 2, Table 8).

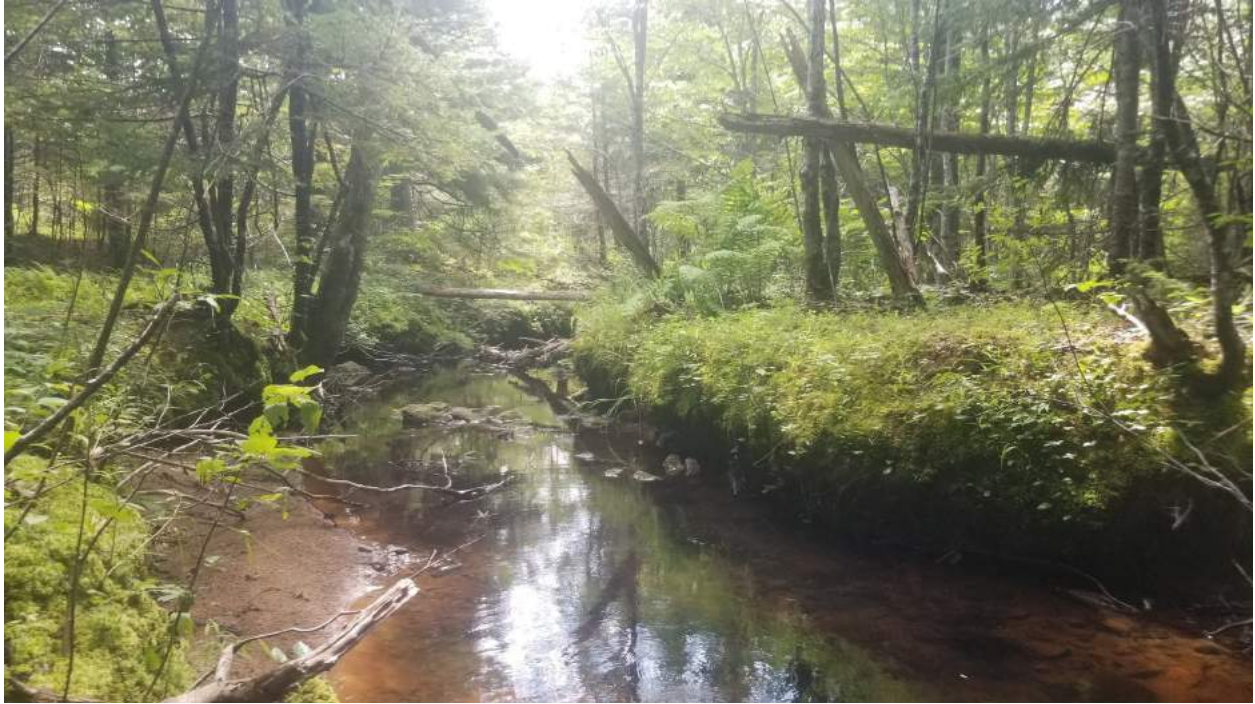
Figure 14: Photo from JC-NBrk-007 showing fine sediment and under-cut stream banks

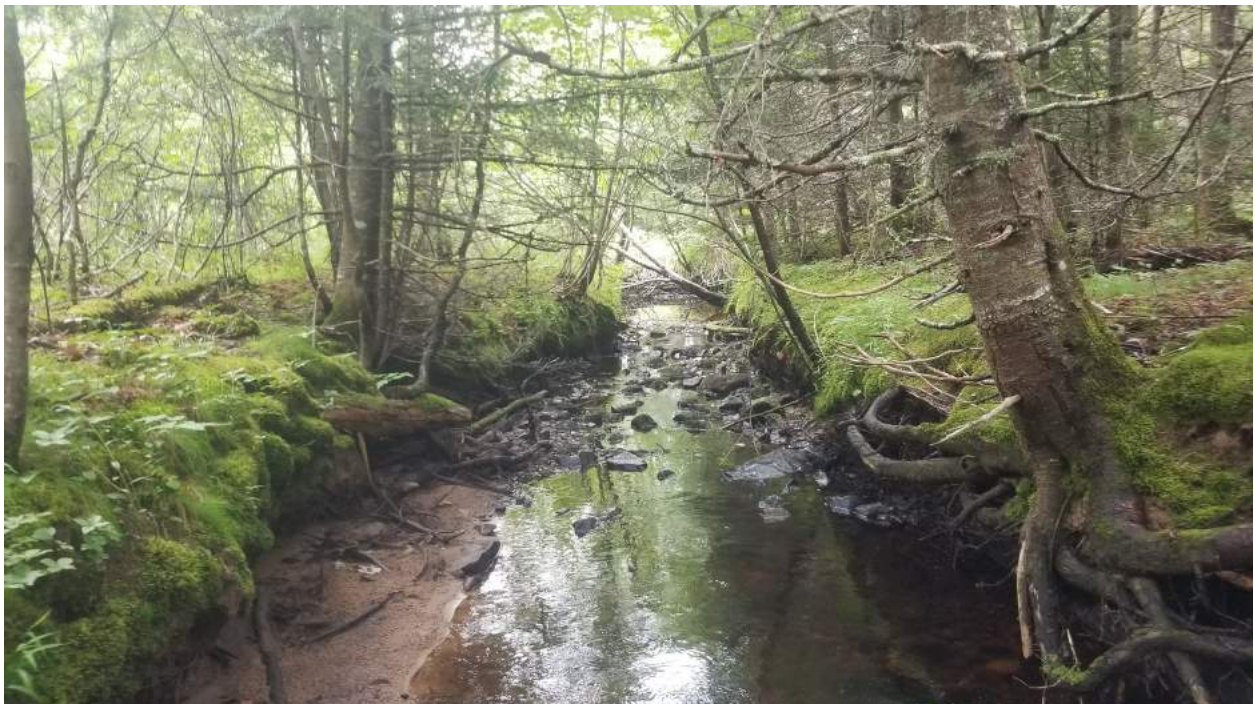
Figure 15: Photo from JC-NBrk-009 showing fine sediment and under-cut stream banks

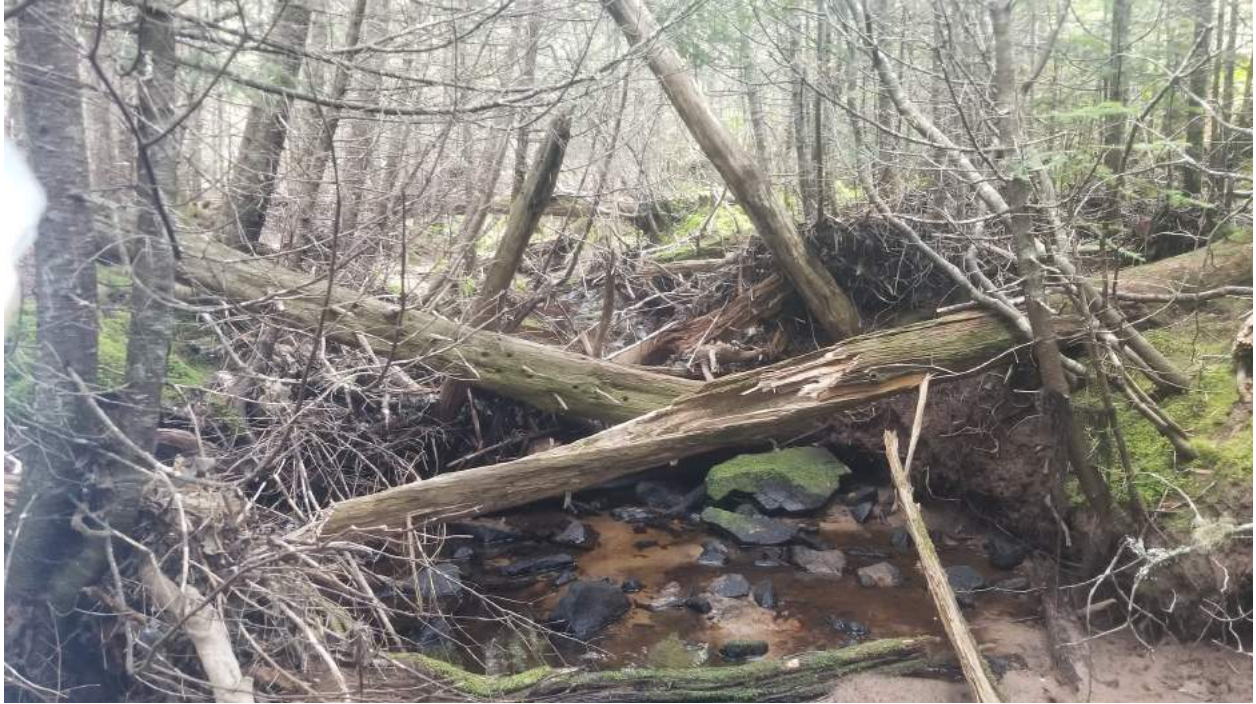
Figure 16: Photo from JC-NBrk-012 showing heavy erosion and fine sediment

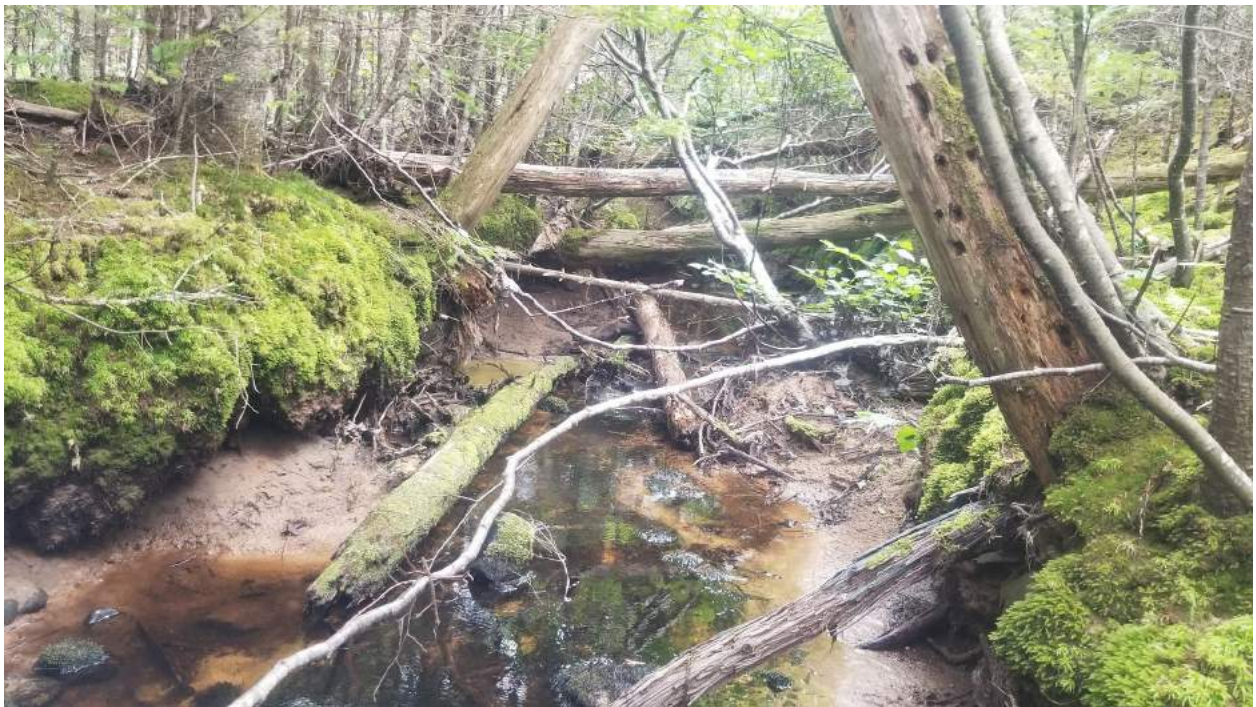
Figure 17: Photo from JC-NBrk-013 showing heavy erosion and fine sediment
