# Habitat Assessments of Joe Brook

February, 2022

EOS Eco-Energy Inc.

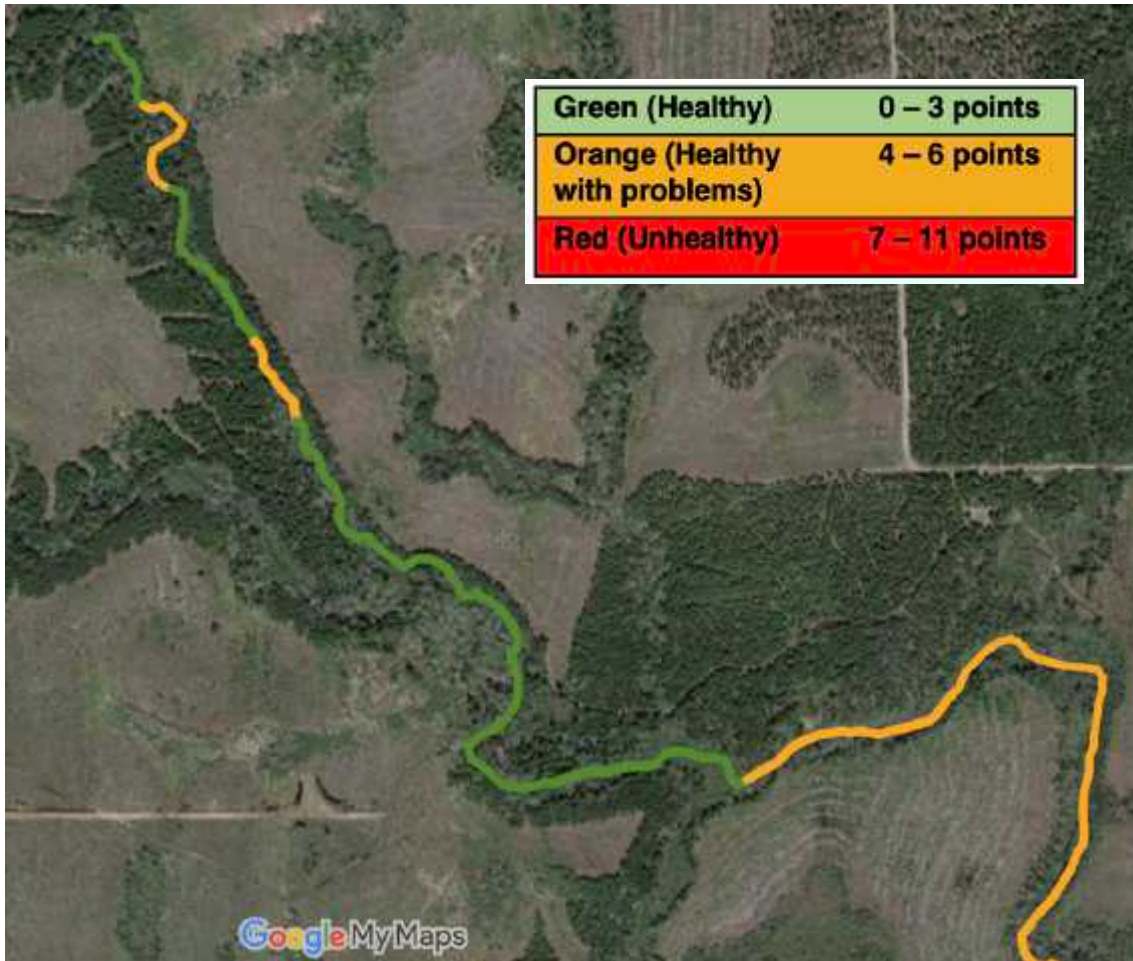
Figure 2: Joe Brook Upstream Point Systems Map (Reach 1-30)

Habitat assessments on Joe Brook began nearly 9 kilometers down a logging road off the Upper Aboujagane Road. Thirty assessments were done in the upstream region of the brook. Of these 30 assessments, only 1 had a total score of 0, meaning that it was in good condition, while the remaining sites could benefit from potential restoration projects. The remaining 29 sites ranged in number of total points. Most sites, or 67% of them, were designated as healthy with problems (4-6 points), while 9 sites or 30% were categorized as healthy (i.e., 1 – 3 points) (Figure 2)

Of these 30 sites, 10 sites recorded less than 25% shade cover, 4 sites recorded vegetation consisting of 60% or more grasses and 19 sites recorded that 40% or more of the bank was slightly eroded.

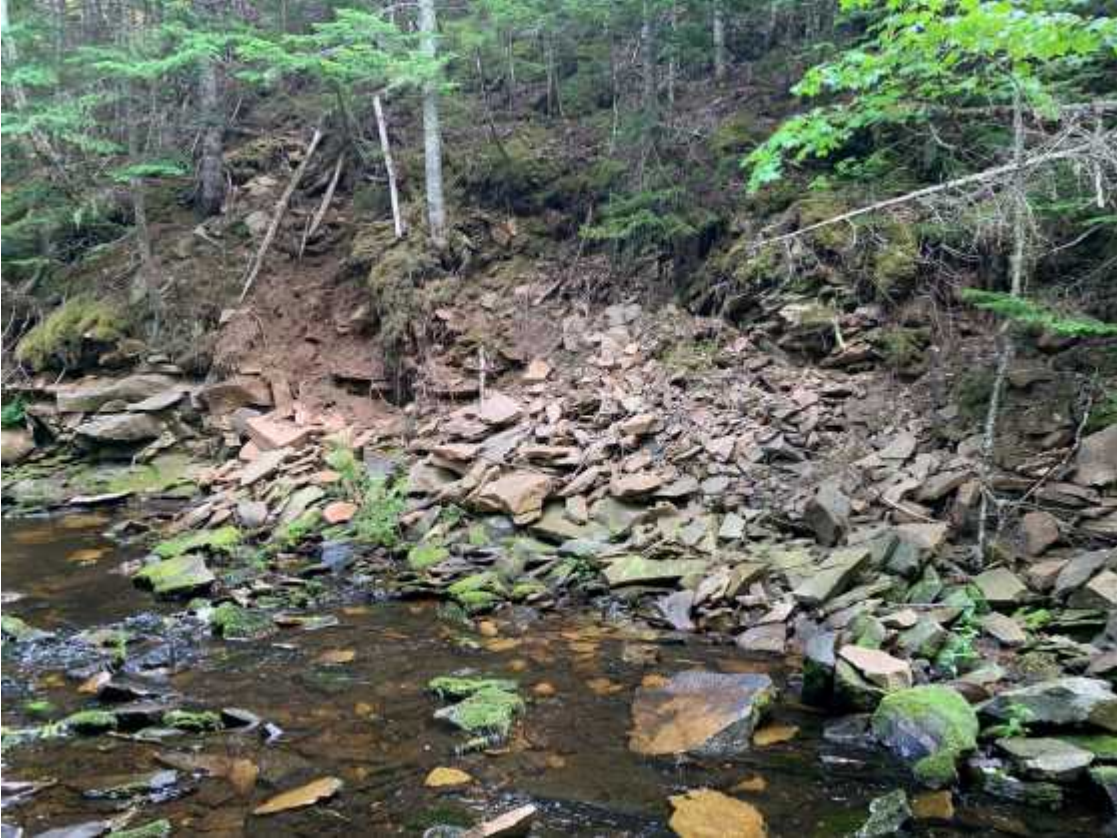
*Figure 3: Photo from JB-19 showing an eroded bank*

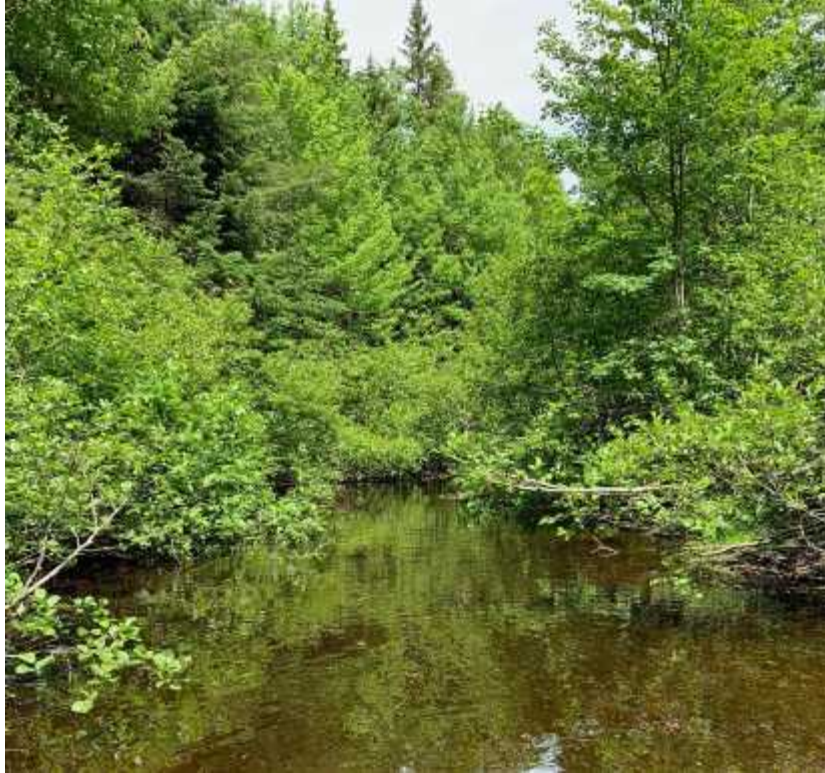
*Figure 4: Photo from JB-14 showing a lack of shade cover*

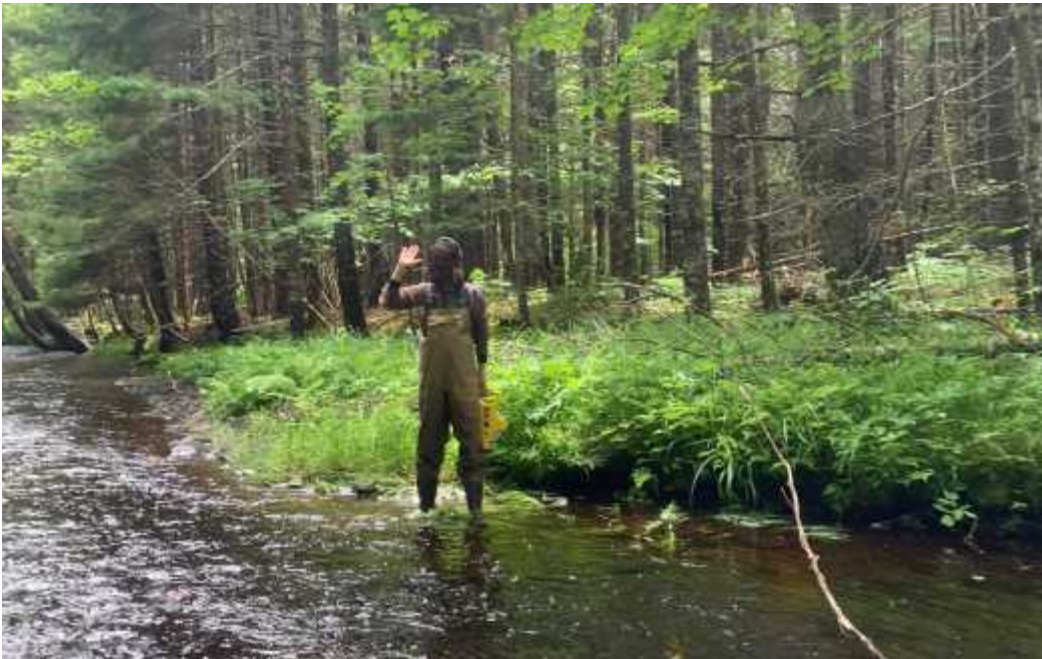
*Figure 5: A photo from JB-26 showing grassy vegetation*

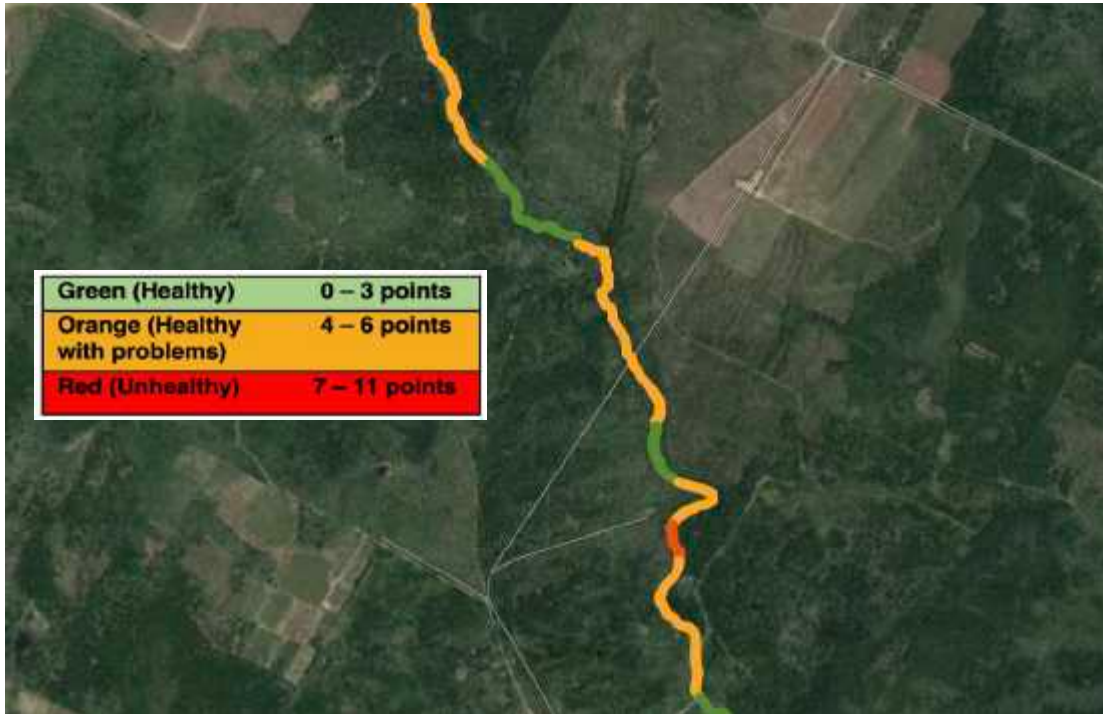
Figure 6: Midstream Point System Map (Reach 31 – Reach 64)

Of these 34 assessments, only 1 had a total score of 0, meaning that it was in good condition, while the remaining sites could benefit from potential restoration projects. The remaining 33 sites ranged in number of total points. Most sites, or 70.6% of them, were designated as healthy with problems (4-6 points), while 8 sites or 23.5% were categorized as healthy (i.e., 1 – 3 points). One site was designated as unhealthy. (Figure 6) (Appendix)

Of these 34 sites, 24 sites recorded less than 25% shade cover, 21 sites recorded that 40% or more of the bank was slightly eroded, 5 sites recorded that over 25% of the bank was heavily eroded,

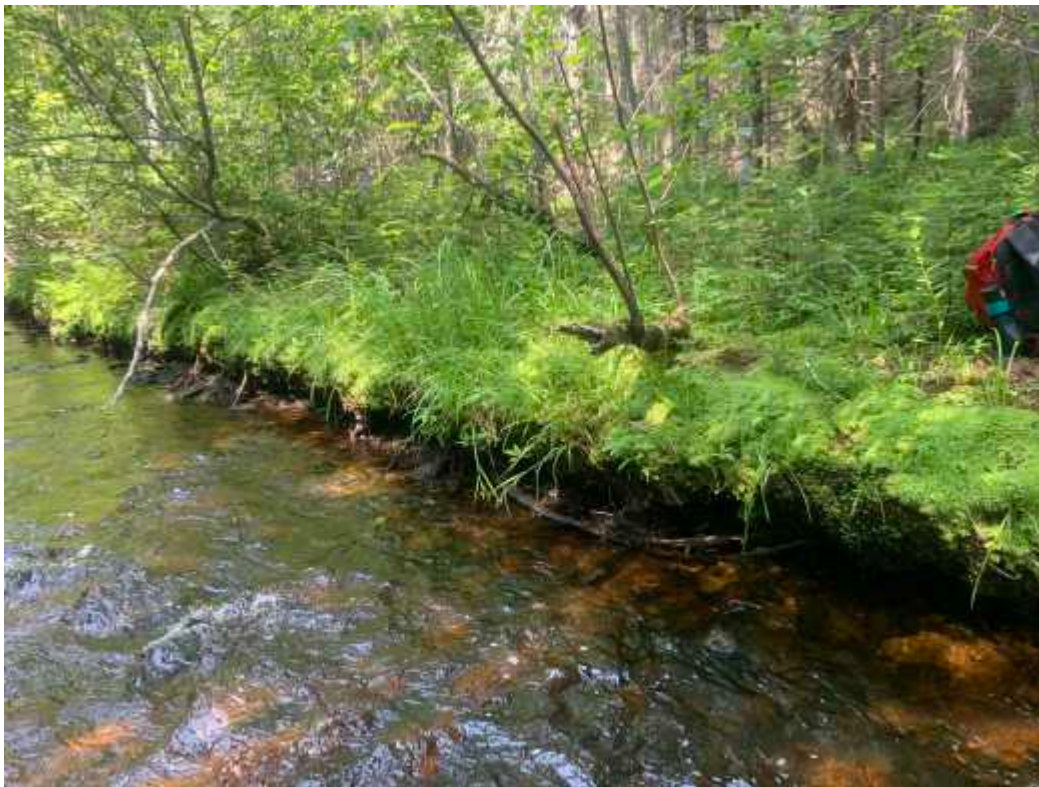
Figure 7: Photo from JB- showing undercut banks and grassy vegetation

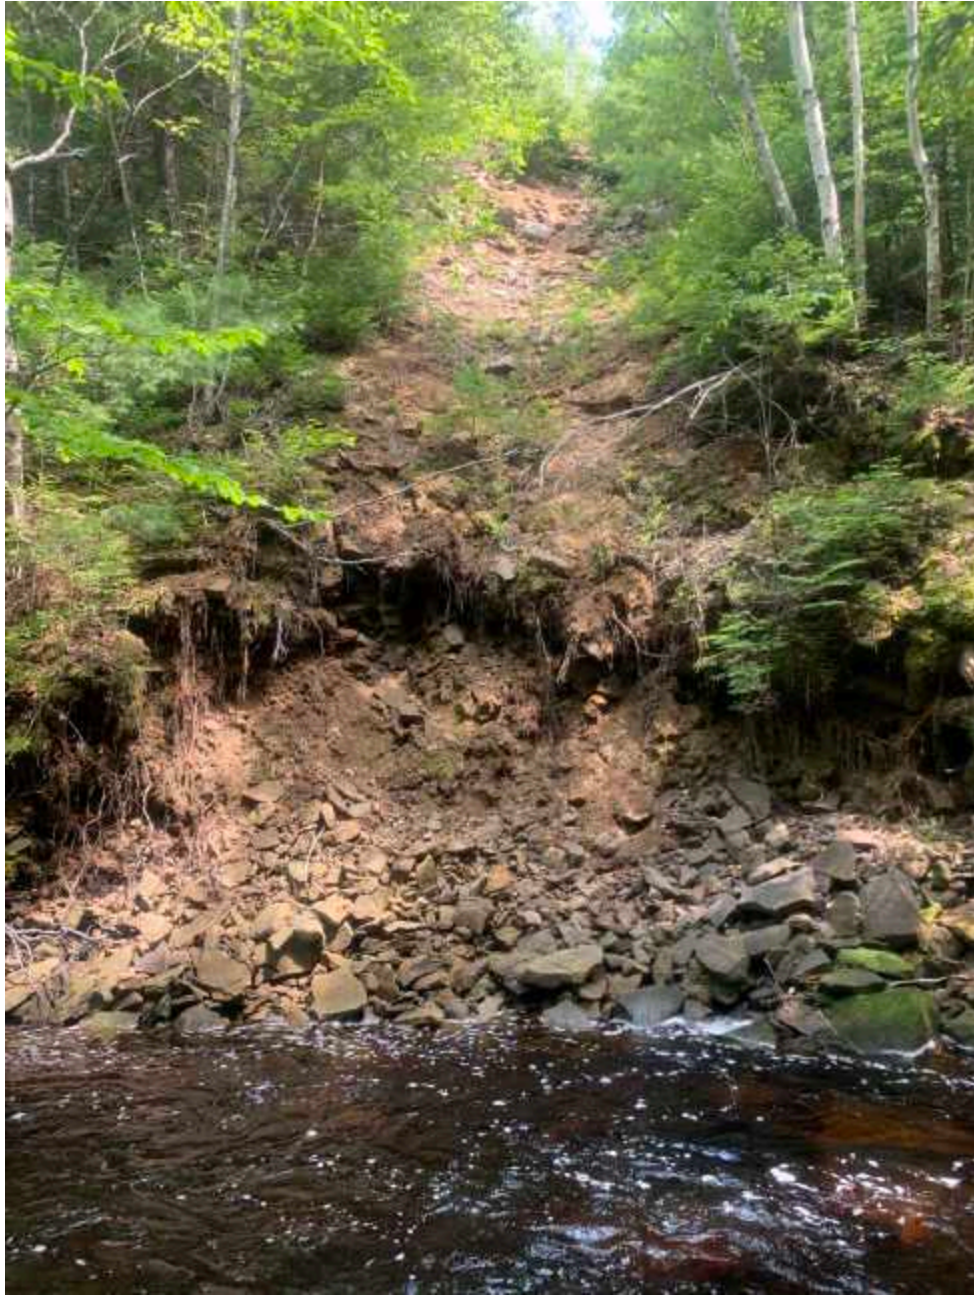
*Figure 8: Photo from JB-57 showing a heavily eroded section of the bank*

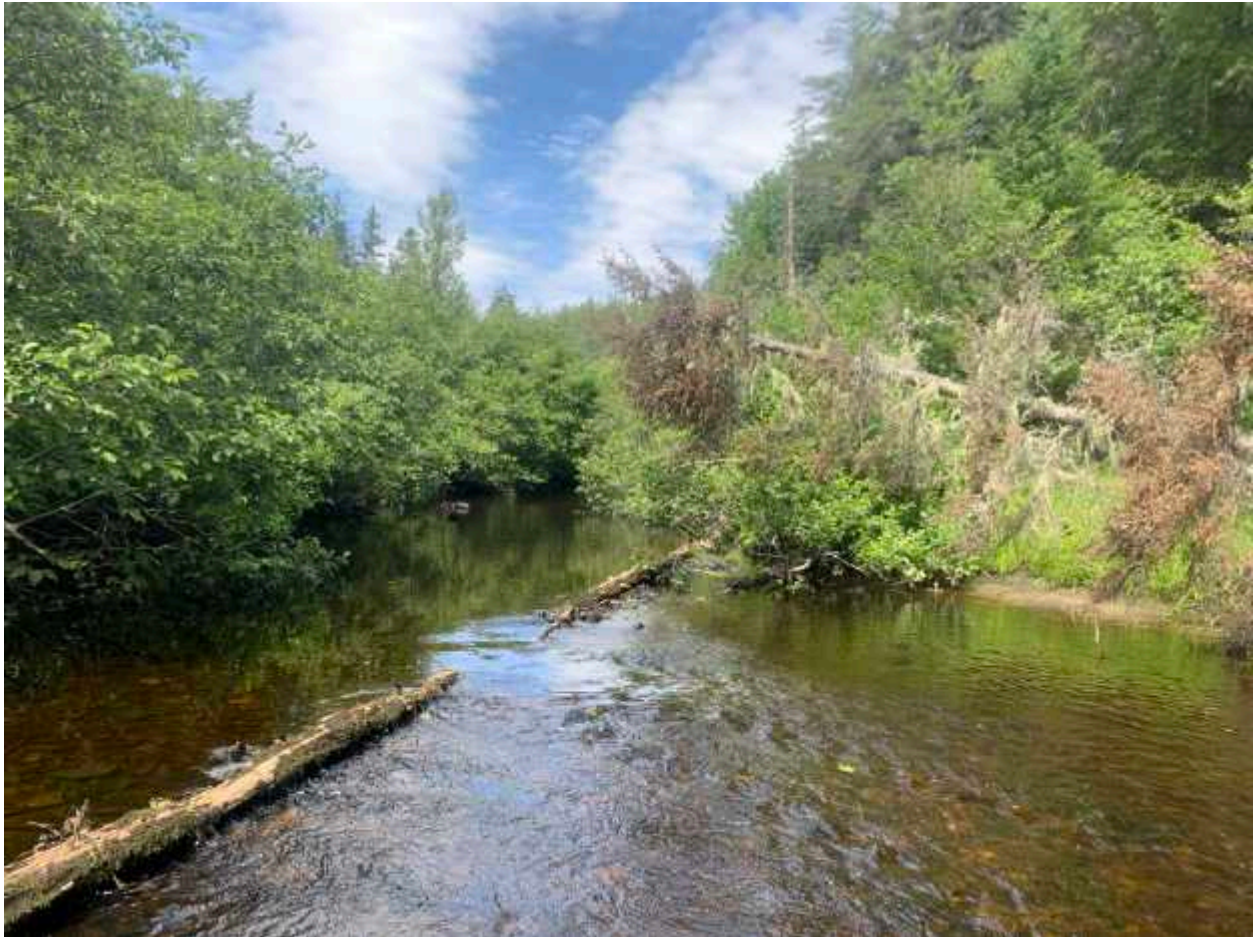
*Figure 9: Photo from JB- 49 showing low shade cover*

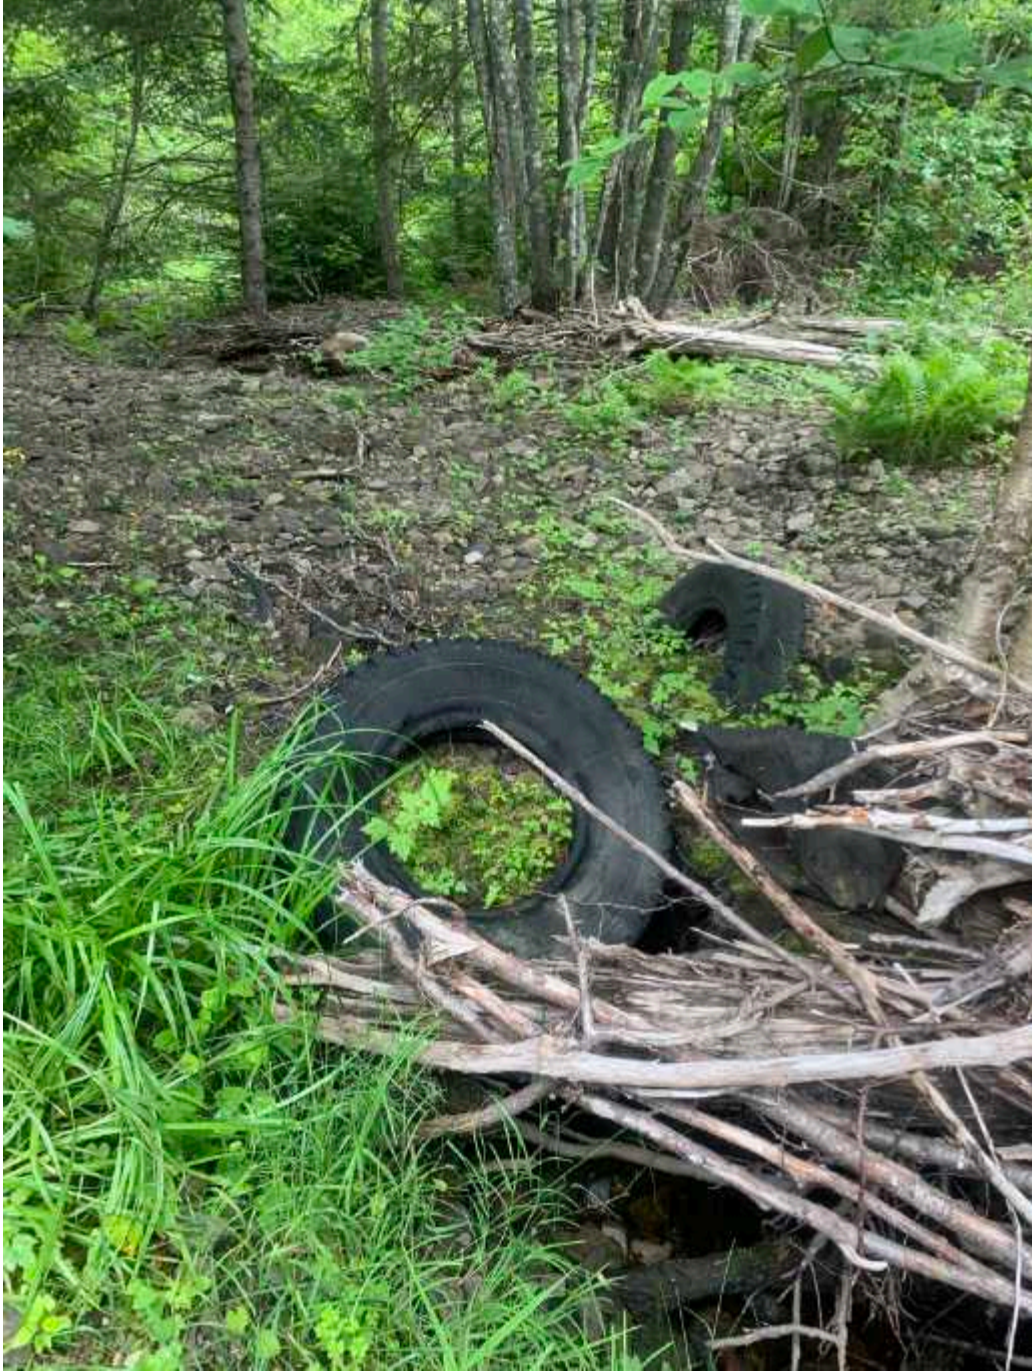
*Figure 10: Photo from JB-61 – part of a dump site*

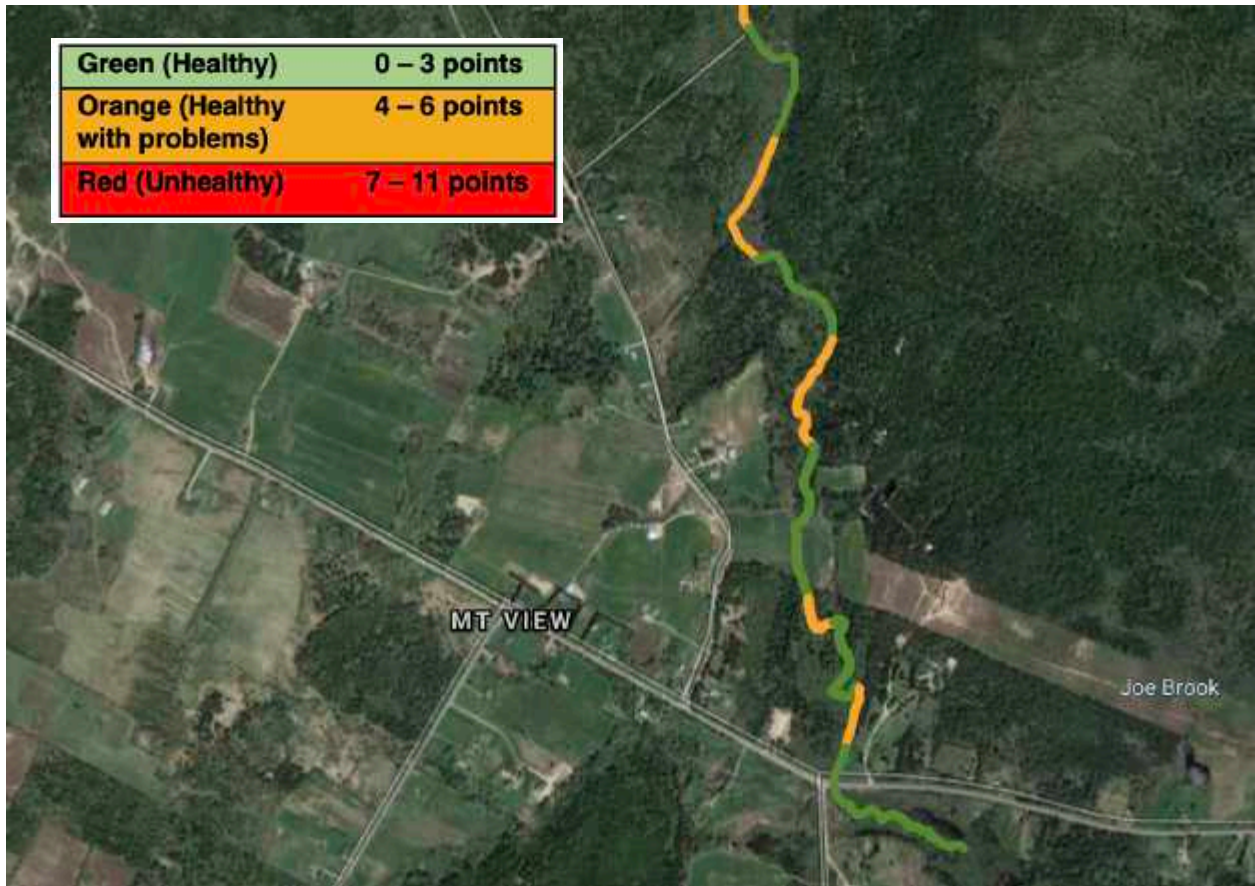
*Figure 11: Downstream Point System Map (Reach 65-77)*

Of these 13 assessments, none had a total score of 0, meaning that all of the sites could benefit from potential restoration projects. The sites ranged in number of total points, 5 sites were designated as healthy with problems (4-6 points), while 8 sites were categorized as healthy (i.e., 1 – 3 points). (Figure 11) (Appendix 2)

Of these 13 sites, 10 sites recorded less than 25% shade cover, and 4 sites recorded that 40% or more of the bank was slightly eroded.

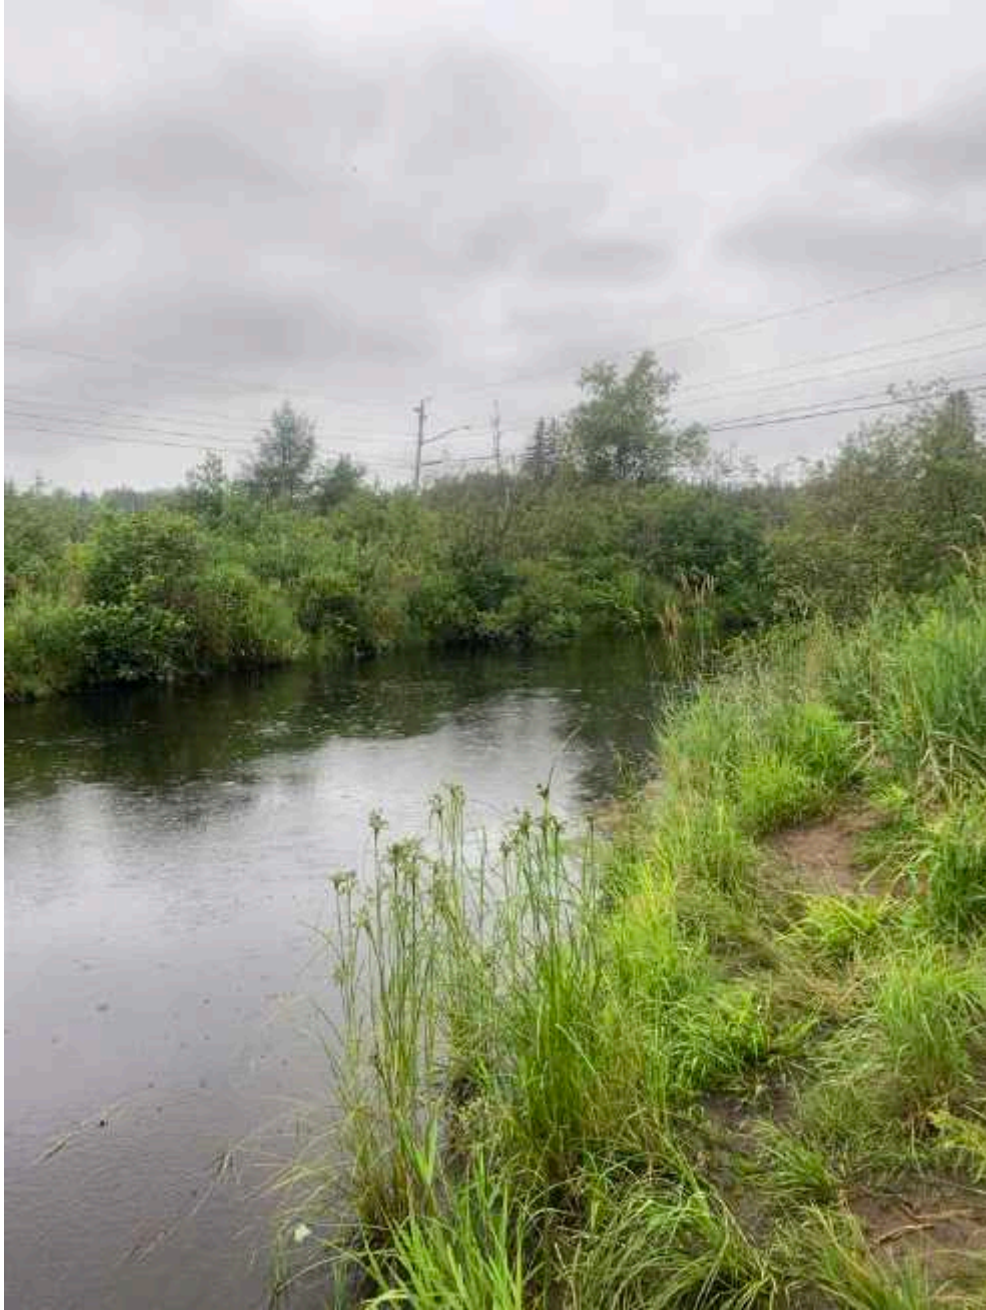
*Figure 12: Photo of JB-75, showing low shade cover*

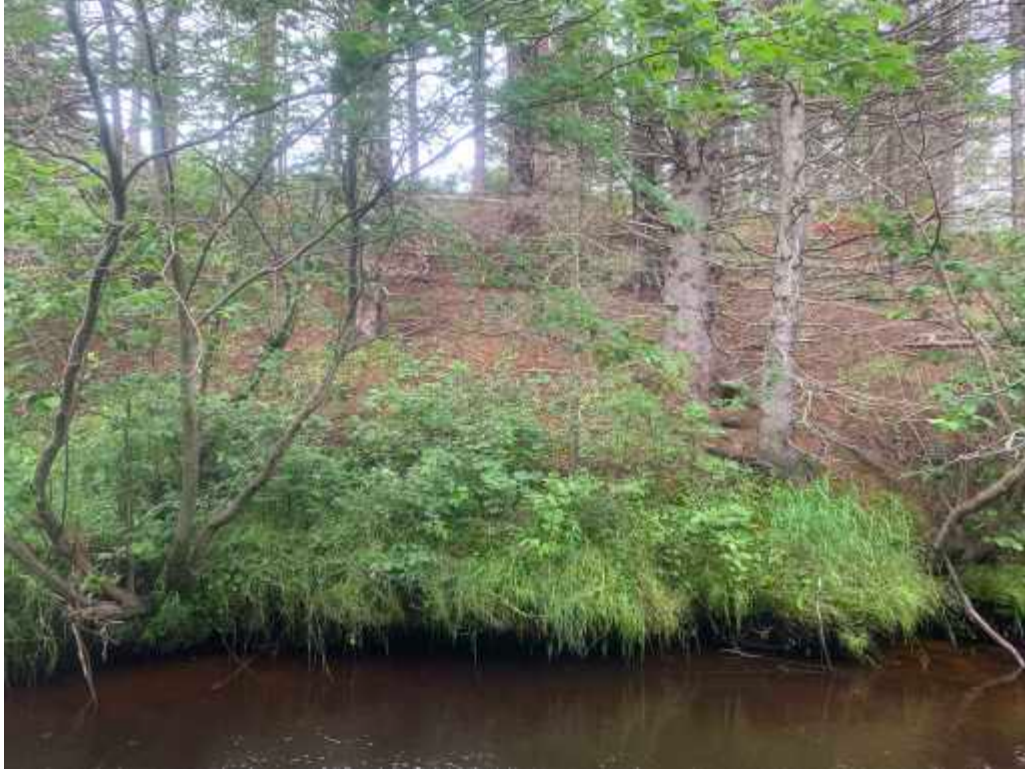
*Figure 13: Photo of JB-73 showing undercut banks*

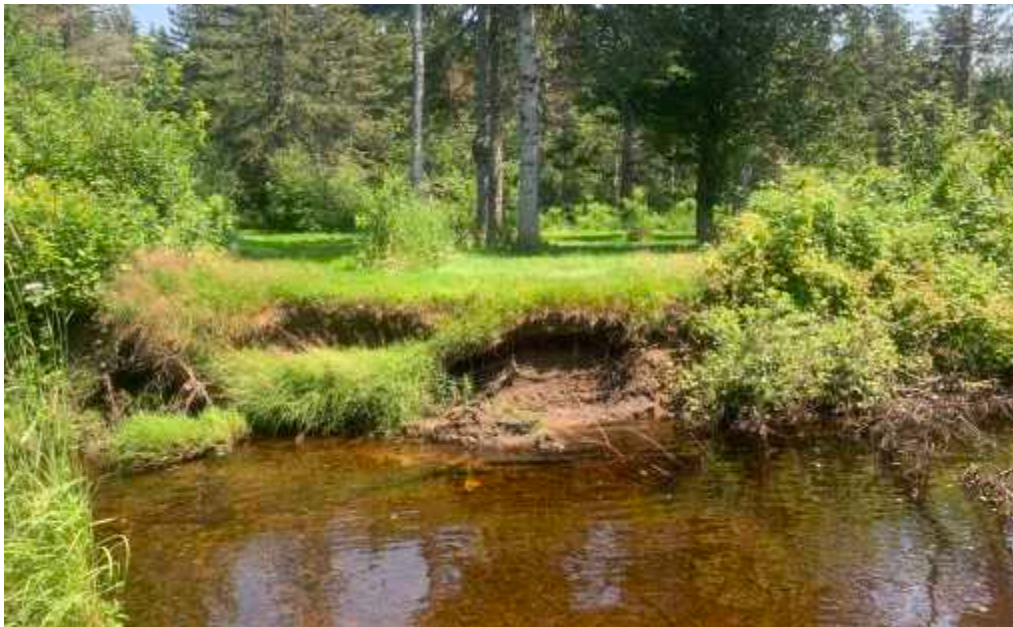
*Figure 14: Photo of JB-70, showing an eroding bank, where a property owner has cut the grass right to the edge of the stream bank*
