Habitat Assessments of Scott Brook

FE22-15

February, 2023

EOS Eco-Energy Inc.

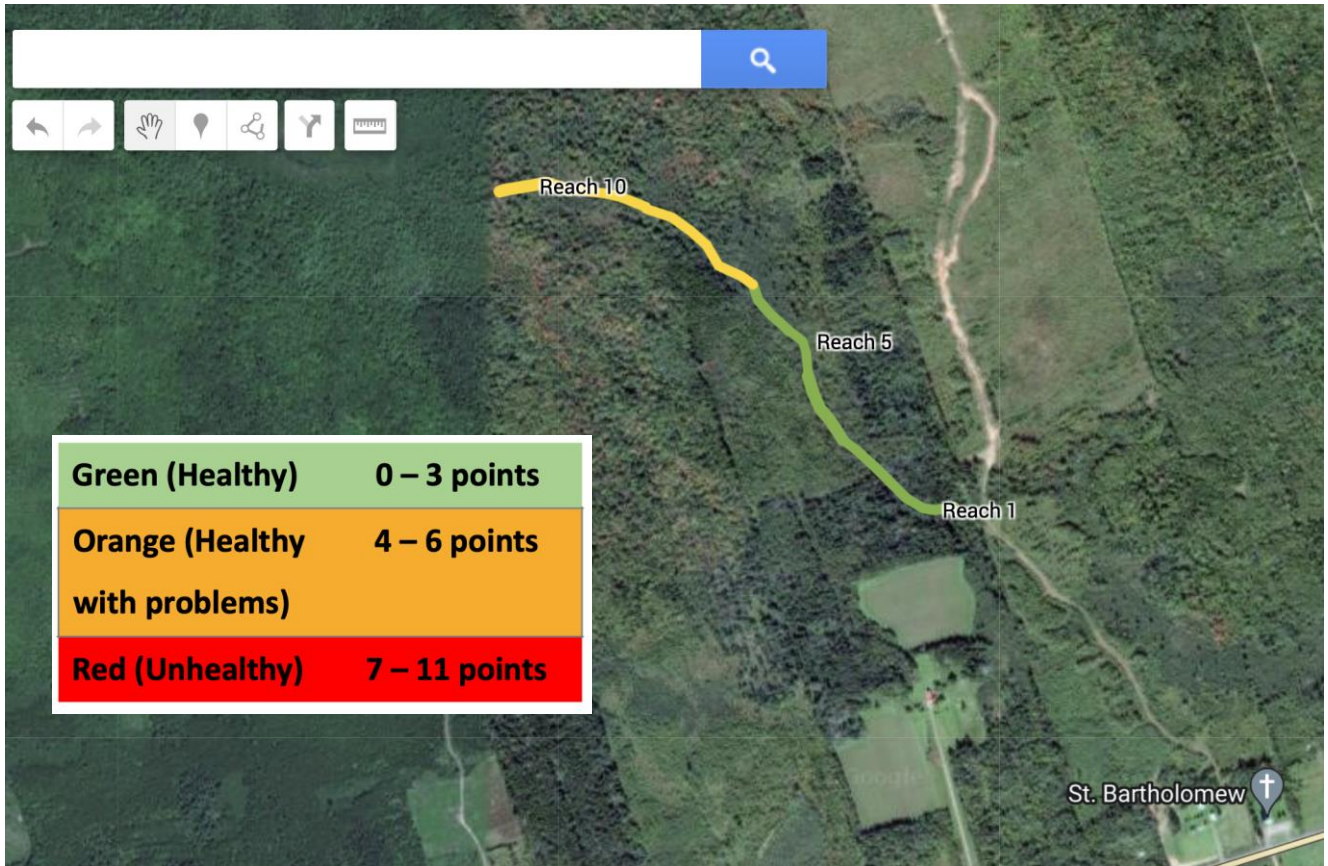
Figure 2: Scott Brook Upstream Point Systems Map (Reach 1-10)

Habitat assessments of Scott Brook began after walking 0.8 km up a resource road to reach the beginning of the stream. 10 assessments were done in the upstream region of the brook. Of these assessments, 4 had a score of 0, meaning they were in good condition, while the remaining sites could benefit from restoration projects. The remaining 6 sites ranged in number of total points. 4 were designated as healthy with problems (4- 6 points), and 2 were designated as healthy (1-3 points). (Figure 2) Of these 10 sites, 5 sites recorded vegetation consisting of at least 60% grasses, and 4 sites recorded banks that were slightly eroded. In terms of in-situ water measurements taken with the multi-parameter probe, 5 sites had dissolved oxygen (DO) values below what is required for early life stages of aquatic life³ and 2 sites had an average pH value below what is suitable for biota⁴.

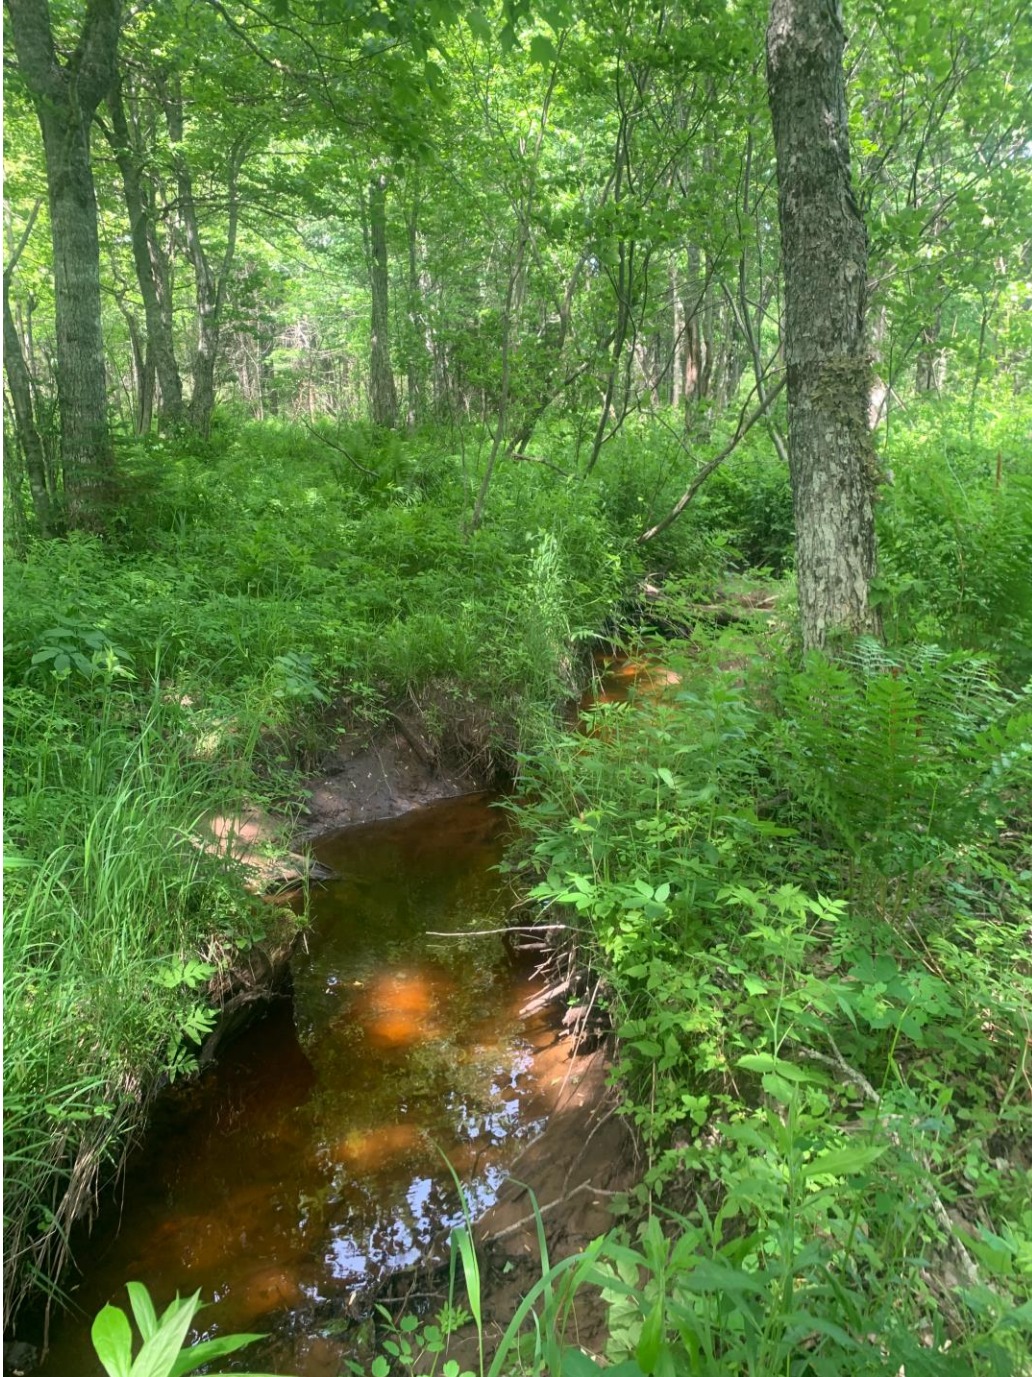
Figure 3: A photo from SB-09 showing grassy vegetation

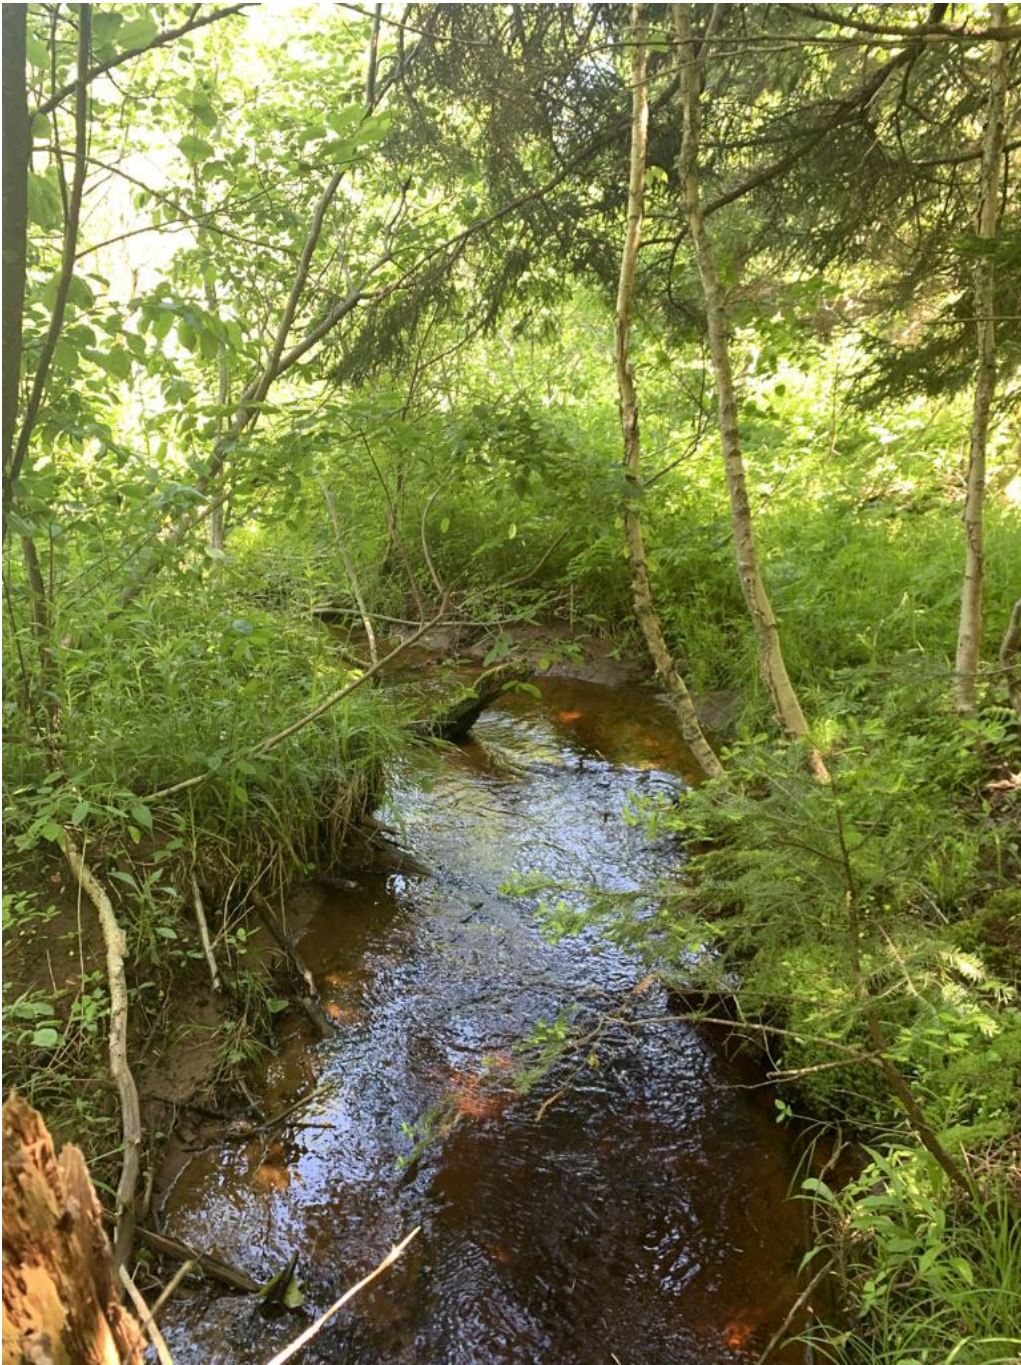
Figure 4: A photo of SB-04 showing a slightly eroded bank.

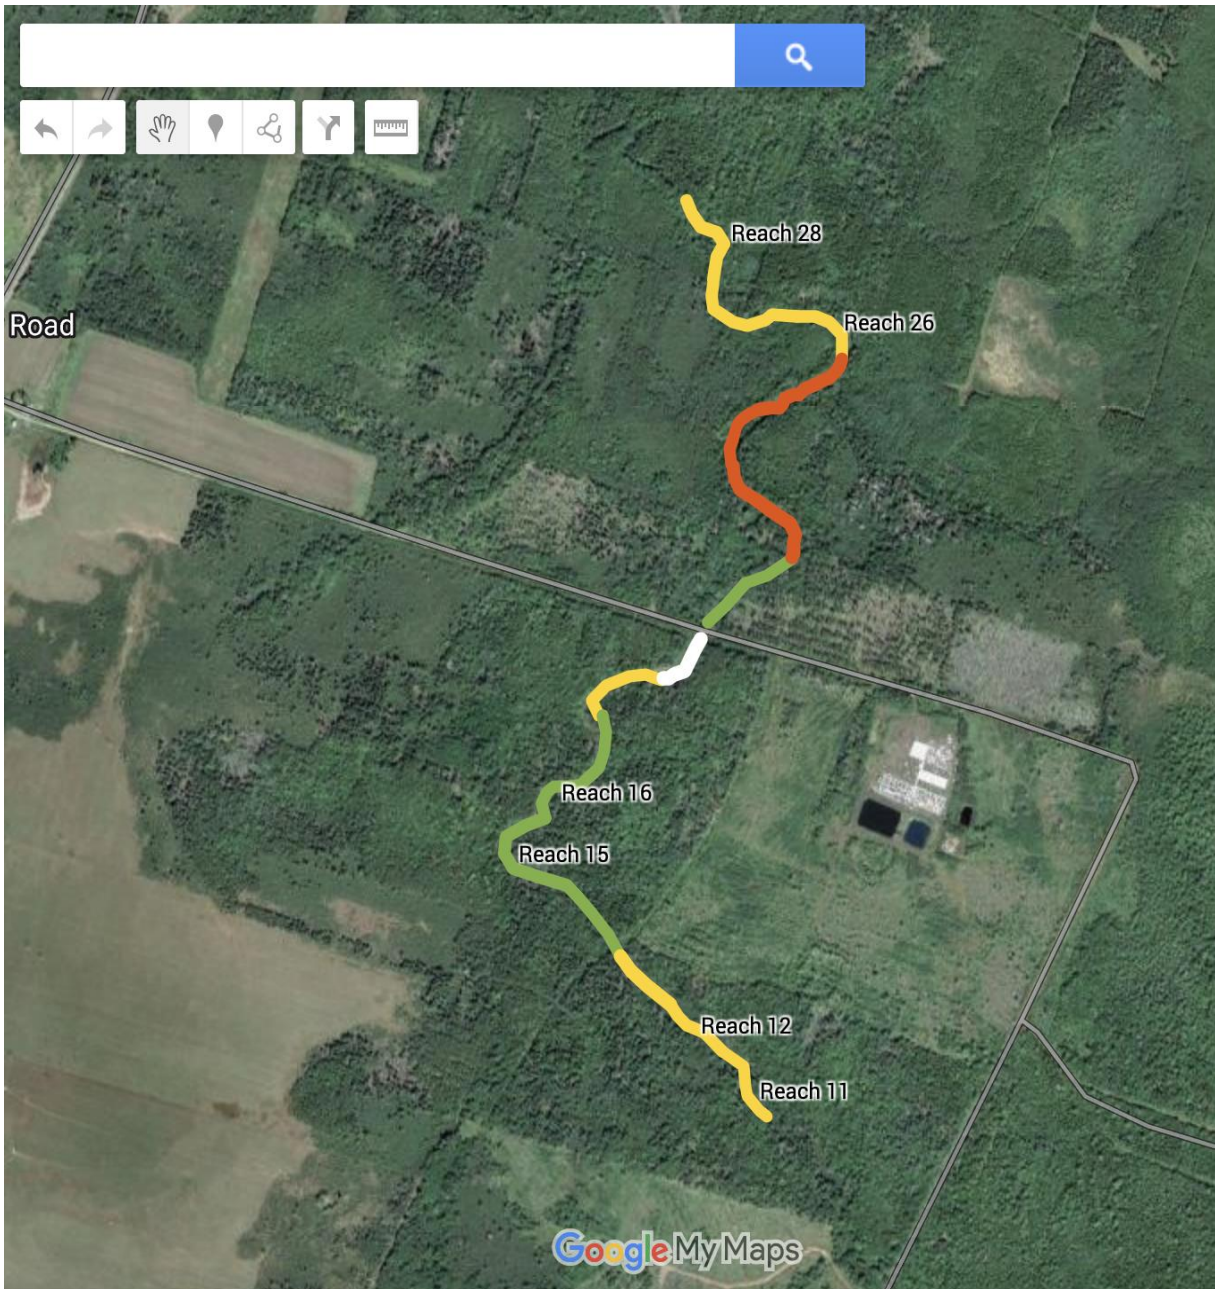
Figure 5: Scott Brook Midstream Point Systems Map (Reach 11-28)

None of the 18 assessments had a score of 0, which means that 100% of them could benefit from potential restoration projects. One of the reaches, was impossible to access to collect the majority of the data, because of its depth, so because of the large amount of missing data, we did not give that reach a score. In Figure 5, this reach is coloured white.

The remaining 17 sites ranged in number of total points. 6 of the reaches were designated as healthy (0-3 points), 7 of the reaches were designated as healthy with problems (4-7 points) and 4 of the reaches were designated as unhealthy (8-11 points). Of the 18 sites, half of them had more than 60% grass as vegetation and low shade cover. 7 recorded banks with high percentages of heavy erosion and 3 had high amounts of light erosion. 2 reaches recorded stream banks that were 25% or more bare of vegetation. All of the reaches had average temperatures over the recommended Environment Canada guidelines for streams.⁵ and dissolved oxygen values below what is required for most forms of life.⁶ 5 reaches had pH values below what is suitable for biota⁷.

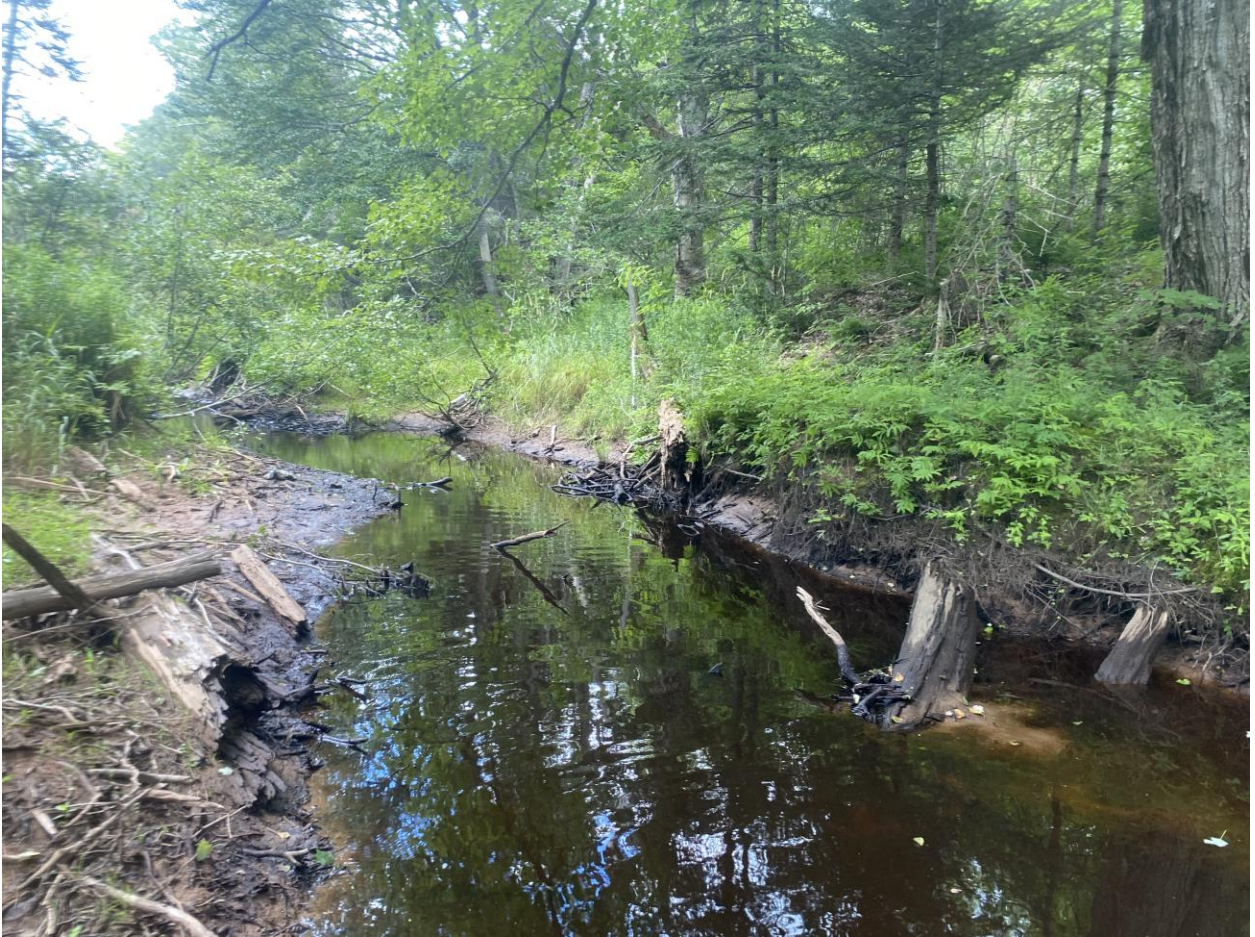
Figure 6: A picture of SB-21, showing eroded banks.

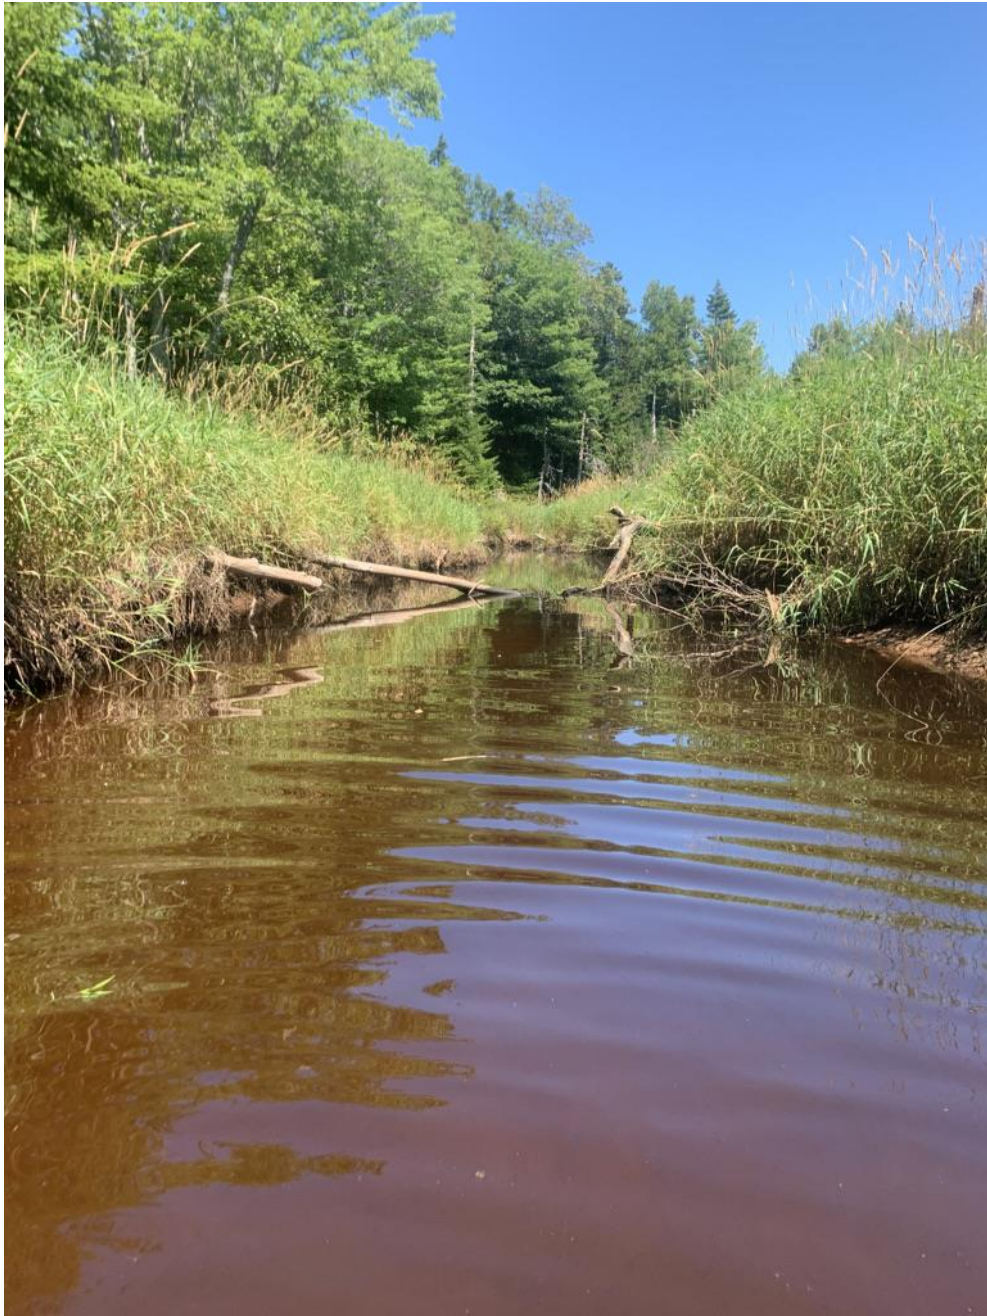
Figure 7: A picture of SB-25, looking downstream, showing low shade cover.

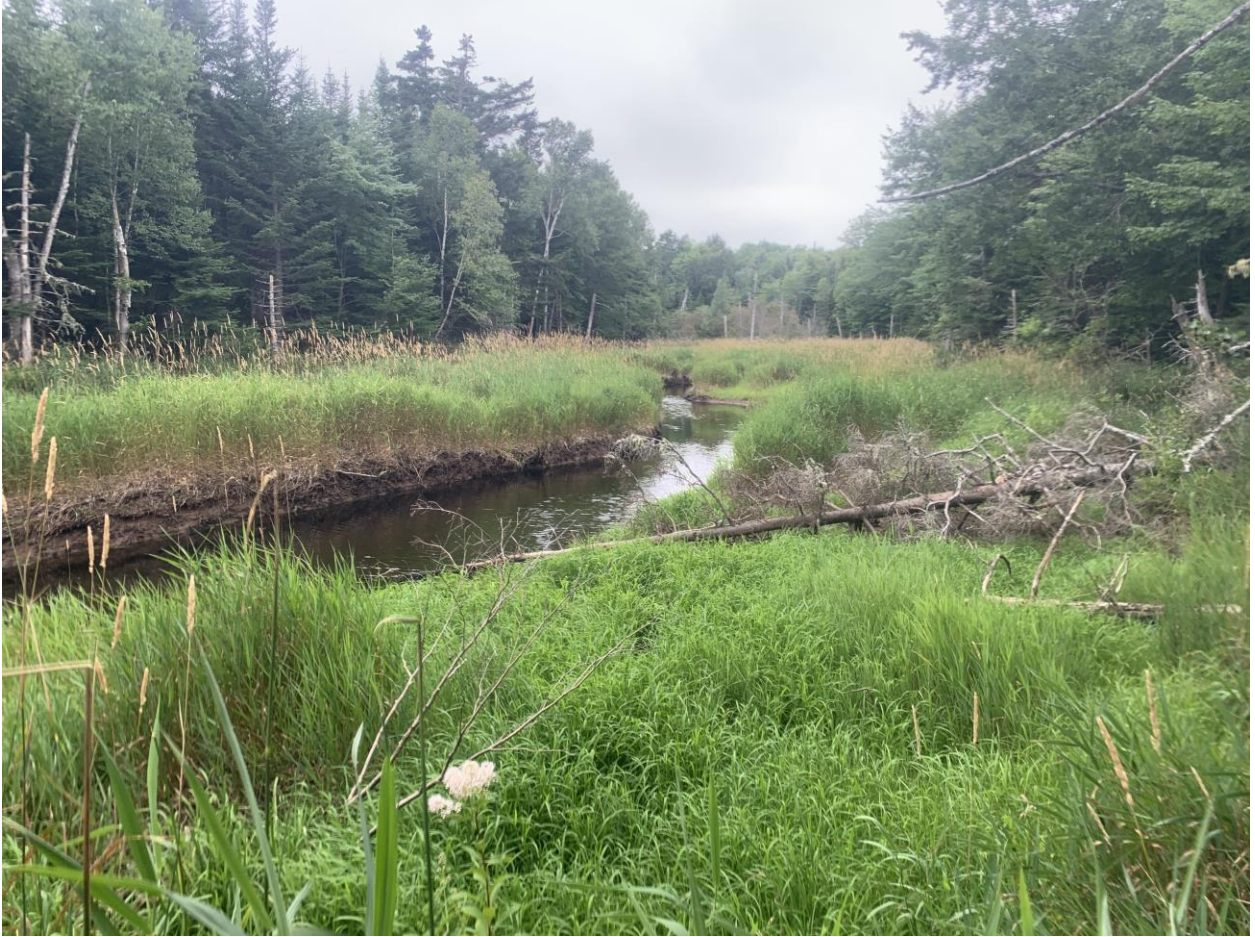
Figure 8: A photo of SB-28, showing grassy banks.

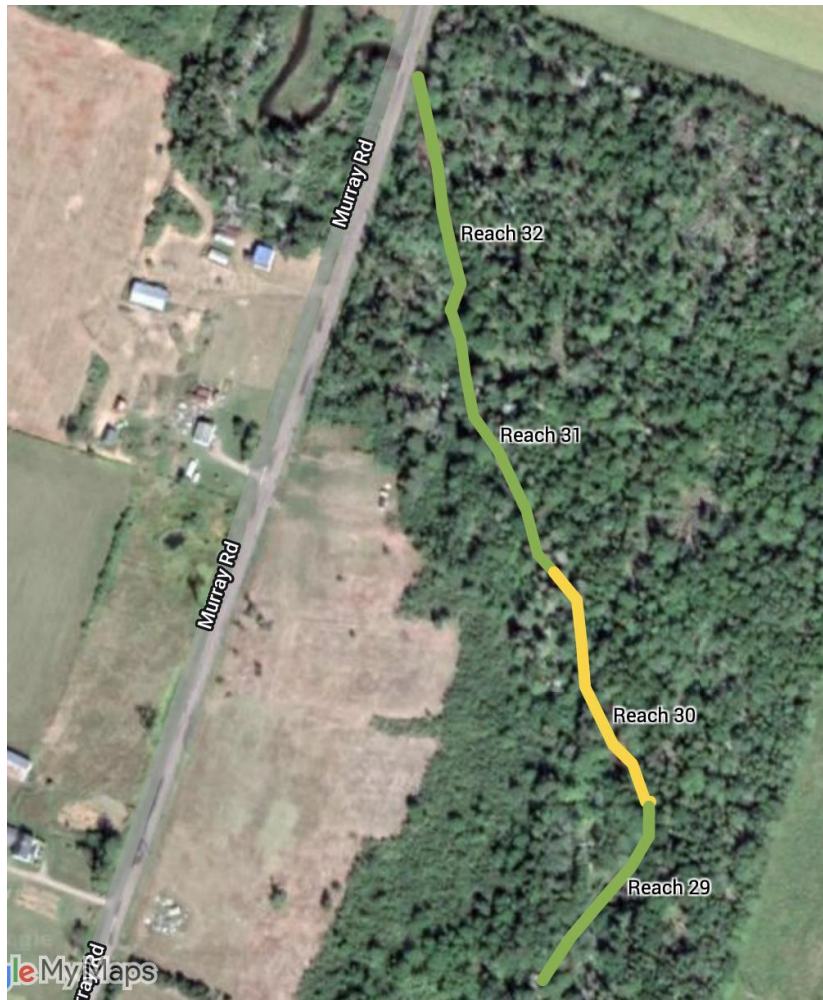
Figure 9: Scott Brook Downstream Point Systems Map (Reach 11-28)

Two out of the four assessments had a score of 0, which means that the other two reaches could benefit from potential restoration projects. One of the reaches was designated as healthy and had only 1 point. The remaining reach was designated as healthy with problems.

Of the four sites, only one of them had more than 60% grass as vegetation. Two of the reaches (half) had less than 25% vegetative shade cover. No significant erosion was present. Two of the reaches had average temperatures over the recommended Environment Canada guidelines for streams⁸. One of the reaches has no DO value associated with it, because our multi-parameter probe was acting up, and not giving accurate values.

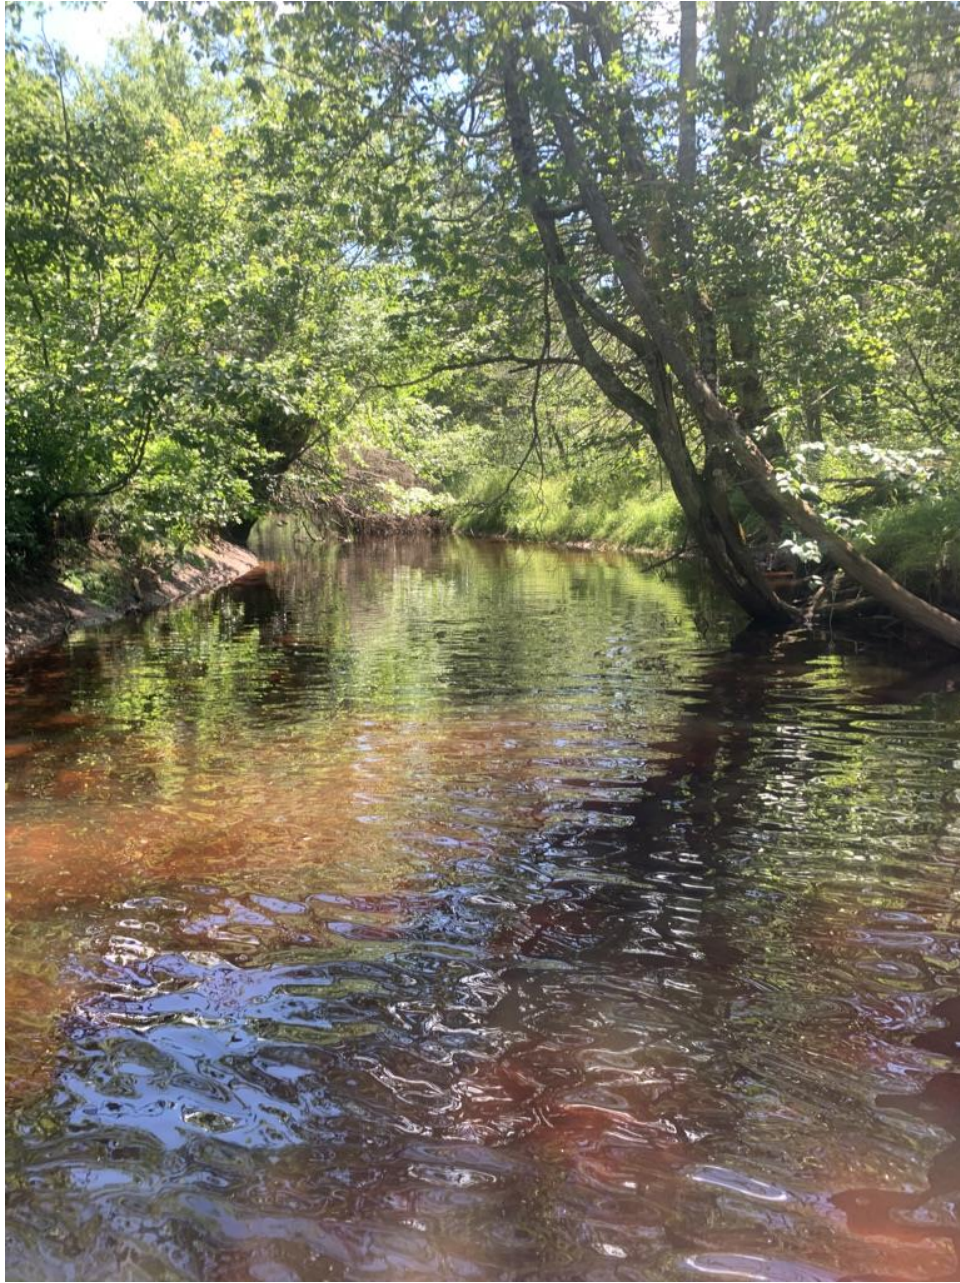
Figure 10: A picture looking upstream at SB-30, showing low shade cover.

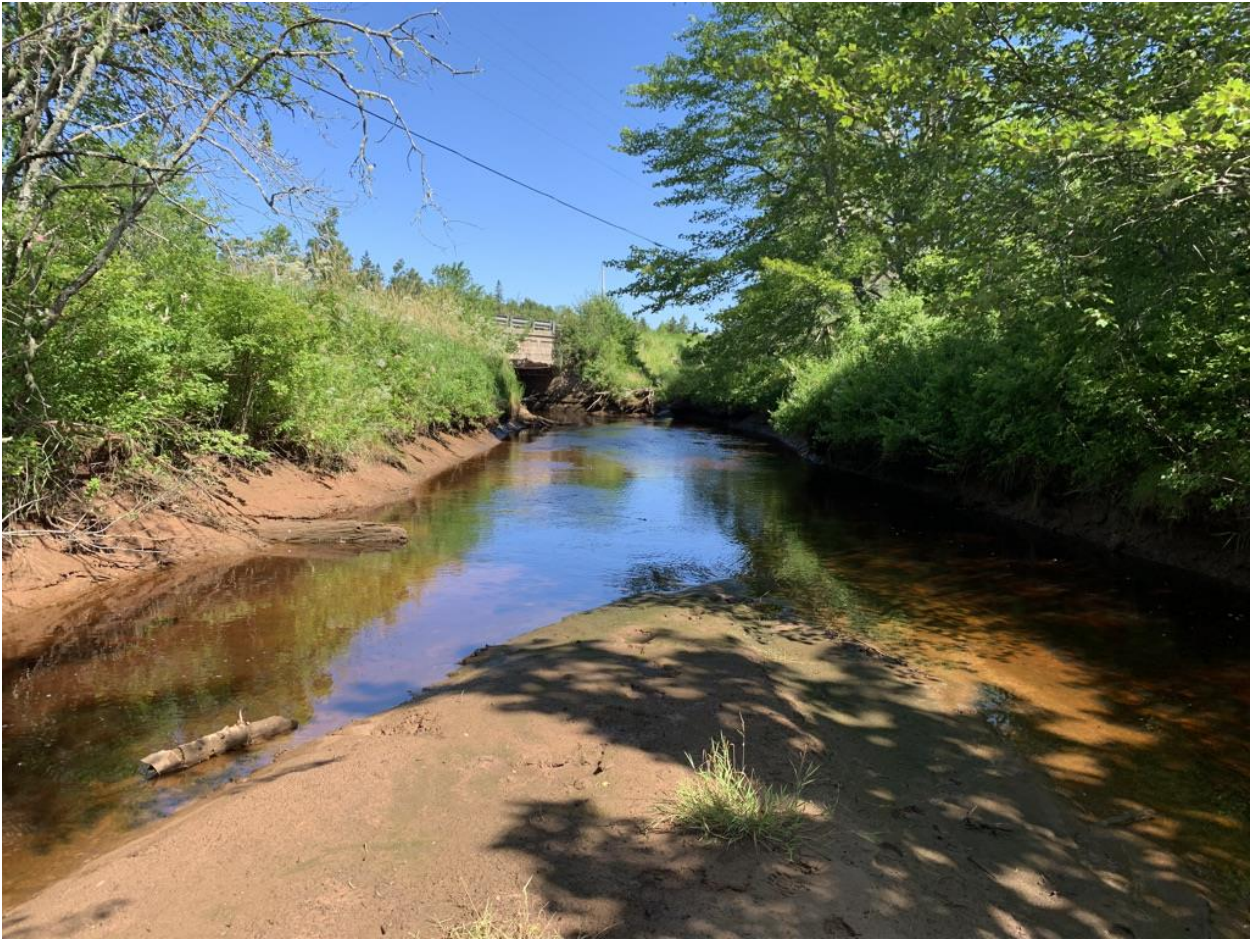
Figure 11: A photo showing SB-32, looking downstream, showing a large amount of grass on one side.
