Riparian Health Assessment of the Tantramar River

Project number F208-121
October 31, 2018
Kelli-Nicole Croucher, Watershed Coordinator

EOS Eco-Energy Inc.
P.O. Box 6001, 131D Main Street
Sackville, NB E4L 1G6
www.eosecoenergy.com

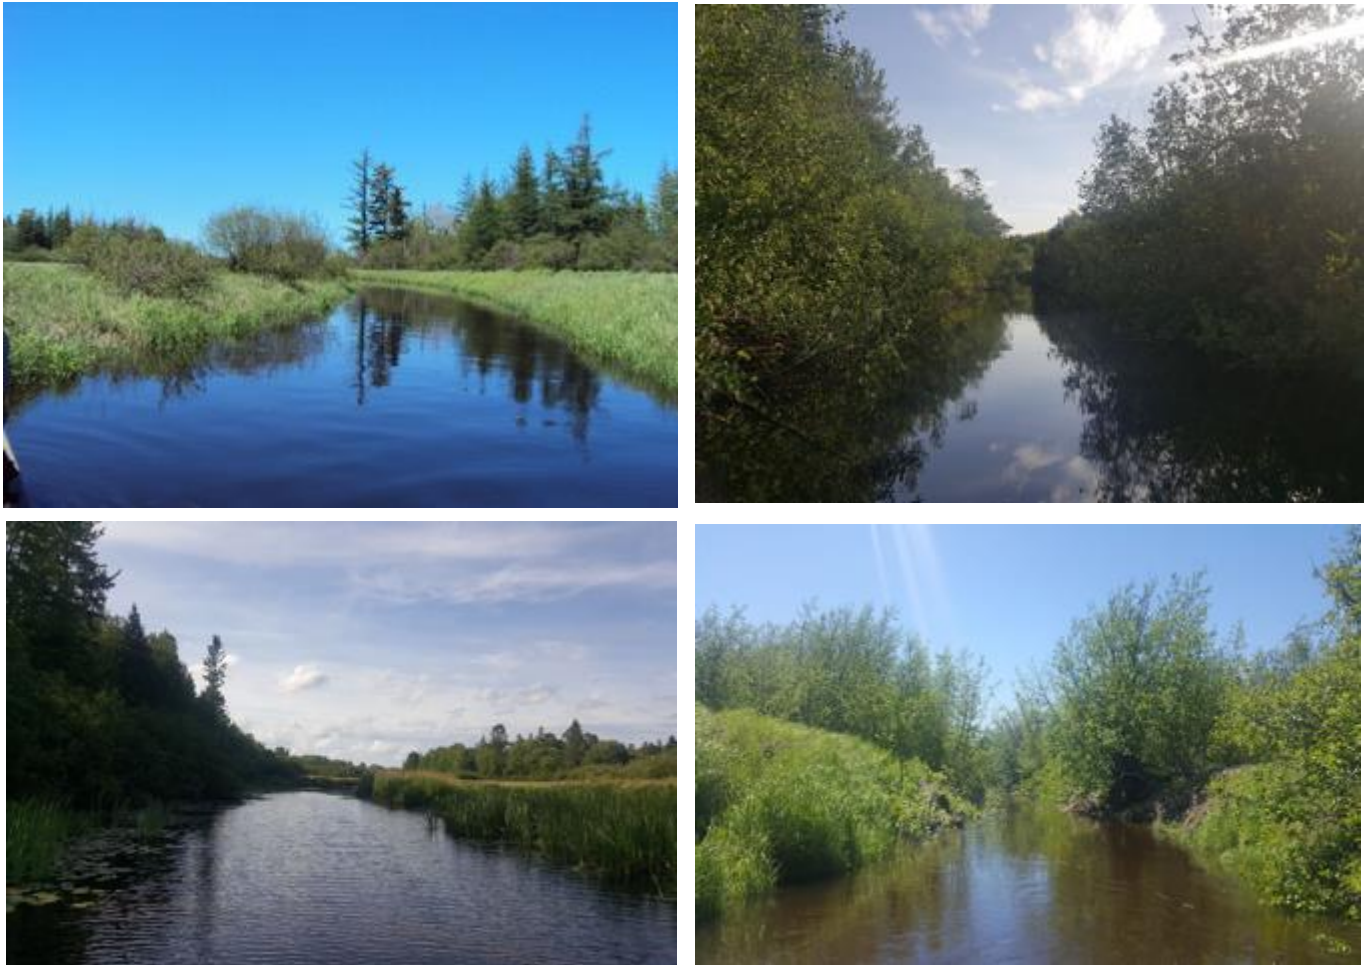
Some indicators of a healthy riparian area include abundant vegetation with very little exposed soil, bare ground, or altered banks (as demonstrated in Figure 4). In particular the vegetation should consist of deep-rooted plant species (e.g. trees & shrubs); few (if any) invasive weeds and disturbance caused plants; lightly browsed vegetation by livestock or wildlife; and the presence of seedlings and saplings for successful regeneration of woody species.

Figure 4: Examples of healthy reaches of the Tantramar River

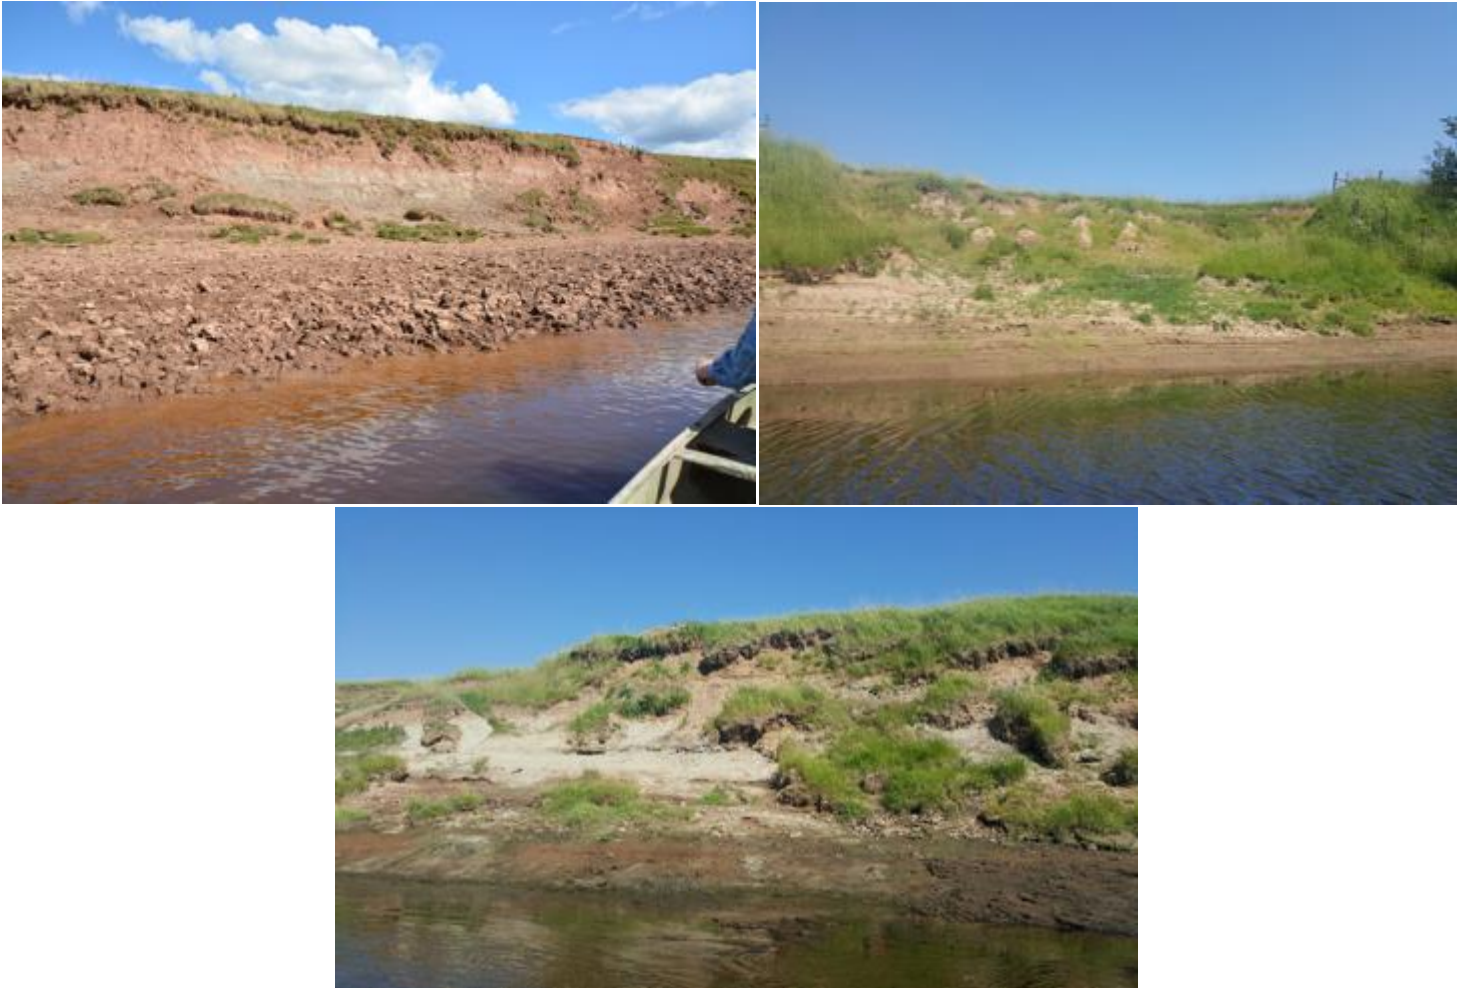
Indicators of an unhealthy riparian area include signs of bank erosion (Figure 5); undercut banks; bare ground (sometimes with rutting or hummocking) from livestock or human activity (Figure 5); standing dead woody vegetation; lack of preferred tree and shrub establishment and regeneration (Figure 6); and an abundance of invasive weeds or disturbance caused plants (Figure 7).

Figure 5: Signs of bank erosion and bare ground from livestock activity

The trend of the river becoming unhealthier kept continuing as we paddled further downstream. The river continued to have very steep banks, limiting the river’s access to a floodplain. There was an increasing amount of human disturbance (mostly through livestock having direct access to the river), leading to an increase of erosion, bare soil, and disturbance caused vegetation. There was an increasing lack of preferred tree and shrub establishment on the river banks due to there being a lack of trees & shrubs at the top of the banks to regenerate the vegetation. This lack of preferred vegetation results in poor streambank root mass protection, leaving the river banks even more susceptible to erosion.

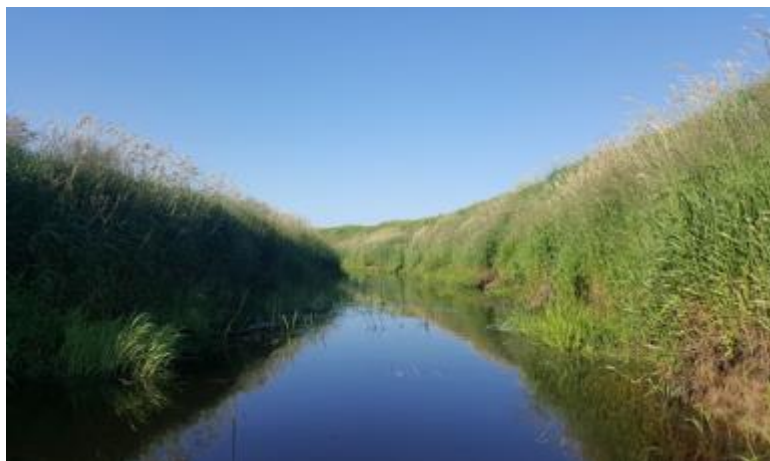
Figure 6: Lack of preferred tree and shrub establishment and regeneration, as well as an incised channel with limited access to its floodplain

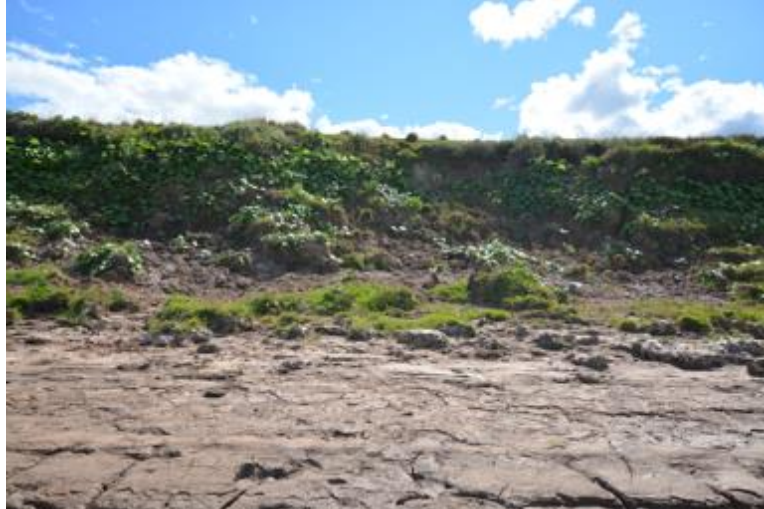
Figure 7: Bank with an abundance of disturbance caused vegetation

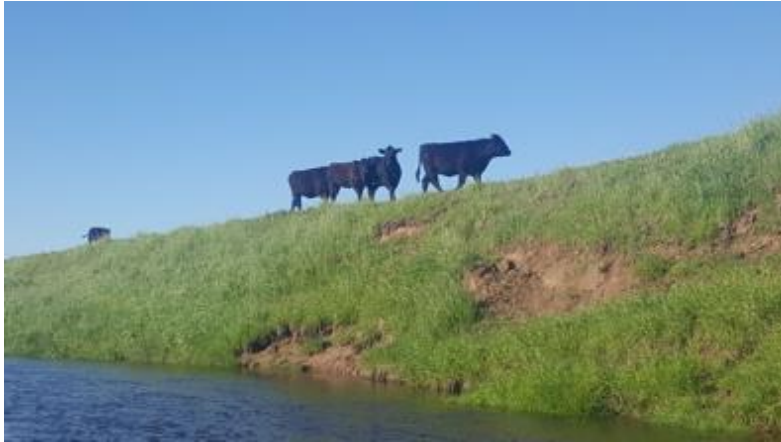
Figure 8: Cows coming down to the river to greet the canoe

The riparian health assessment data gathered from this project will provide a record of the current state of riparian health of the Tantramar River. Using this data, we can plan restoration projects for problem areas and work to prevent potential future problems by maintaining the healthy reaches of the river. In the future, we would like to extend our assessments to tributaries/smaller streams of the Tantramar River, as well as other watersheds within our area. We would also like to build on the riparian health assessments to produce more in-depth riparian inventories. This will result in the long-term achievement of healthy riparian areas that will maintain biodiversity by providing habitat and protect aquatic habitat by trapping sediment and filtering water.
