# Water Quality Monitoring in the Tantramar River Watershed 2018 Water Quality Report

Date: March 2019

EOS Eco-Energy Inc.  
P.O. Box 6001, 131D Main Street  
Sackville, NB E4L 1G6  
[www.eosecoenergy.com](http://www.eosecoenergy.com)

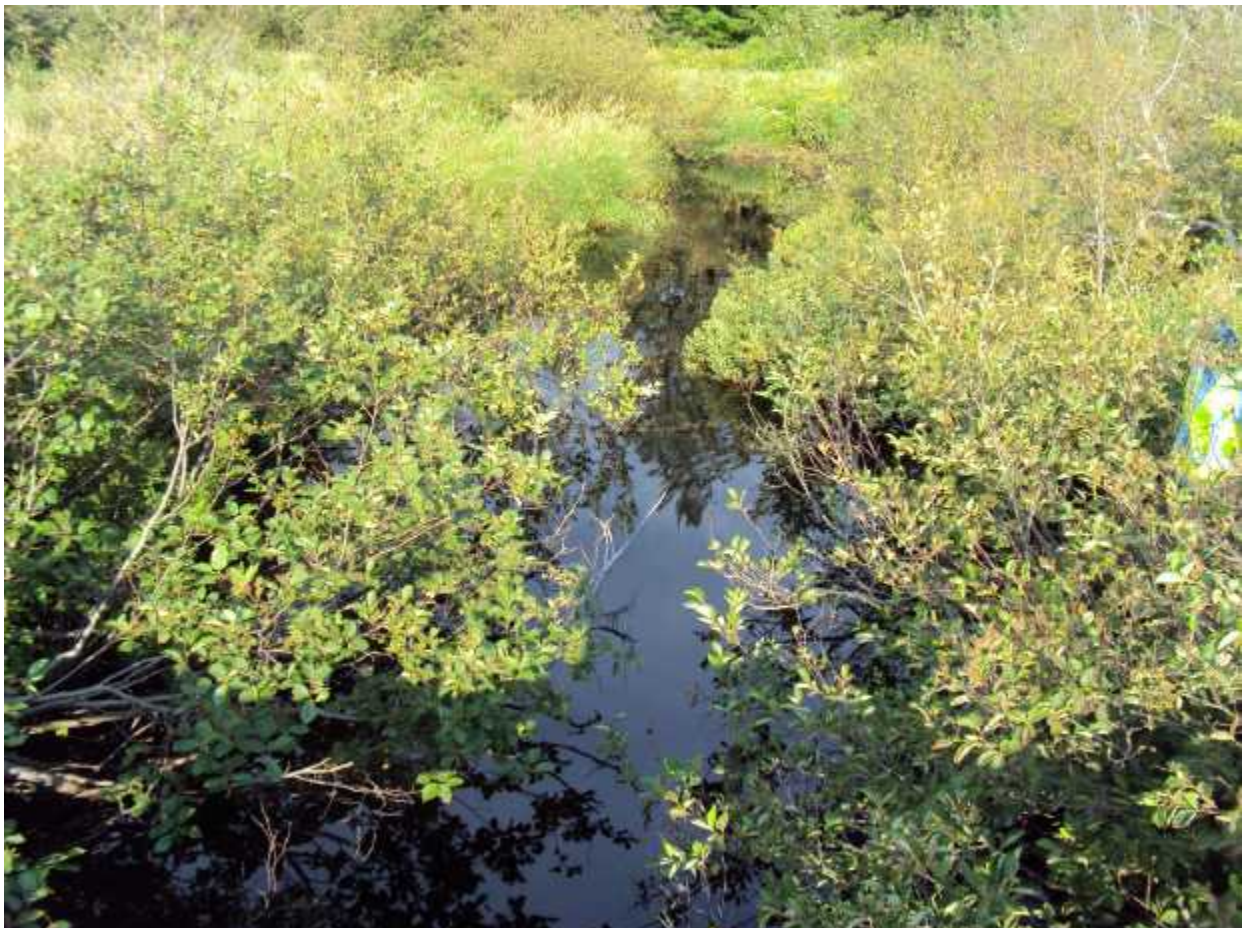
Wetlands to the east of Rte 940 between Centre Village and Anderson Settlement drain into a Ducks Unlimited Canada wetland restoration site where it then forms East Brook. This narrow watercourse meanders south-west through agricultural land, transmission line right-of-way and forested areas. The brook then runs under the Cookville Road before joining the Tantramar River. The sample site is located on Rte 940 directly off the west side of the bridge near the Ducks Unlimited pond.

*Photo 1: East Brook, downstream of Ducks Unlimited site in August*

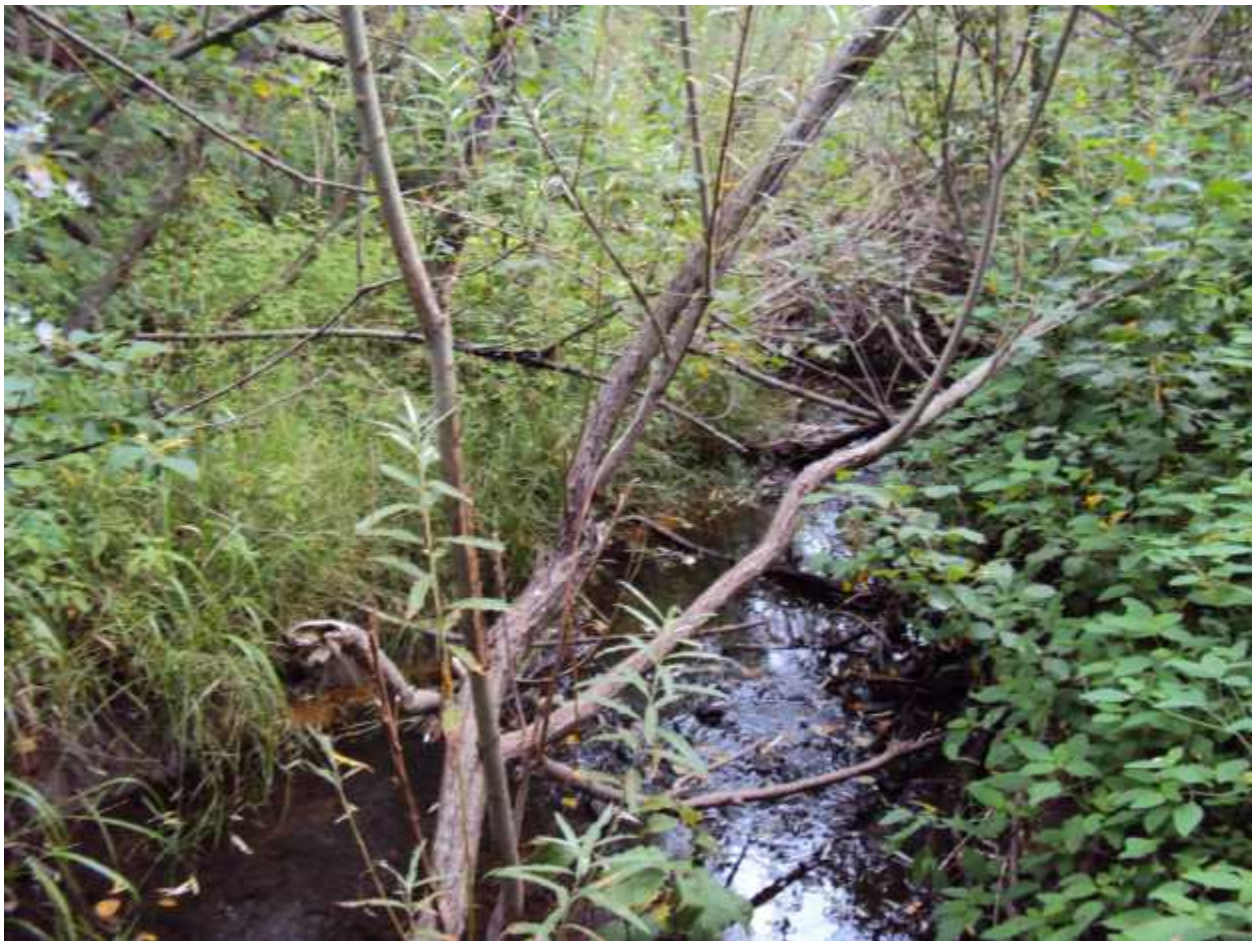
Harper Brook drains wetlands to the east of Rte 940 between Midgic and Centreville. The brook forms and then quickly crosses to the west of Rte 940 through a single culvert, before re-crossing near a cattle pasture a short distance downstream. It then travels south-west through a relatively undisturbed area before again crossing Rte 940 through a single culvert where it then flows into a wetland with Patterson Lake to the north. Agricultural disturbance negates any natural confluence of Harper Brook and the Tantramar River. Samples were taken on the east side of Rte 940, upstream of the most northern culvert crossing. The sample site looks to be used for swimming, has light undercutting at the banks, and a cattle crossing downstream.

*Photo 2: Harper Brook sampling site on Route 940 in August*

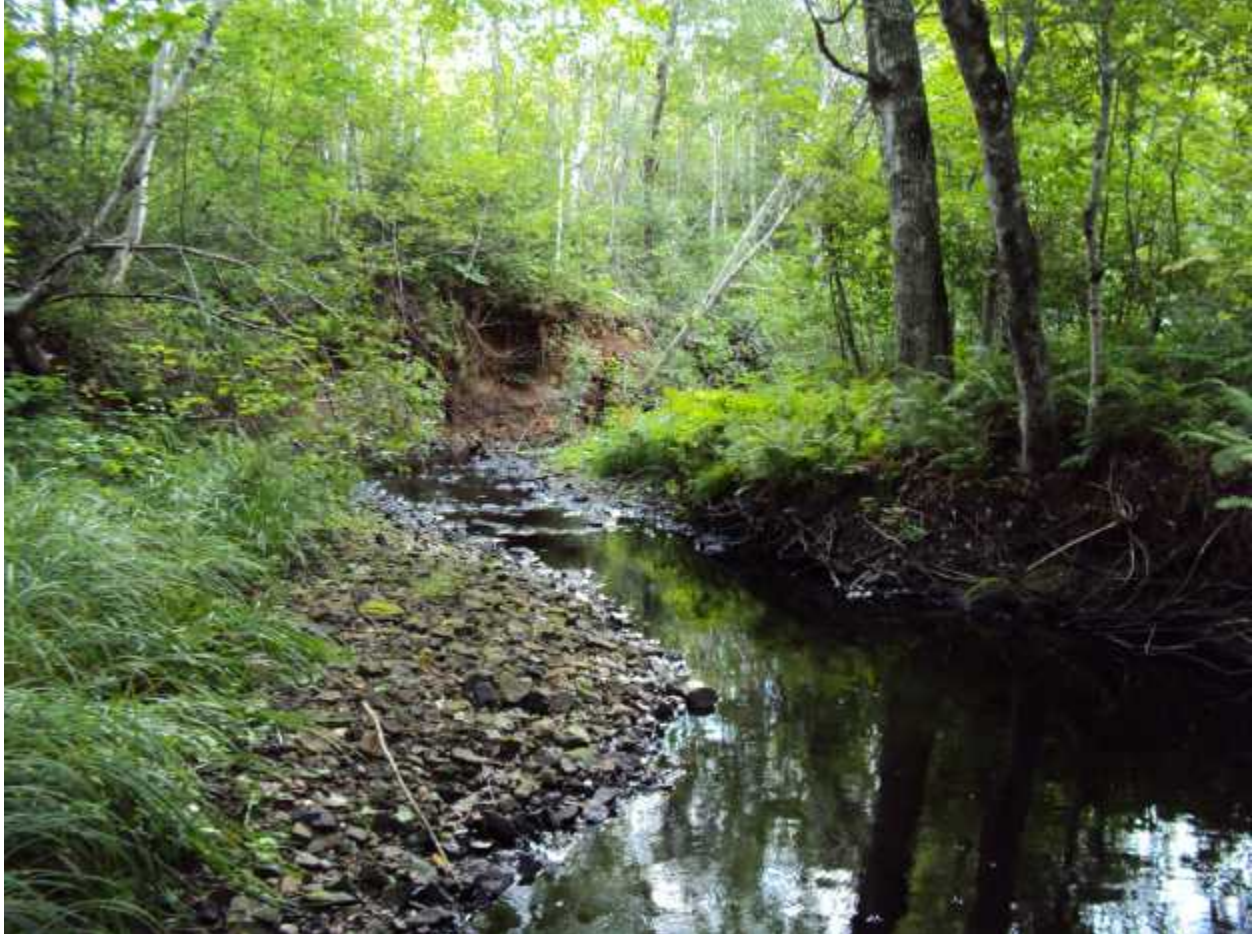
Musquash Brook drains wetlands north of Sackville Parish and flows through wooded and agricultural areas south-east into the Tantramar River. Samples were taken directly upstream of where the brook meets Towse Rd. The site has considerable bank erosion, lots of vegetation and deciduous trees, and a rocky bottom.

*Photo 3: Musquash Brook, downstream of sampling site in August*

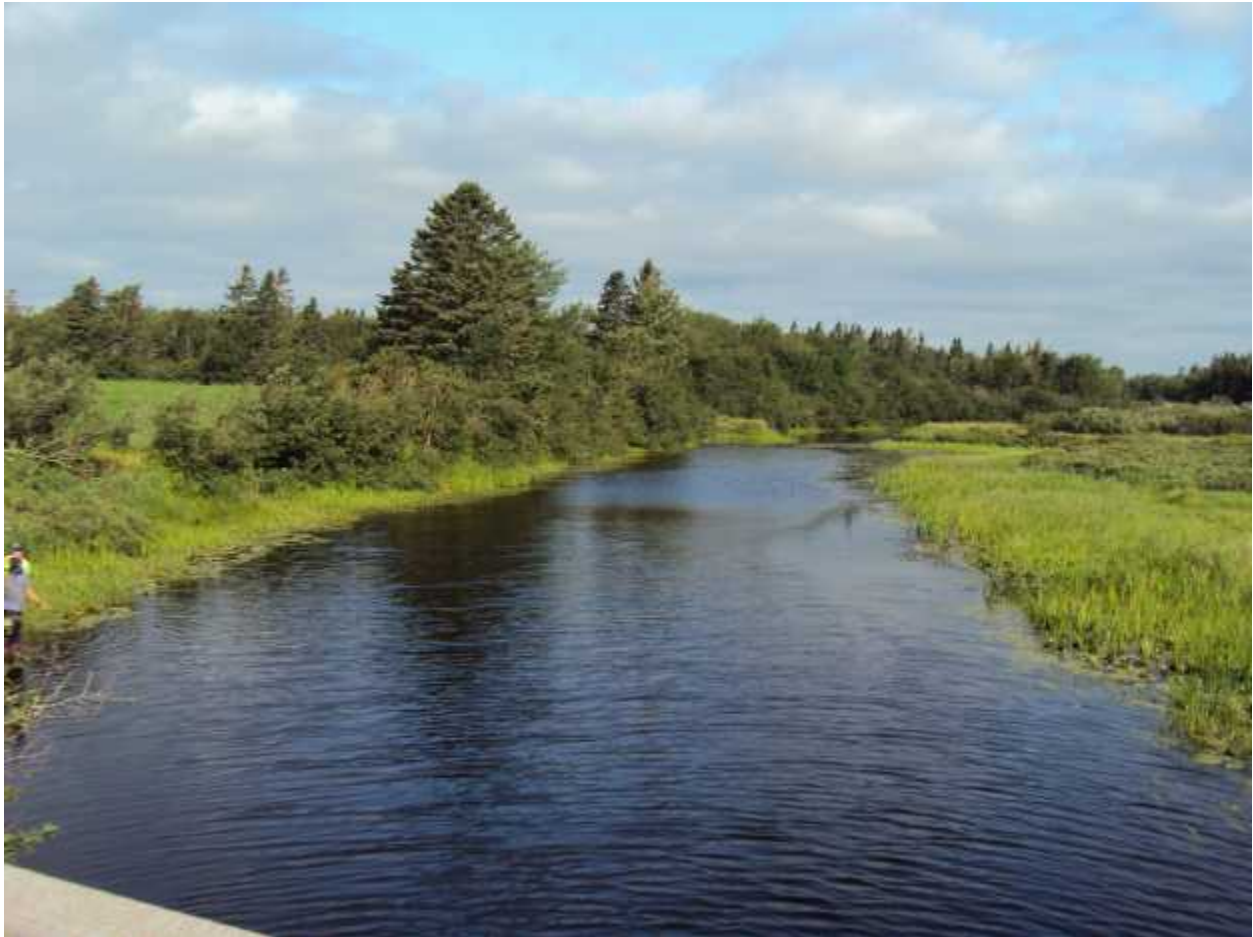
This site was chosen as it represents a comparatively natural portion of the Tantramar River that was also very accessible. Samples were taken upstream on the western end of the wooden bridge on Cookville Road. The site is quite deep and is a popular fishing and swimming spot. There is a diversity of vegetation along low sloped banks and a large riparian buffer.

*Photo 4: Tantramar River, upstream of bridge on Cookville Rd. in August*

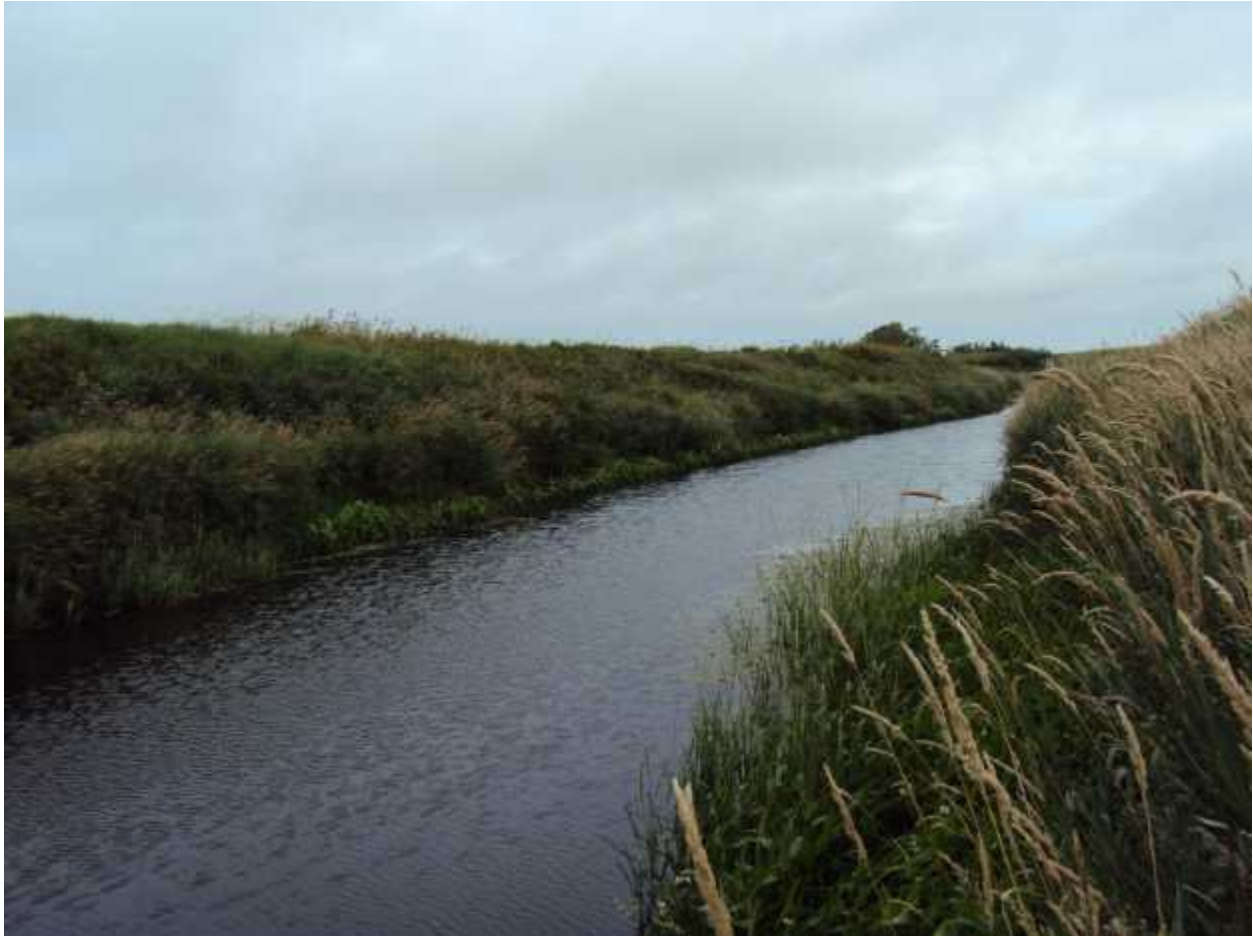
The site is downstream of the “Tantramar River on Cookville Rd.” sampling site with approximately 10 km of watercourse between the two points. It flows predominantly south with slight meandering through mostly wetlands near Cookville, with increasing rural and agricultural land downstream. Samples were collected directly upstream of and on the eastern side of the double culverts under the 940. The area around the sample site shows significant streambank erosion likely due to a lack of deep rooted vegetation.

*Photo 5: Tantramar River at double culvert on 940, upstream in August*

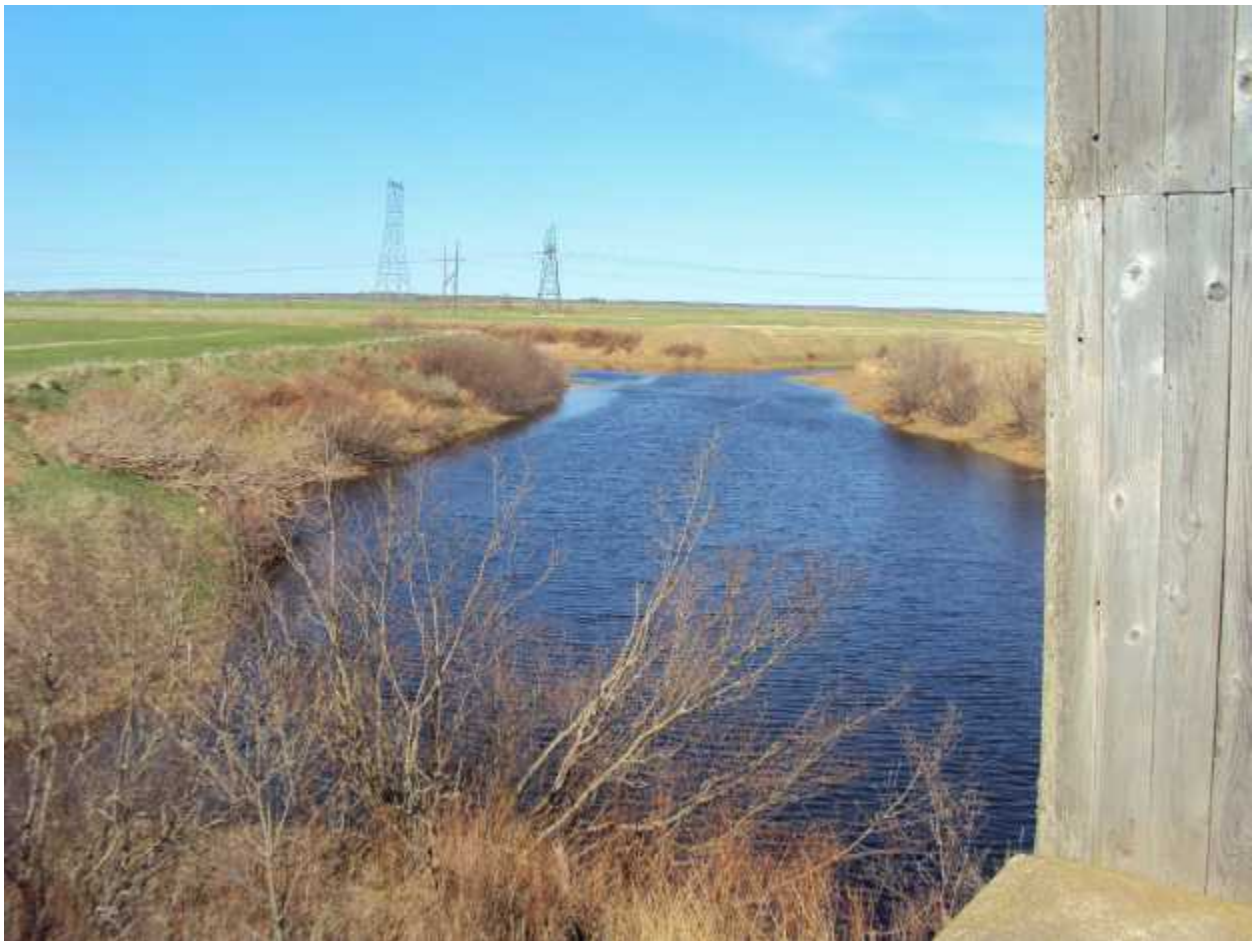
This site is located approximately 3 km south along the Tantramar River from the “Tantramar River Double Culvert” site. The river runs south through predominantly agricultural land with deep channeling of the banks. The site was chosen as it was previously sampled for surface water quality by the DELG on October 3, 2006. The site was also easily accessible and would best capture a highly impacted portion of the river without being too tidally influenced. The site is also slightly downstream of the Goose Creek and Tantramar River confluence. The area surrounding the site has steep banks with little root mass protection.

*Photo 6: Tantramar River upstream of covered bridge on High Marsh Road sampling site. Goose Creek joining from the south-west.*

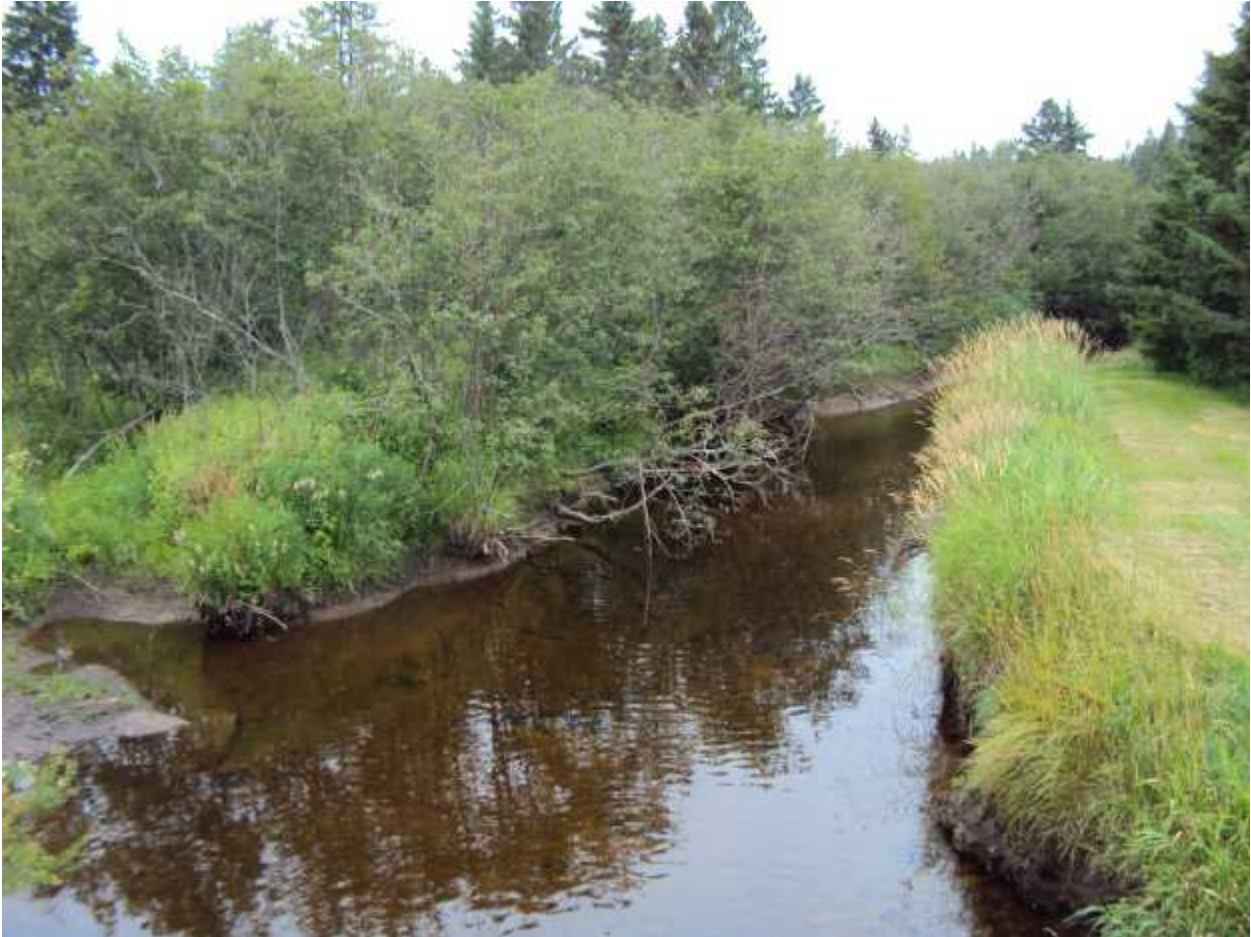
Joe Brook runs north-west under Mount View Rd. and flows into the north-western arm of Silver Lake. It runs through mostly rural, forested land upstream of the sample site and then becomes more residential downstream. Samples were collected upstream and to the east of the bridge on Mount View Rd. The site is a popular fishing spot.

*Photo 7: Joe Brook, upstream of bridge on Mount View Rd. in August*

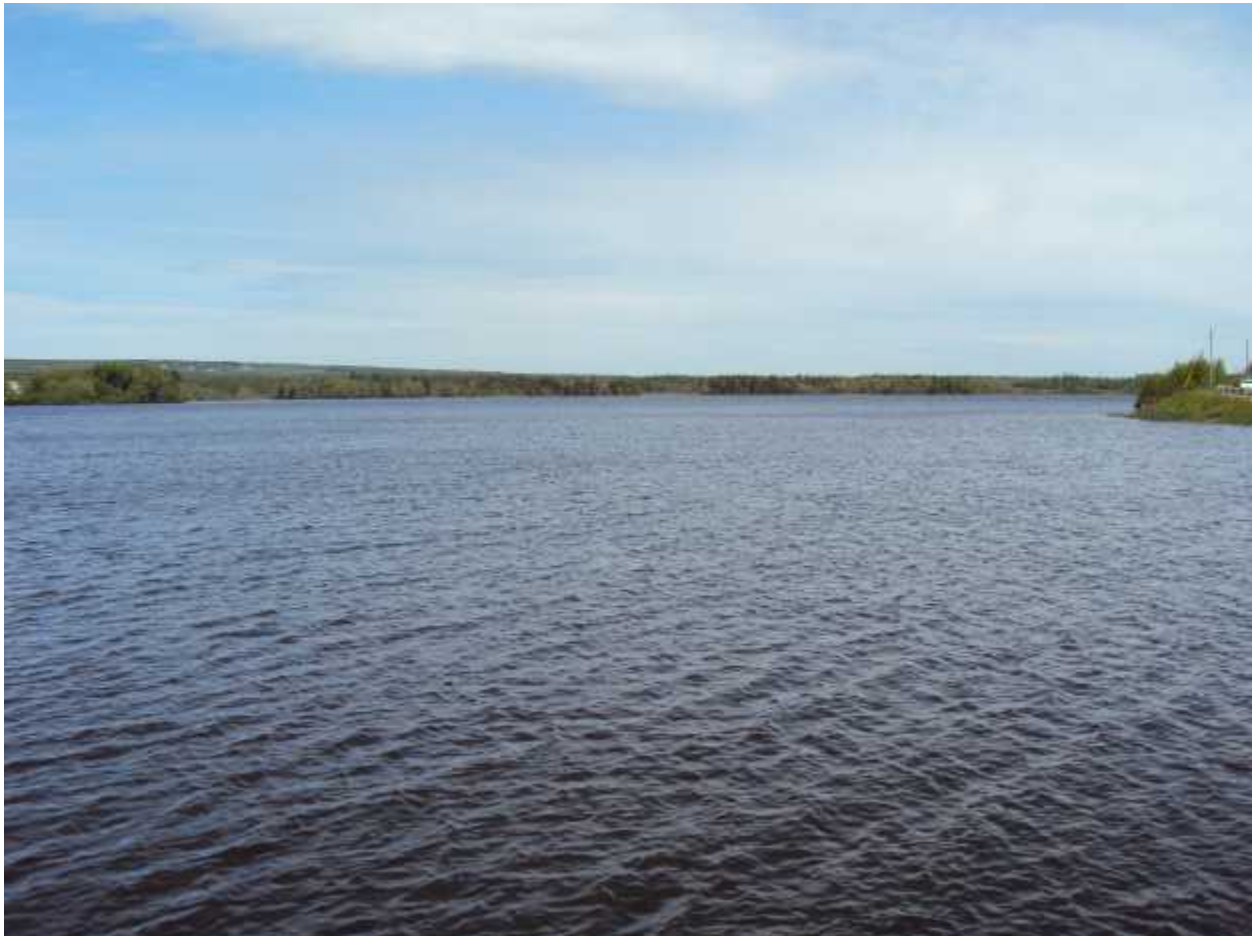
Silver Lake is located within Middle Sackville and was originally created as a mill pond. It is now used for recreational activities such as fishing, boating and swimming with moderate residential development surrounding it. There is a supervised freshwater beach at the southern end of the lake near Route 940. The site was chosen as it represents unique factors in the assessment of the watershed and for the strong public interest in the health of Silver Lake. Samples were gathered at the outflow point of the lake, upstream of the bridge on the 940. The area surrounding the sample site has rocky banks with little vegetation.

*Photo 8: Looking north-west of Silver Lake outflow sampling site in June*

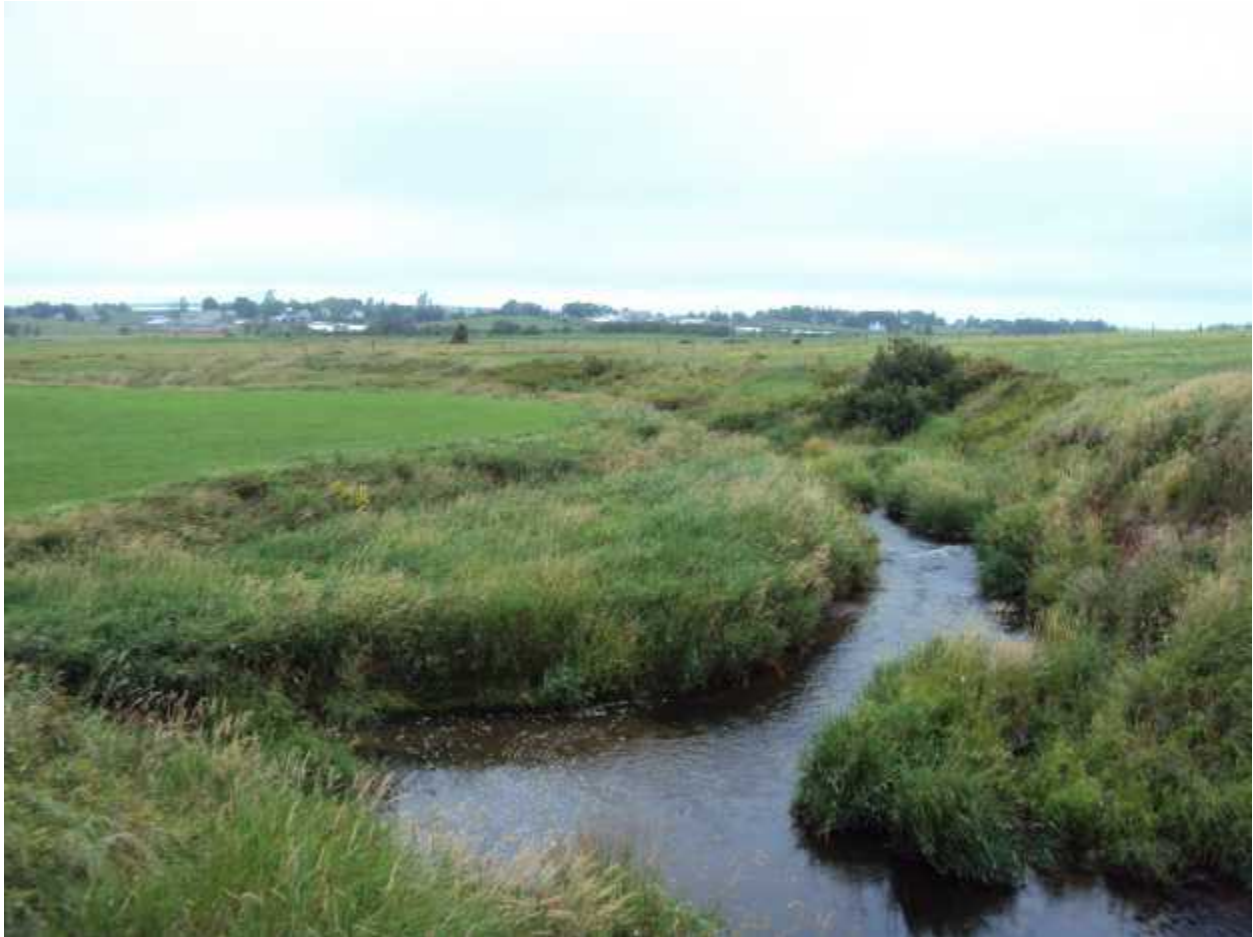
Morice Creek forms at the outflow of Silver Lake where it heavily meanders south-east through agricultural and conservation land before meeting the Tantramar River. The site is also downstream of the Middle Sackville sewage lagoon. Samples were collected upstream of the bridge on the south side. The site area was quite deep, had remanence of an old bridge, and grassy banks.

*Photo 9: Morice Creek, upstream of sample site on Folkins Dr.*

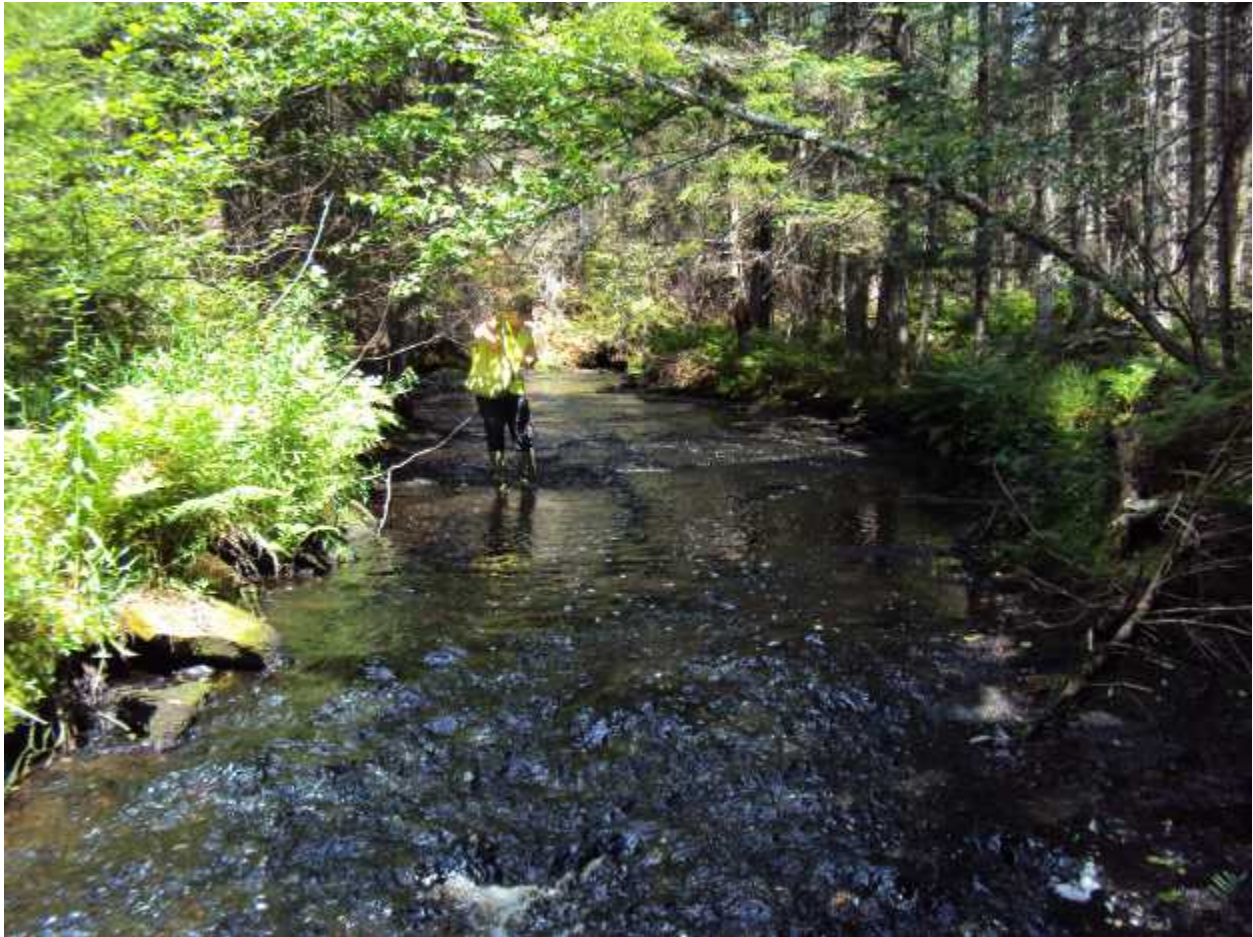
*Photo 10: Sampling Robinson Brook in July*

The site is located between the northern arm of Big Jolicure Lake on Brooklyn road past the Luciphy road intersection. It was chosen as it was previously sampled by ECCC for CABIN on September 16, 2010 and would capture information on a relatively undisturbed portion of the Tantramar watershed which flows into the Tintamarre National Wildlife Area. The shallow brook runs south through mainly rural, forested land.

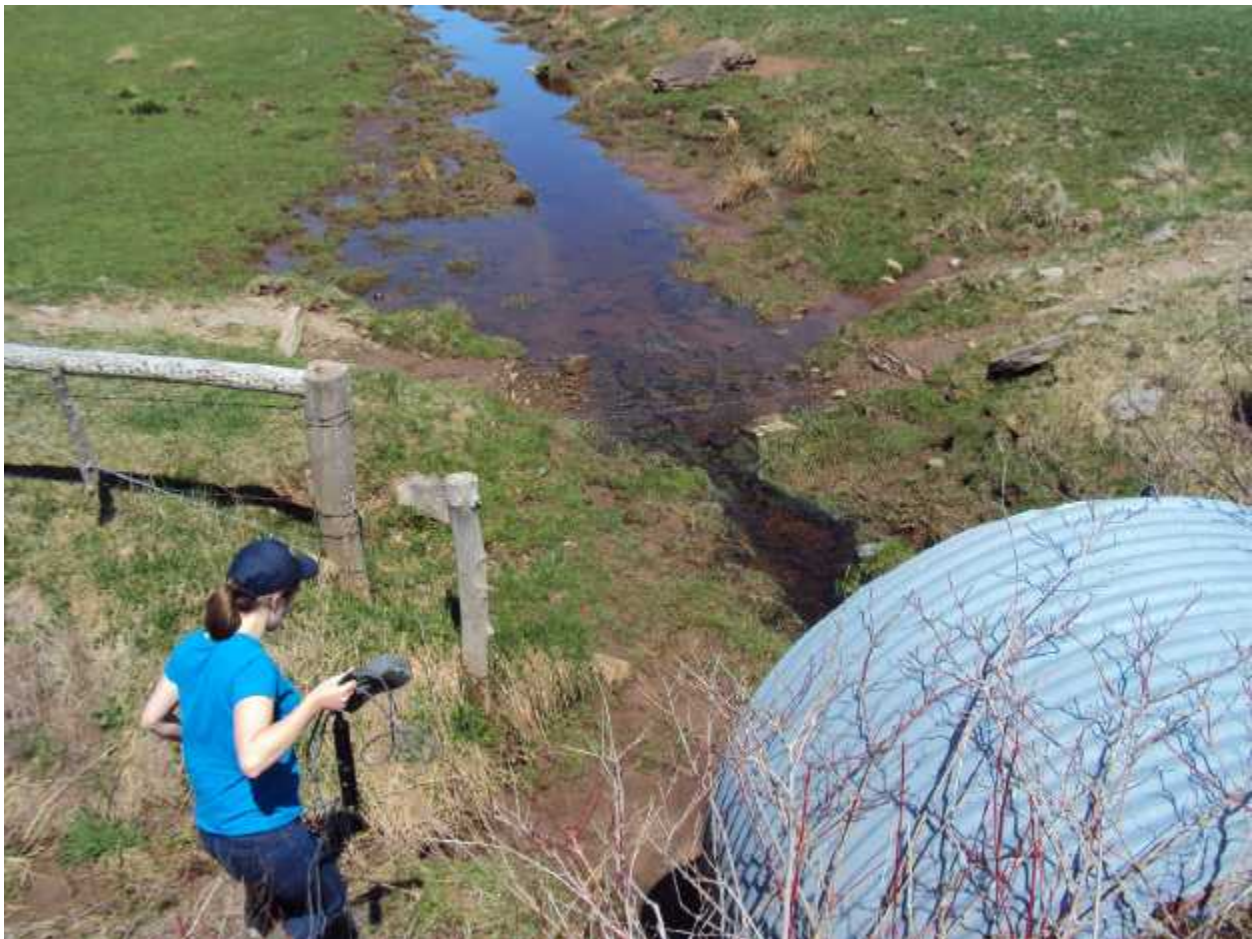
The sampling site is on Troop Valley Road, approximately 0.5 km from Jolicure road. Samples were collected downstream of Troop Valley Road and on the south side of the river. The sampling site showed slight bank erosion, a silty substrate, algae on shoreline, turbid water due to sediment disturbance, and signs of cattle who frequent a man-made watering hole close by and downstream to the sampling location.

*Photo 11: Aulac River during initial site visits in May*

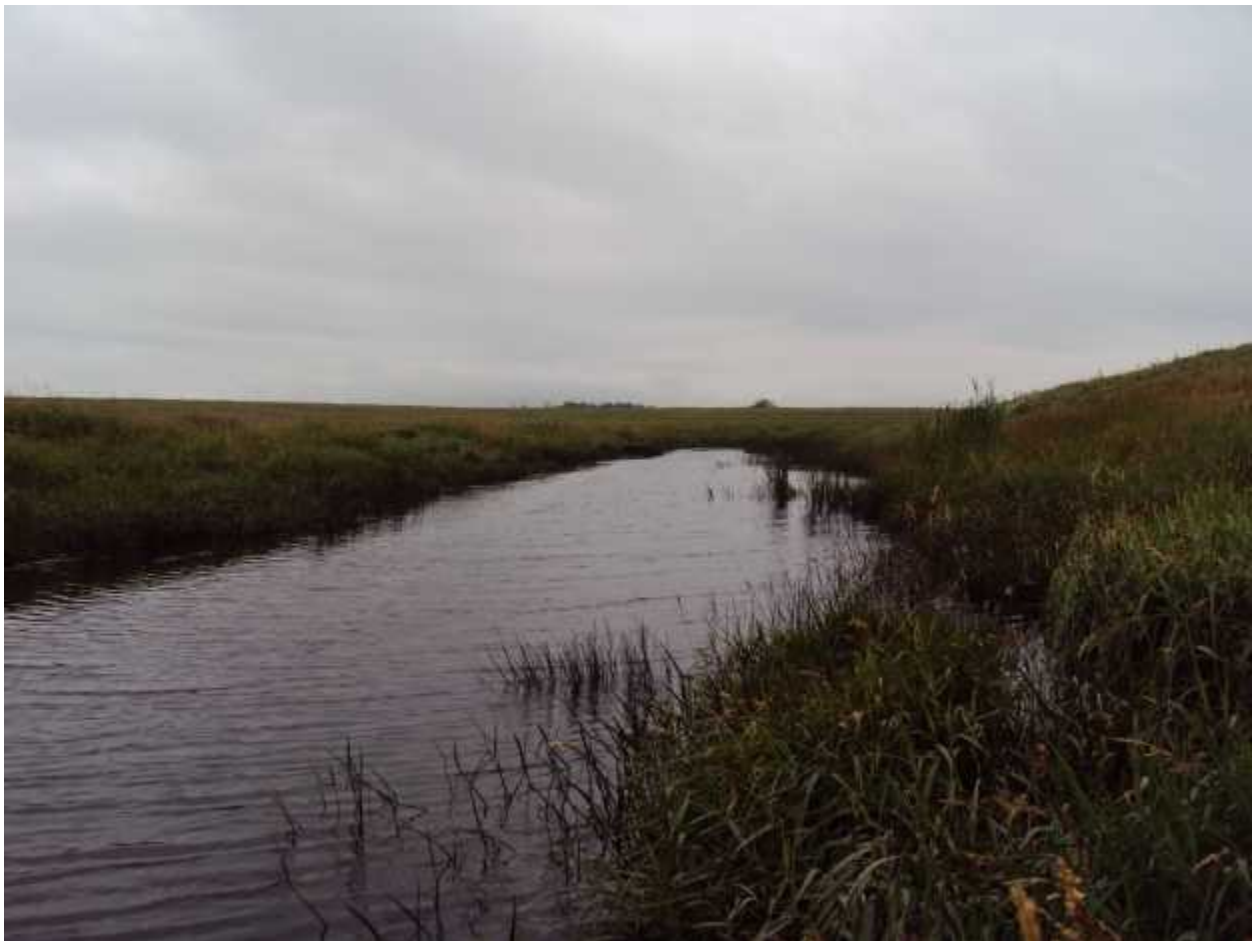
The headwaters of La Coupe River are the Jolicure Lakes within the Tintamarre National Wildlife Area. The river runs south-west, takes a sharp turn east downstream and joins the Aulac River where it continues on to be dispersed on the intertidal mudflats of Cumberland Basin. Upon exiting the wetlands of the protected wildlife area, the river runs through mostly agricultural land to the west and rural land to its east. The site was chosen to be sampled as it was the only accessible site in close proximity to the Aulac River. Samples were collected within the riparian area on the north side of the river. The area surrounding the sample site had grassy banks with a gradual slope and a flooded riparian zone. There was also algae lining the shores and possible cattle crossing downstream.

*Photo 12: La Coupe River, upstream of sampling site in August*

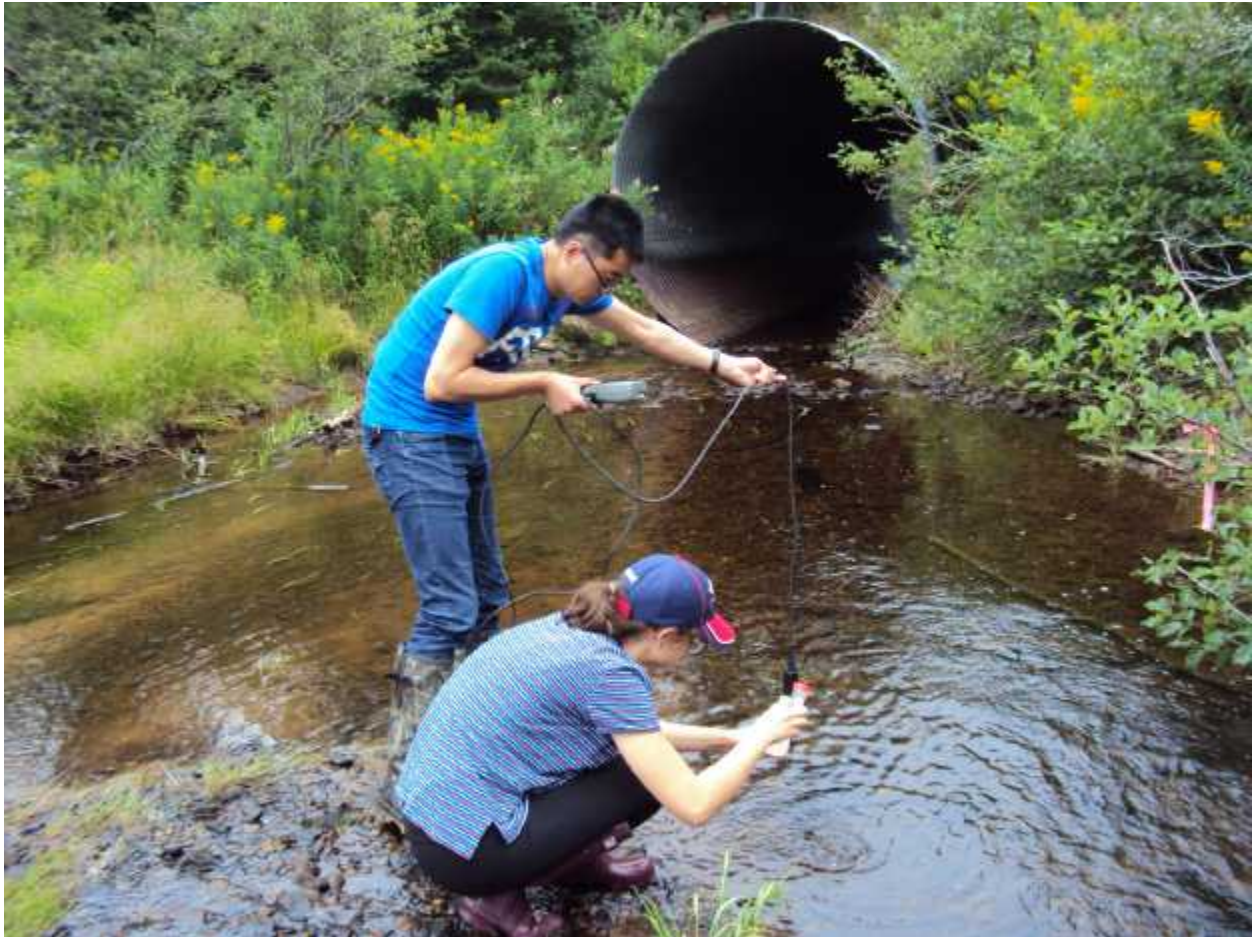
*Photo 13: Samples being collected by volunteers at the Reservoir Brook site in August*

Reservoir Brook flows southeast through mainly wooded areas west of Sackville. It eventually flows into Carters Brook and into the Tantramar River. Samples were collected upstream and to the east of the large culvert on Fairfield Road. At the sample site, algae is evident on the rocky substrate with plenty of deciduous and conifer trees, shrubs and grasses.

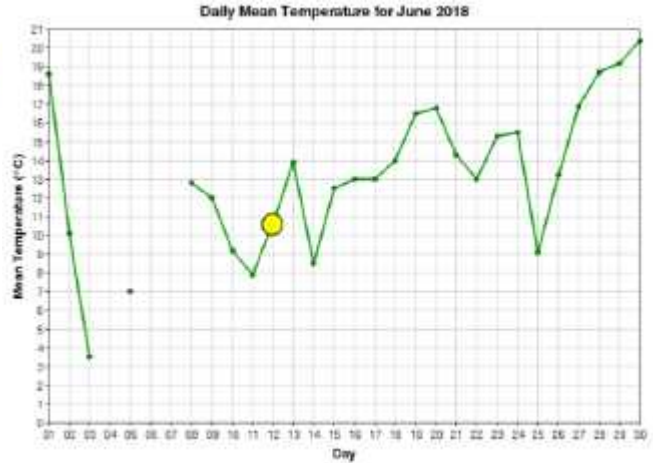
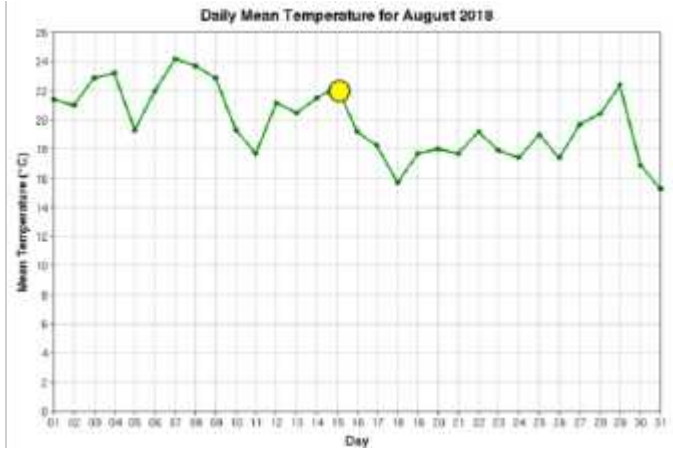
## Appendix 1 – Daily Mean Temperatures During Sampling Season

Note: yellow dots indicate sampling day. Data was sourced from Nappan, NS weather station (the closest one to Sackville/the Tantramar River Watershed).
