Water Quality Monitoring in the Cape Tormentine Watershed 2019 Water Quality Report

Date: March 2020
Kelli-Nicole Croucher, Watershed Coordinator
Eric Arbeau, Student Assistant

EOS Eco-Energy Inc.
P.O. Box 6001, 131D Main Street
Sackville, NB E4L 1G6
www.eosecoenergy.com

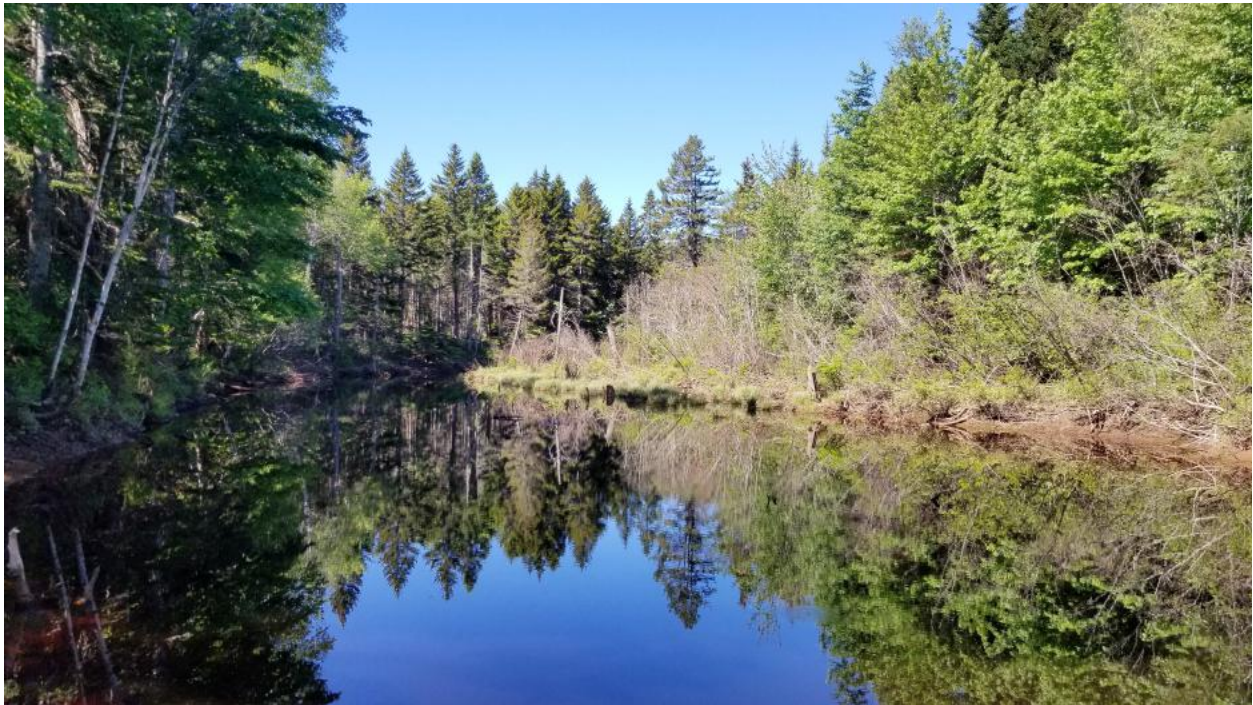
Looking Upstream Scott Brook off Noonan Road in July 2019 (Photo: KN Croucher)

Scott Brook meanders northeast from its point of origin where it runs under Noonan road before turning north. This site features a heavily blocked culvert under Noonan road which would disrupt fish passageway, as well as considerable bank erosion. The brook flows through dense forest near its origin, as well as agricultural and residential land downstream of this sampling site. Collected samples were taken upstream of the Noonan road culvert along the east bank.

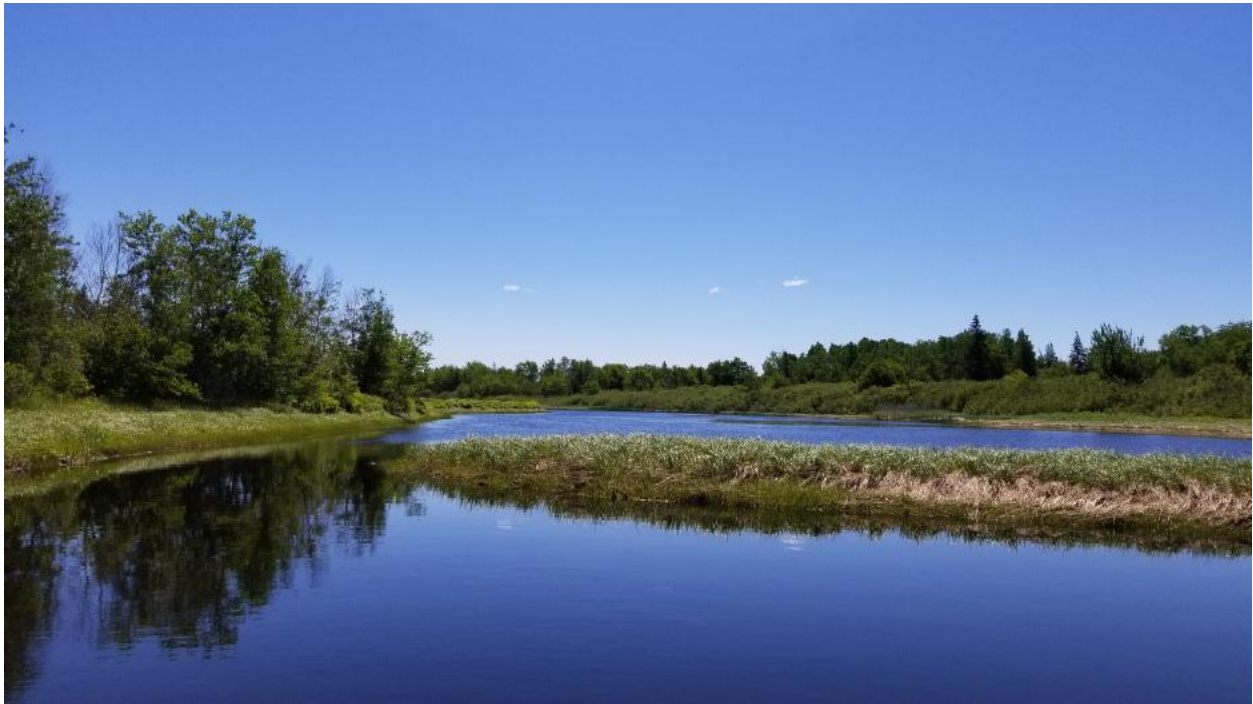
Looking Upstream Blacklock Brook off Route 955 in July 2019 (Photo: KN Croucher)

This site, at the mouth of Blacklock Brook, sees the brook flow through a culvert under Route 955 into the Northumberland Strait. The concrete structure at this site is the remnants of a DUC fish passageway. Samples were collected upstream of Route 955 from the concrete wall in the middle of the brook. This section of the brook has a wide flood plain with a mixture of vegetation (grasses, shrubs & trees) and flows mostly through rural forest and agricultural land. This site had an abundance of minnows present in May – July.

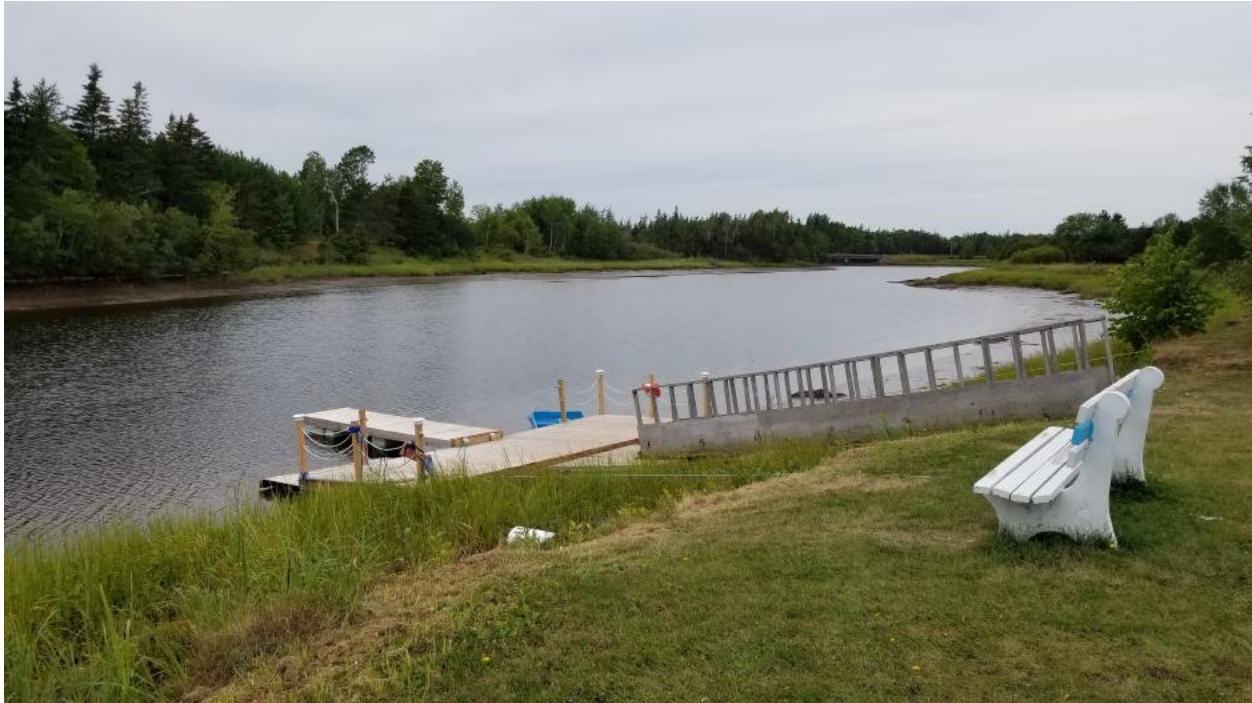
Dock Where Samples are Collected from Gaspereau River in Port Elgin, August 2019 (Photo: KN Croucher)

The Gaspereau River site in Port Elgin is located upstream of the Route 970 Bridge. The site is located within the village on Main Street, near many residential and retail buildings. This site is also used frequently for swimming, boating and fishing. This location is tidally influenced as it is near the mouth of the river, where it empties into the Northumberland Strait. Samples were collected from the community dock where Route 970 meets Main street. This site also had a sulphur smell in July & August.
