Improving Water Quality and Advancing Climate Change Adaptation in Tantramar with Rain Gardens and Other Low Impact Developments – Year 3 Report

January, 28, 2021

Submitted to Eco Action Community Funding Program

EOS Eco-Energy Inc.

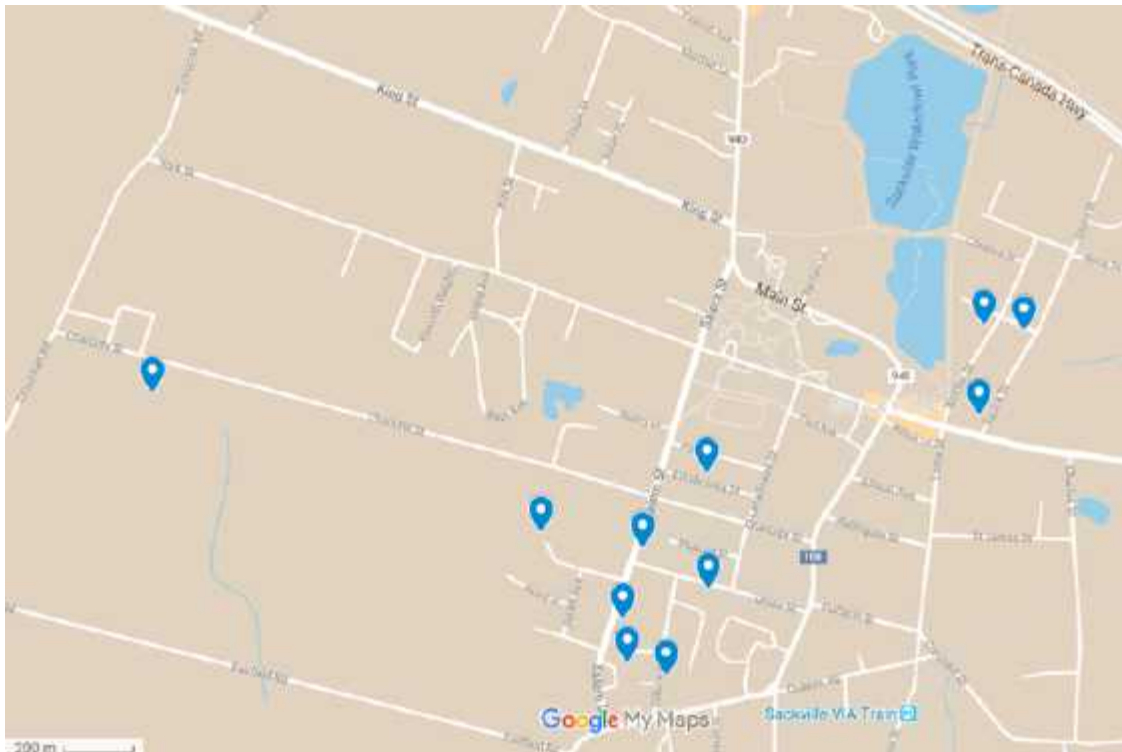
Map of Rain Garden Project Locations Summer 2020

During late spring and early summer 2020 we planted 11 rain gardens on residential properties in flood-prone areas of downtown Sackville, NB. This total surpasses EOS' goal by one extra residential garden. The garden locations are represented on the following map. The locations include a good distribution around town with gardens near Sackville Waterfowl Park (Weldon St., Squire St.), uphill from the Lorne St. area which has suffered chronic flooding issues (Estabrooks St, Union St., Hillcrest Ave., Salem St., Brenmar Cres.), and finally up at the top of Charlotte St. at a higher elevation that then drains through town.

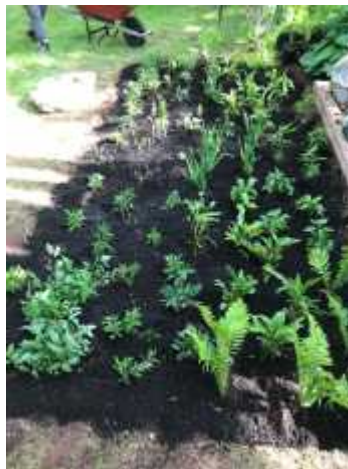
A 100 sq ft rain garden was planted in the back yard to catch rain from the end of a drainage pipe that collects rain from the driveway and adjacent property to direct it towards a culvert under the road that tends to clog. This rain garden will help catch the storm water before it makes its way to the culvert, preventing clogging. Prior to installation of the drainage pipe, flooding would occur during rain events adjacent to the driveway and garage. 4 volunteers helped dig and plant and garden. Neighbours came by to see what was going on which offered an impromptu educational lesson. The homeowner committed to, not only maintaining the rain garden, but to planting a second one once the first grows and fills in and she can divide the plants. The garden contains the following plants:

The plants at 9 Brenmar Cres. grew exceptionally well and started to fill out the garden space immediately, aside from the bloodroot which did not do well. Some plants also experienced mildew (asters & monarda). The homeowner noticed that some of the first-year plants (e.g. brown-eyed susans) had grown even better than their more mature counterparts throughout the property. This garden had the tallest joe-pye weed and irises out of all the gardens we planted. Bees were spotted in the turtlehead during EOS' fall visit and the homeowner noted that the garden provided great habitat over the summer to bees, insects, birds, etc. The homeowner expanded their rain garden, prepared an additional space near a downspout for another, smaller rain garden (we had previously identified it as a good spot during our property assessment), and acquired a rain barrel to help with water conservation on their property.

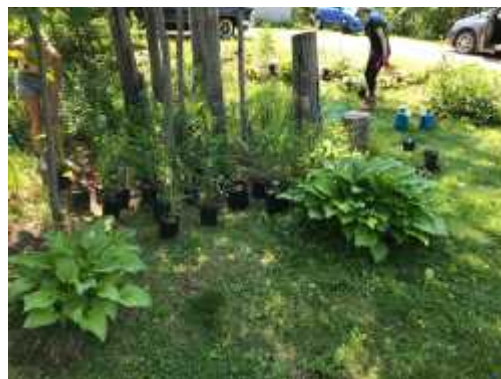
The homeowners have seen evidence of water pooling in front of the house at the base of the slope from the driveway and surrounding land. They remarked that it looks like a pond with heavy rainfall or following spring melt since the soil is clay rich with poor permeability. There has also been flooding noted in the culverts in front of properties down the street. A small rain garden (50 sq ft) was planted to help reduce water accumulation in the front yard. Two volunteers helped plant the garden with 33 plants spread over a 50 sq foot area. Plants selected prefer wet to very wet conditions and don't mind the shadier spot where this garden is located. Both homeowners committed to looking after their rain garden. The garden contains the following plants:

Despite the dry summer, the plants at 176 Charlotte St. appear to have done well. The homeowners noted that the few times we did have a good rainfall, the rain didn't pool as long as it used to. The homeowner has had a rain barrel at the back of the house for a number of years, and recently acquired a 2nd to install at the front of the house.

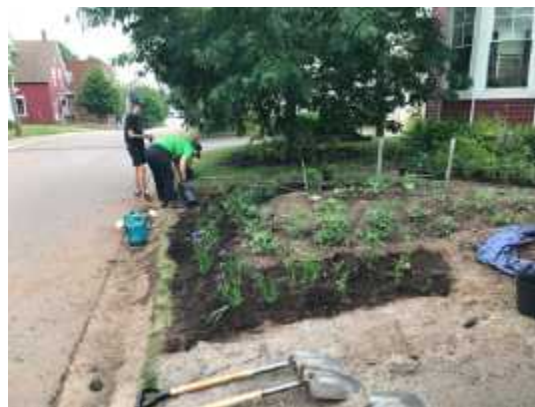
This rain garden was placed in a publicly visible location on the front lawn. This is a popular residential street that people walk on to access Bridge St. or Waterfowl Park. Areas around this property are lower lying and impacted by floods and poor drainage. The homeowners reported flooding in their basement and neighbours' basements during heavy rain events. This rain garden will help catch rain off the house roof (no eaves) prior to reaching the storm drains on the Weldon St. The 100 sq ft garden meanders around an existing vegetable garden and around a tree, helping to remove more grass on the front lawn and improve permeability on the property. Three volunteers helped plant the garden. The garden contains the following plants:

Most of the plants at 24 Weldon St. did well over the summer, except for the ferns which appeared to have dried up following the hot, dry summer. The coneflowers were still thriving near the back of the garden during the EOS visit in the fall. The homeowner mentioned noticing the garden did hold back the water when it rained a few times during the summer & fall. The homeowners also acquired a rain barrel to further help with water conservation.

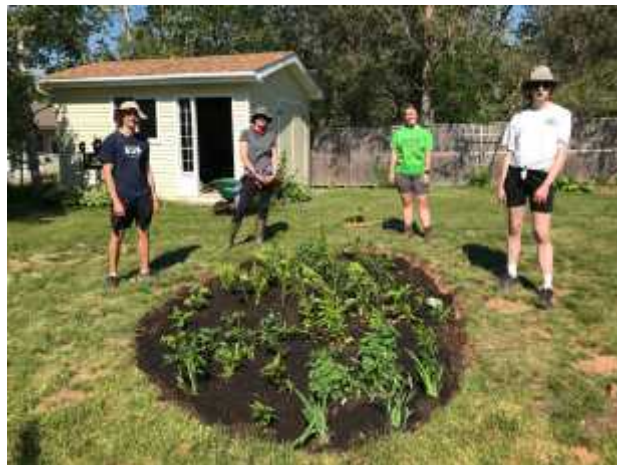
The rain garden was planted in the backyard near the bottom of the property. The land slopes toward the back of the property, bringing storm water from the driveway and upper part of the property, resulting in the bottom of the property being very soggy and muddy after rainfall and snow melt. The homeowner has started building a bio-swale at the bottom of the property to try to alleviate the soggy. This rain garden will help catch water before it reaches the bottom, reducing the soggy of the backyard. The garden was planted in an oval shape measuring about 100 sq ft. 4 volunteers helped dig and plant the garden. The homeowner committed to looking after the garden, watering it and maintaining it. The garden contains the following plants:

The garden at 17 Bowes Ave. grew well throughout the summer, however the ferns did not do well due to the dryness and some plants also experienced mildew (asters & monarda). Bees were flying around the pink turtlehead during the fall EOS visit. The homeowner noted that the summer was so dry that even the base of their property which is usually always damp/soggy was dry. By the fall, the homeowner expanded their rain garden into a larger kidney bean shape and acquired a rain barrel to help with water conservation on their property.

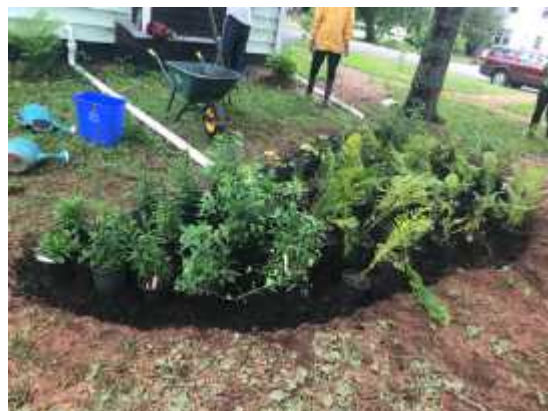
This rain garden was planted on the left-hand side of the house catching rain off of the roof as two of the rain gutters/eaves are directed towards this site, as well as from the driveway since the property is sloped slightly down towards the back of the backyard. The road culverts around this property tend to fill in the springtime. The driveway used to pool water before the homeowners covered it in woodchips. The 100 sq foot garden has an organic kidney bean shape and is located in a shady area so that plants selected can tolerate at least some shade. Two volunteers, one homeowner and two children helped dig and plant this garden. The homeowner committed to maintaining his garden and directing a third downspout into the garden. He also committed to teaching his children about the plants in the garden and his young daughter was already an avid wild plant forager! They were excited to be planting wild beebalm (monarda). The garden contains the following plants:

The garden at 9 Hillcrest Ave. took a bit of a beating with the dryness this summer. Some of the ferns were visibly dried up on our fall visit, however the other plants seemed to have fared well.

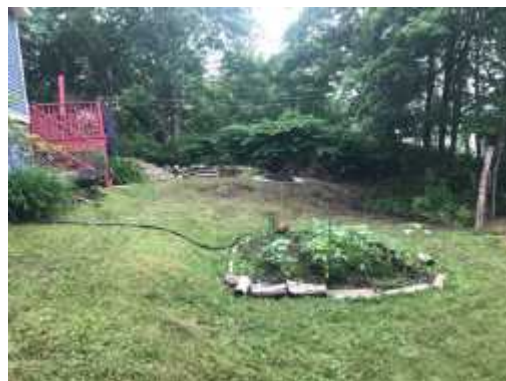
The location of the rain garden on this property changed slightly from the front lawn to the back yard as the backyard collects runoff from the road as well as rainwater from the roof. The location of the rain garden helps keep storm water out of storm drains further below on Park St. There are no roadside ditches or curbs on Estabrooks Street, so the rain & storm water travel downslope from the property across the street, into the front yard, and continue across the property down to the backyard where there has been evidence of flooding observed by the homeowners. The 100 sq ft rain garden was planted with the help of 3 volunteers and one homeowner. During the planting it was raining, and town staff came to house next door to investigate reports of flooding at that location. These next-door homeowners decided they too would look into a rain garden for the future. The homeowner committed to looking after his garden. The garden contains the following plants:

The garden at 15 Estabrooks St. did very well over the summer. The homeowners noted an improvement in the area after rainfall that usually would be soggy. During our fall visit the brown-eyed susans, coneflowers, and pink turtleheads were in bloom and thriving with lots of insect visitors. The Town of Sackville did some work on the north side of Estabrooks Street to direct heavy rain flow along the street into the homeowner's sumac patch on the east end of their property instead of into their neighbour's house.

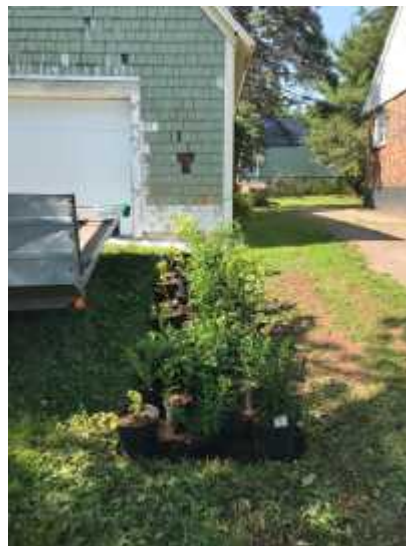
This rain garden was placed in a publicly visible location between two driveways on Milner Avenue (the back entrance to 30 Squire). This street sees foot traffic from people walking to the Sackville Waterfowl Park entrance at the end of Morgan Ln. Water from 3 neighbouring backyards, and off of the garage roof, flow downwards towards the road. This rain garden will collect the water before it reaches the road, preventing it from entering the storm drain system. It is a small 50 sq foot garden containing 39 plants. One volunteer helped plant the garden. The garden contains the following plants:

The garden at 30 Squire St. did well over the summer and was observed by EOS staff to be growing well in the fall. The homeowner noted that the area of their yard where the rain garden was planted was a little dryer during rain and heavy rain episodes than before. The Town of Sackville also did road work adjacent to the rain garden to help with storm water in the area.

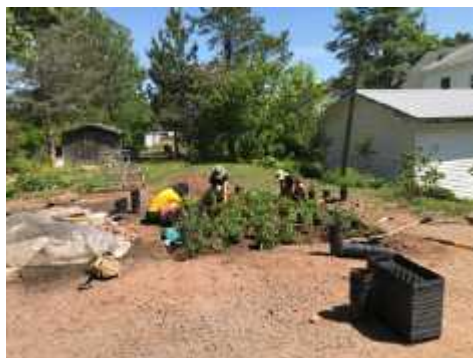
76 Salem St.

Water collects and pools on the driveway located on the left-hand side of the house. There are no eaves on the house, so all the rain falls off of the roof as well. There is a slight slope, so the stormwater tends to flow off of the driveway towards the backyard. This rain garden will collect the storm water from the driveway, as well as off of the neighbors shed roof. The garden was dug in part of the heavily compacted gravel driveway as the homeowners wanted to reclaim some of the large parking area. This site was effectively a depaving site which received a rain garden. The homeowners spent many hours digging out the 100 sq foot garden. Thus, we had 4 volunteers help dig and plant the garden. The homeowners were thrilled to receive so many plants and apart from committing to maintain the garden, they also promise to share the plants once they grow and need to be divided. They are looking forward to helping create other rain gardens with their plants in the future. The rain garden is visible from Union St. The garden contains the following plants:

The garden at 76 Salem St was planted in part of the heavily compacted gravel driveway. The homeowners wanted to reclaim and restore this section of the driveway to catch rainwater and restore the soil. They have plans to use a permaculture approach in their small backyard. The garden was planted in full sun and did very well all summer. The homeowner would like to plant an additional rain garden.

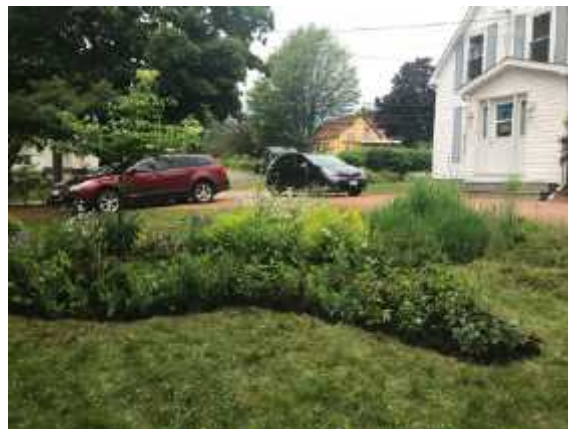
This 100 sq ft rain garden is located near the front of the property next to the house. It is an extension of a pre-existing garden. Runoff flows downslope from the driveway to the back field of the property where there is evidence of flooding in the spring. This rain garden will help catch water from the driveway, as well as part of the roof, as one of the eaves is directed toward the proposed garden location. Two volunteers and one homeowner helped with the garden. The garden contains the following plants:

The plants at 98 Salem St. did very well this summer, aside from the joe-pye weed which dried from the bottom up despite the homeowner watering (potentially due to a nearby tree taking up the water instead) and the asters & monarda experiencing mildew. The homeowner was very happy with how the garden turned out. It was their first time having pink turtleheads in a garden and they flowered very nicely. The homeowner also enjoyed seeing the swamp milkweed flower and then produce seed pods.

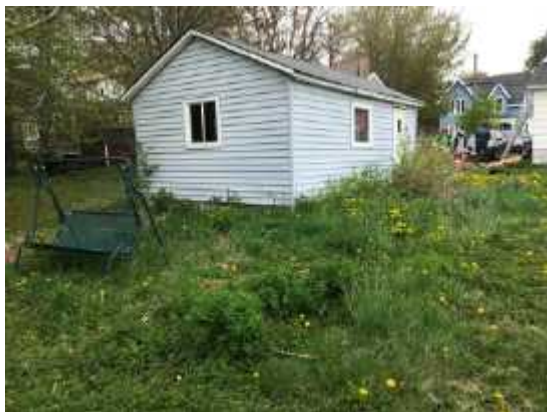
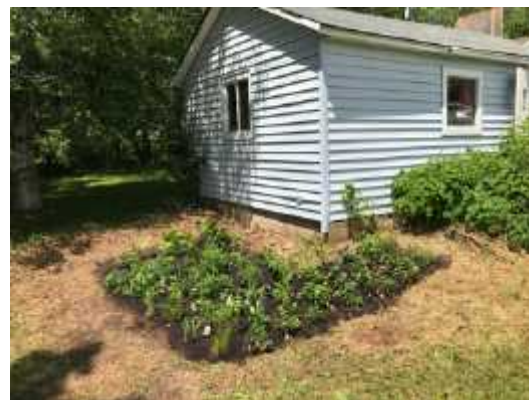
Before After

This rain garden was planted to catch rain off the garage roof and the sloped backyard. The site was changed from the proposed front lawn to the backyard because it receives more rainwater pooling, and a rain garden would be more beneficial there. It will help catch rain and reduce the amount of runoff that would reach a ditch behind the house. The homeowner has experienced basement flooding and has seen swampy patches in the backyard. The 100sq foot rain garden is visible from the street and was planted with the help of 4 volunteers, two children and one cat. The homeowner and her children were excited to look for butterflies that the garden would attract and committed to watering it a lot during this dry time of the summer and looking after it in the long-term. The garden contains the following plants:

The garden at 30 Union St. did well this summer, though the ferns didn't thrive. Bees were seen flying around the garden during our fall visit. The homeowner had a backwater valve installed earlier this year (through an EOS bulk purchase) and plans to install a few gutters on the house before the snow falls.

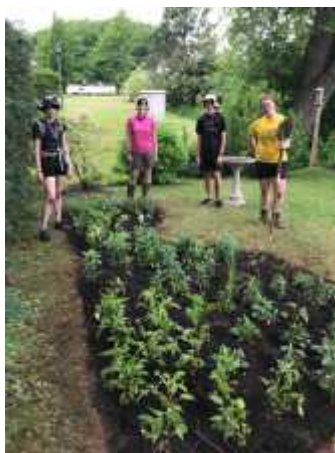
This property is located in an area prone to flooding in Sackville. While the homeowners do not experience flooding on their property, they do see pooling of water in the park behind their property following a heavy rain and all the storm water on their property flows downslope to the park. This rain garden was located in the backyard to catch water downslope of the driveway before it reaches a municipal park and a street that is flood prone. The garden is visible from the municipal park at the rear of the house. The 100 sq foot garden was planted with 91 plants. Three volunteers helped the plant the garden. The homeowner committed to looking after and maintaining his new rain garden. He had many other beautiful gardens on his property. He also committed to chronicling the development of the garden and taking photos of it often to share with others. The garden contains the following plants:

The garden at 4 Squire St. looked very healthy and well organized during our fall visit. Bees were visiting the flowering pink turtlehead and black-eyed susans. The homeowners acquired a rain barrel to further conserve water on their property. The homeowner was happy with the vibrant colours in the garden throughout the season and planned to save milk weed seeds to be planted elsewhere.

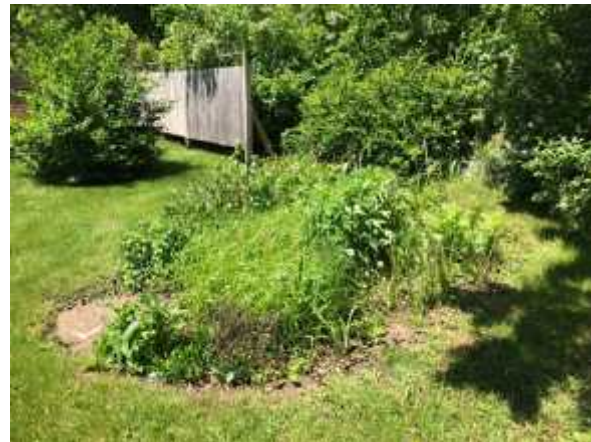
10 Bennet Street. We had planted around a shrub which has since been removed by the homeowner and this is the bare patch in the garden.

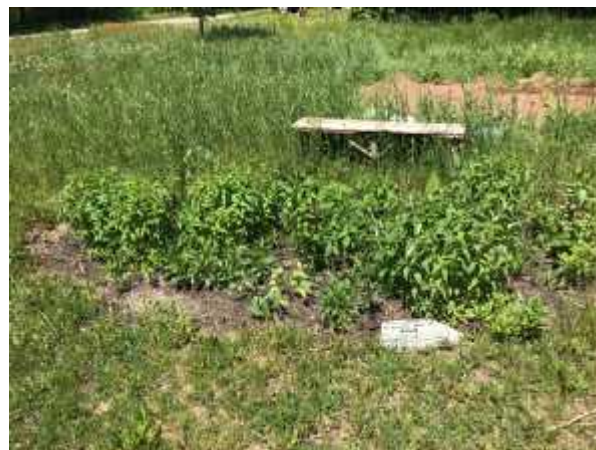
100 Bridge Street. The addition of the rustic bench by the garden adds a nice touch.

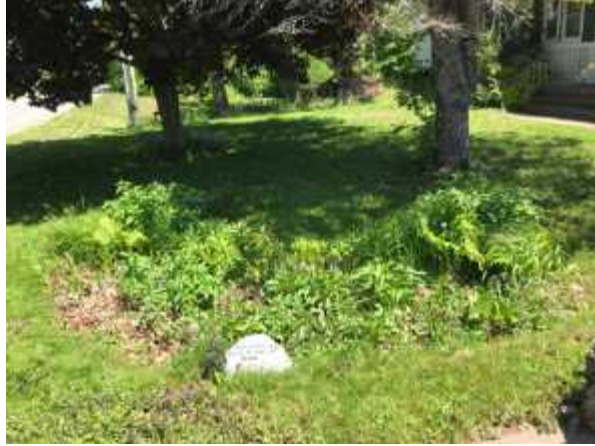
25 Harris Street. The kidney shape and symmetrical planting looks great still.

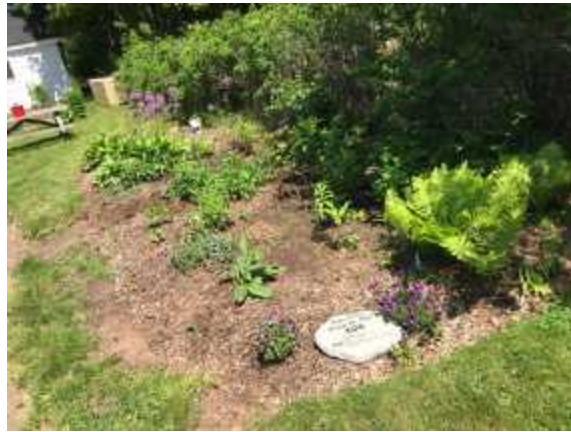
11 Morgan Lane. The homeowner definitely over-weeded her garden. The perennials that remain will fill in and spread in over-time though.

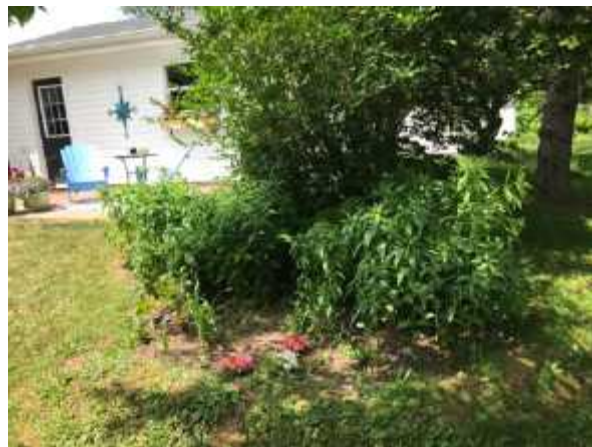
9 Clarence St. Some of the irises did not survive in this garden and the homeowner has since replaced them with other flowers.

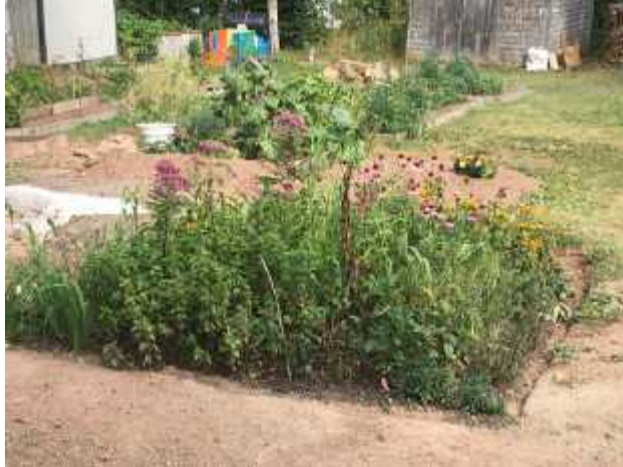
Rain garden in late summer (planted in a driveway to help restore the soil and absorb runoff). Photo credit: L. King

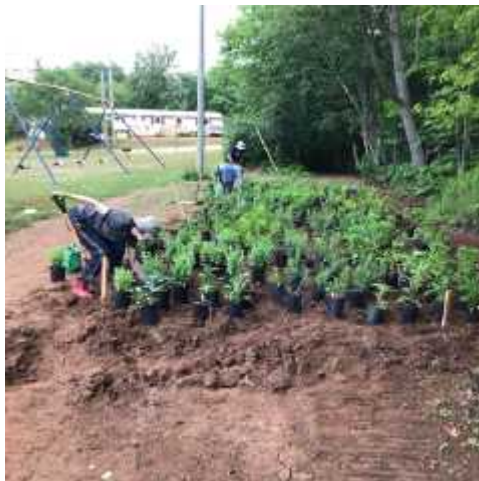
Planting the Dorchester Rain Garden. Photo credit: A. Marlin

EOS was able to purchase 128 plants and the Village contributed funding for another 207. Because the funding from Dorchester came only late in the spring, our plant order has some substitutions (liatris and sedum) because no more native plants could be found so late in the season. These plants are favourable to pollinators and butterflies and are often found in rain gardens. The Village of Dorchester prepared the site with topsoil. EOS staff and seven volunteers helped plant the rain garden over an 8 hour day. The Village committed to watering the garden daily until it is growing on its own and they will continue to maintain it. They also plan to plant additional trees and shrubs along the back of the park. A neighbourhood child was also interested in the garden and told us she commits to bringing a water bottle to water the garden and look for butterflies.

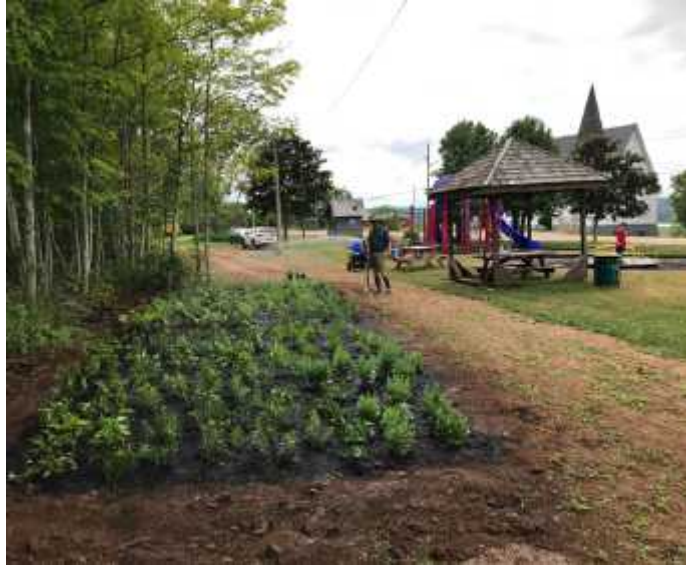
Freshly planted Dorchester Rain Garden. Photo credit: A. Marlin

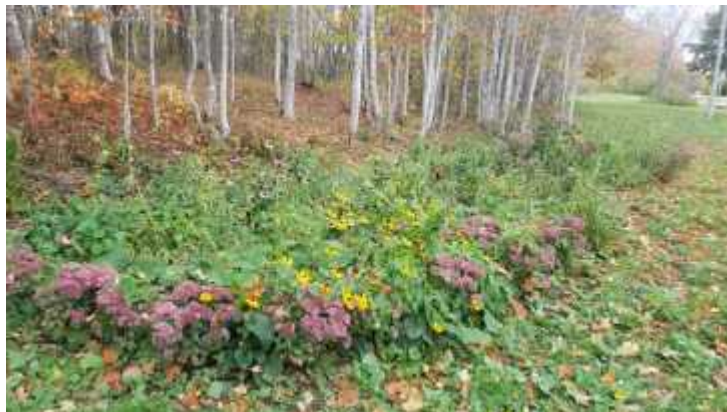
Dorchester Rain Garden in the fall. Photo credit: KN Croucher

A follow up visit was performed later in the fall to see how the rain garden did throughout the summer. The Village thought the rain garden project worked out great. They stated that “The garden has helped beautify a section of Richard Park which has needed attention for many years. The project was the motivator to clean up the area.” The garden creates “a pleasing transition from park to wooded area where trails are being added”. The plants all seemed to do very well at this location. It was great to visit the garden at different times throughout the summer & fall to see the colour scheme change as the different plants flowered.

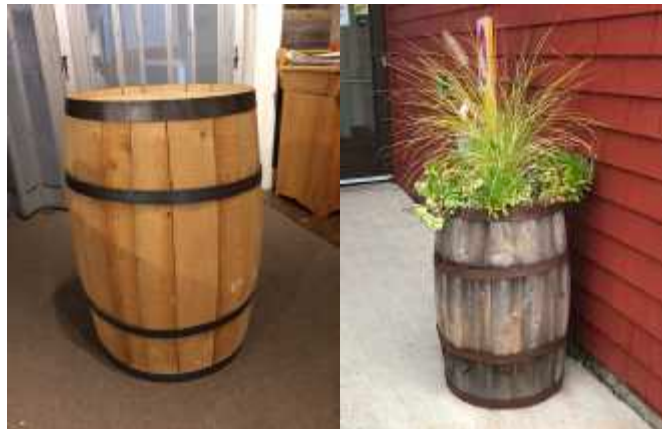
- For a more natural, rustic look, you can let your rain barrel weather and gray naturally.
- If you would like to preserve the colour of the barrel, a water and weather sealer can be applied to bring out the grain of the barrel or you can use a wood finish to stain the barrel a colour of your choice.

New Barrel

Naturally Weathered Barrel
