Riparian Health Assessment of the Gaspereau River

F209-125

January 2020

EOS Eco-Energy Inc.

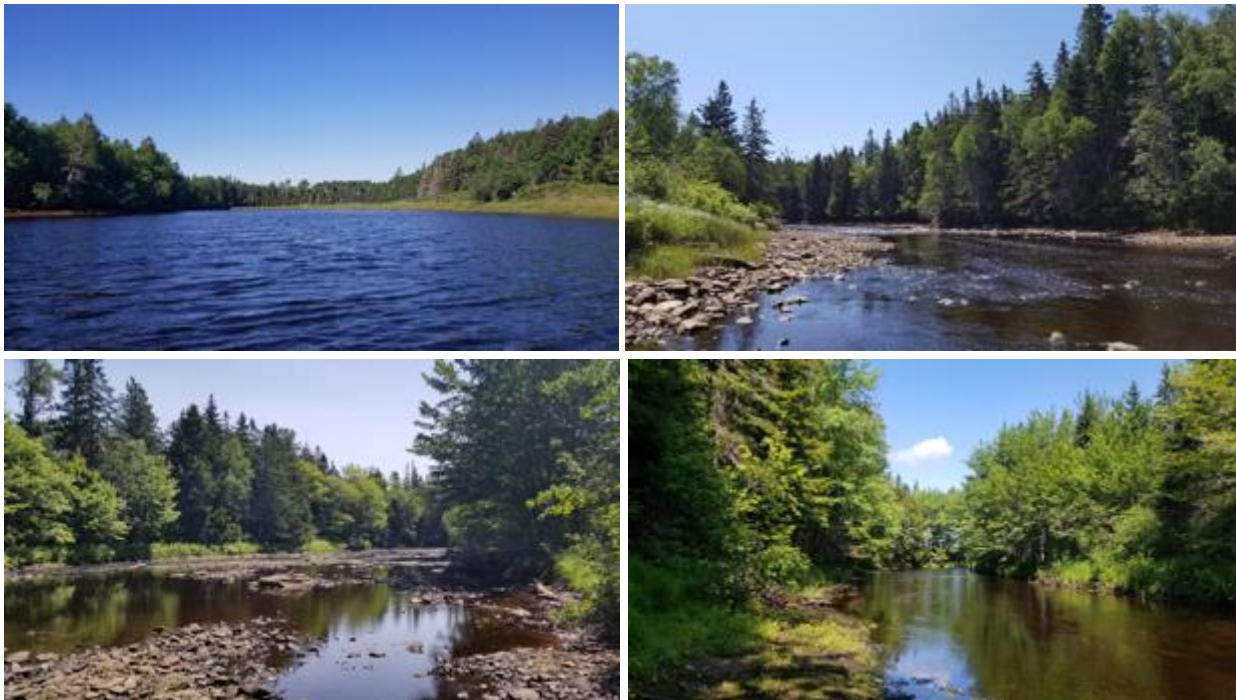
Some indicators of a healthy riparian area include abundant vegetation with very little exposed soil, bare ground, or altered banks (as demonstrated in Figure 3). In particular, the vegetation should consist of

Figure 3: Examples of healthy reaches of the Gaspereau River

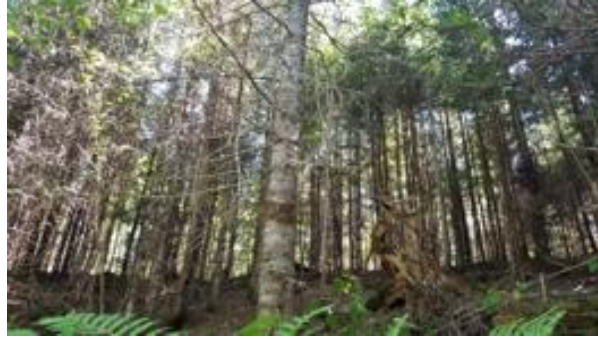
The first 4 assessments (~ 2 km) of the river were healthy with problems. This is mostly due to the human impact and clearcutting in this area. There were invasive and disturbance caused plants present. However, the biggest issue was the lack of streambank root mass protection (4/6) and the reach being structurally altered by human activity (clearcutting, 0/3). Clearcutting was noticeable while walking the river for the first kilometer with thinned out trees or younger (1-3 inch trunk) conifer plantations (Figure 5). The Coburg Road access point also appeared to be a popular gathering spot for campfires as beer cans and other food packing was scattered around the end of the road down to the banks of the river. This continued throughout this reach of river, with debris and garbage being found a ways downstream. There was also a good amount of industrial debris within the first few kilometers (e.g. tires, oil canisters, beams of wood, material scraps from erosion fencing, etc.).

Figure 5: View of conifer plantation from river

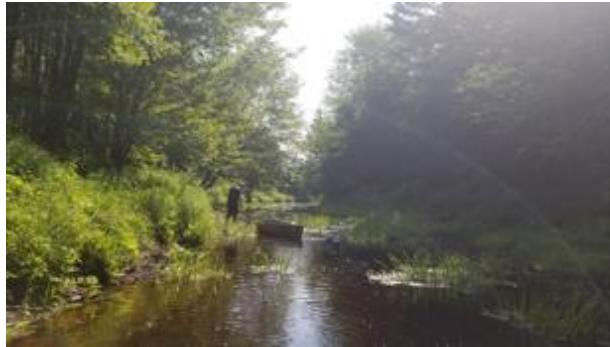
A big challenge of this project was site accessibility. To start, there were a limited number of access points to get into the river. The Coburg Road/logging road access point we took advantage of we not in favorable driving conditions until later in the summer (after having attempted to drive it at the start of the summer). Similarly, as we started to get more rain at the end of the summer/start of fall, the logging roads became unfavorable to drive again making it difficult to access the final section of the river towards Route 940 as we had wanted to. In addition, the river frequently changed from being wide and shallow enough to walk in (Figure 10), to channelized and deep, where you would want a canoe to paddle through or would have to climb up the steep riverbanks to follow alongside the river.

Figure 10: EOS staff pulling canoe through shallow section of the river

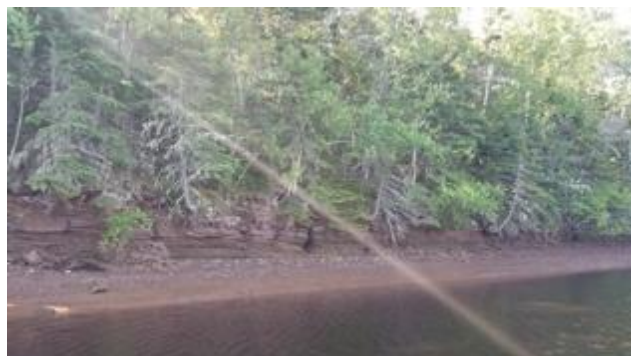
There was also evidence of this access point being a popular campfire spot and hunting spot (hunting stands along the river). Lots of gaspereau were swimming in this stretch of river. Progressing downstream the river widened out again with grassy, easily accessible flood plains and mud flats present depending on the tide. There was also a stretch where the river bank on the right-hand side facing downstream was on a ~ 90° with sedimentary rock (Figure 13).

Figure 13: Sedimentary rock shoreline

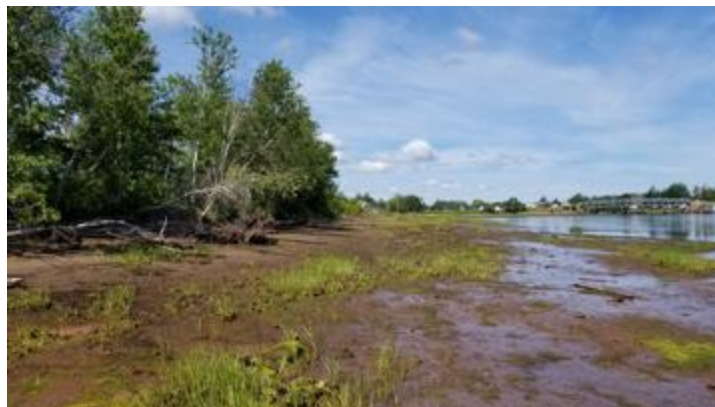
The last two assessments were from the Main St. bridge down to the Trans Canada Trail bridge (Table 6) and from the Trans Canada Trail bridge to the river outflow (Table 7). Both these assessments were healthy with problems overall. Their vegetation ratings were both healthy with problems and their soil/hydrology ratings were unhealthy. This stretch of river goes through the heart of Port Elgin, passing under 2 bridges and passing the community dock. Human streambank alteration lowers the soil/hydrology scores in these assessments. This stretch of the river is also tidally influenced and transforms into mudflats at low-tide (Figure 15). The bottom stretch of this river has experienced drastic streambank erosion (Figure 16). In October 2019, after our assessment was complete, EOS partnered with NatureNB, the Village of Port Elgin, and Shediac Bay Watershed Association to plant 130 trees along an eroded section of the Gaspereau River to help stabilize the streambank and help protect the village sewage lagoon.

Figure 15: Mudflats at low tide at bottom of Gaspereau River
